CAMP FIRE

Watershed Emergency Response Team

Final Report

CA-BTU-016737

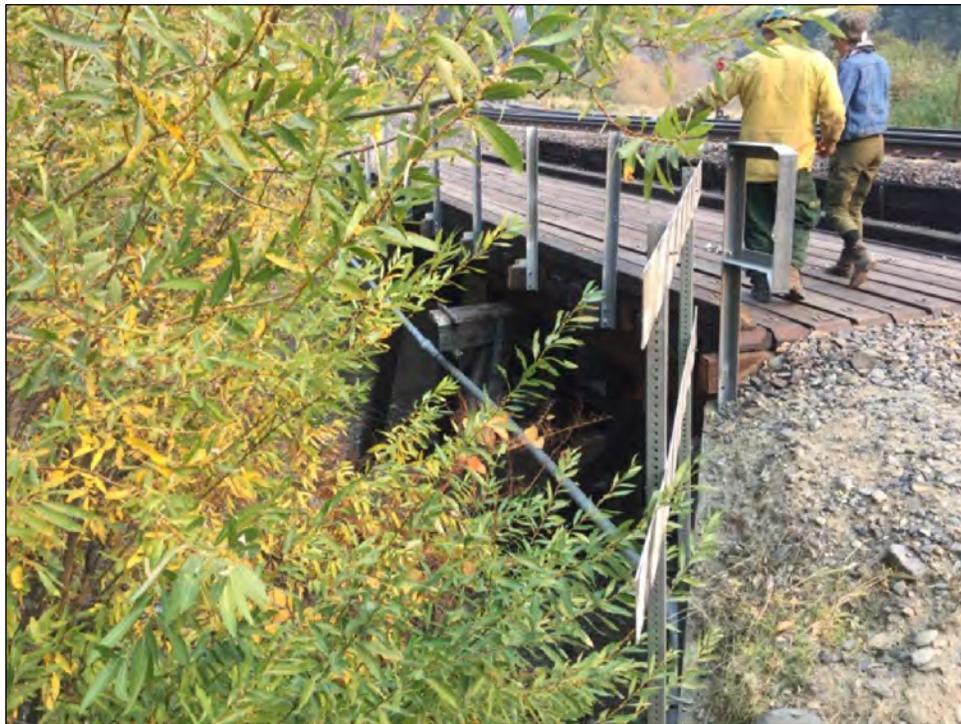
Potential Hazard to Life: low
Potential Hazard to Property: high
FEMA/DWR 100-yr Floodplain: yes
Preliminary Emergency: Storm patrol
Protective Measures

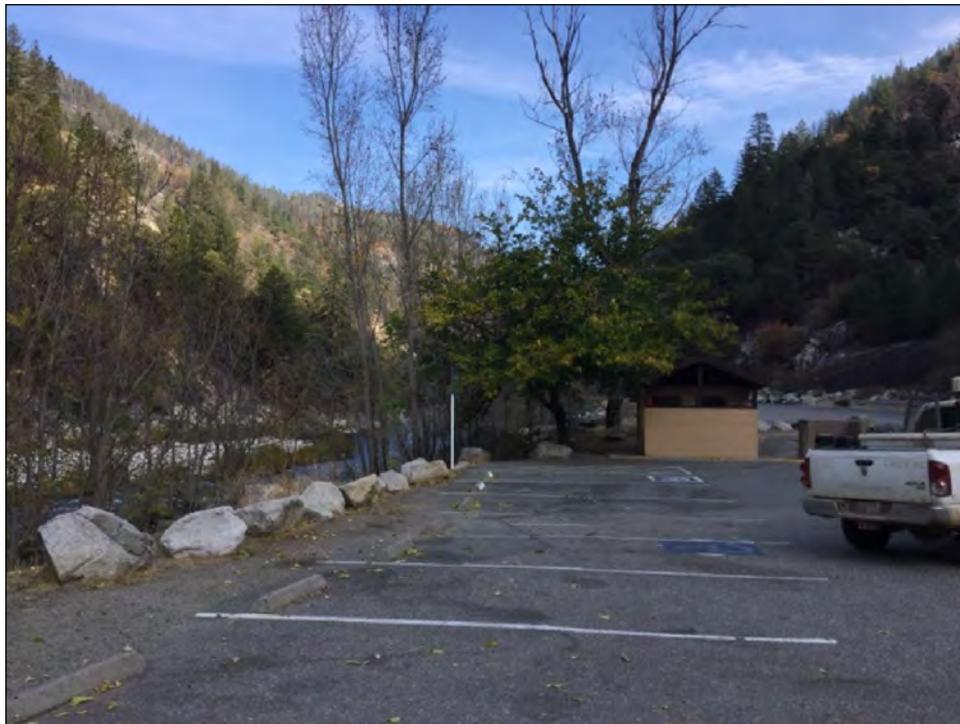
Potential Hazard to Life: low
Potential Hazard to Property: low
FEMA/DWR 100-yr Floodplain: yes
Preliminary Emergency: Early warning system. Close facility during heavy storms.
Protective Measures

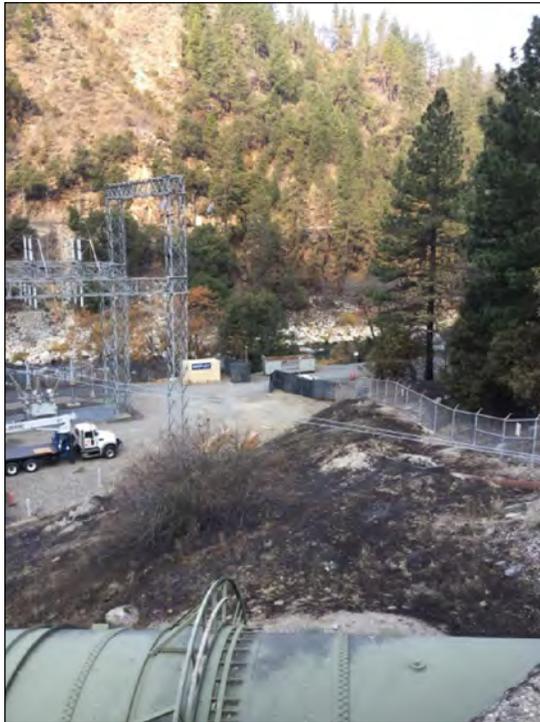
Potential Hazard to Life: low
Potential Hazard to Property: low
FEMA/DWR 100-yr Floodplain: no
Preliminary Emergency: Early warning system. Notify PG&E.
Protective Measures

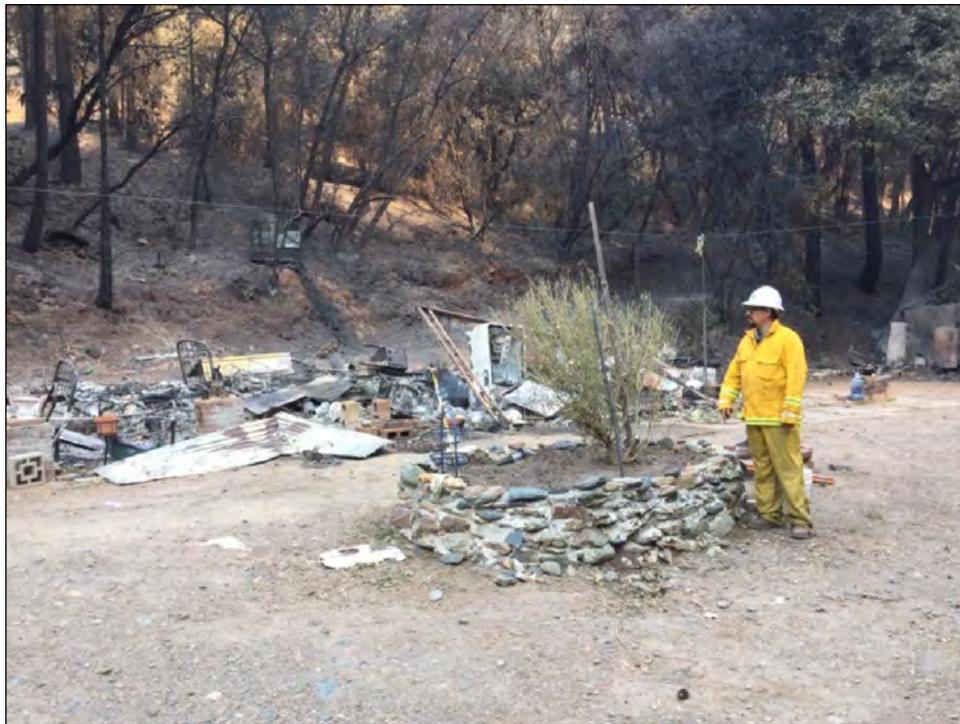
Potential Hazard to Life: low
Potential Hazard to Property: low
FEMA/DWR 100-yr Floodplain: yes
Preliminary Emergency: Early warning system
Protective Measures

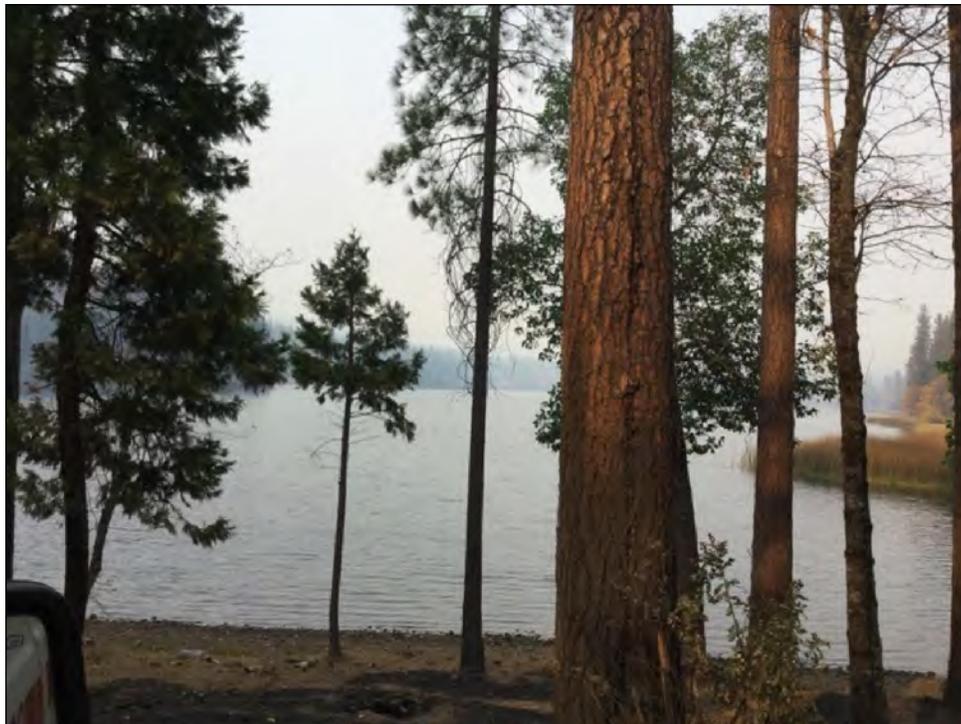
Potential Hazard to Life: no
Potential Hazard to Property: low
FEMA/DWR 100-yr Floodplain: yes
Preliminary Emergency: Notify local water district
Protective Measures

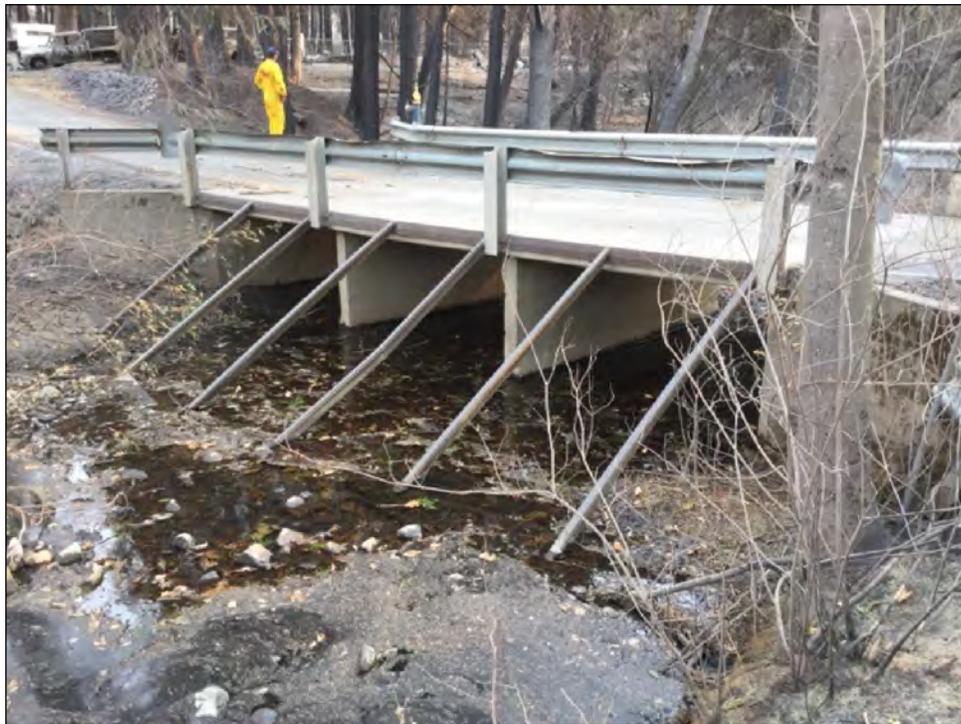
Potential Hazard to Life: low
Potential Hazard to Property: moderate
FEMA/DWR 100-yr Floodplain: no
Preliminary Emergency: Storm patrol
Protective Measures

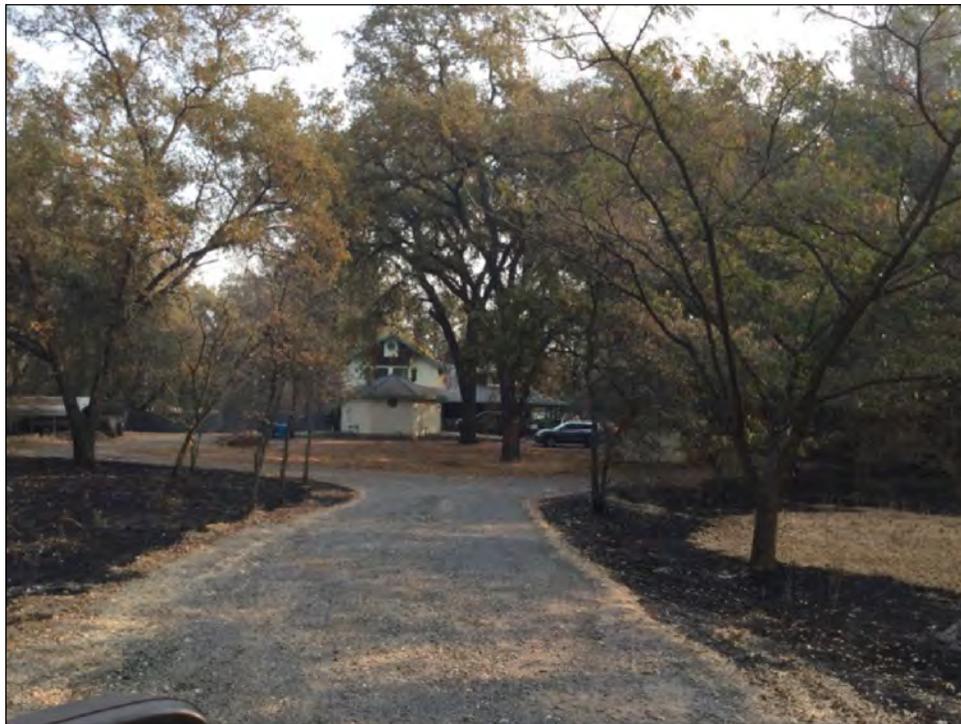
Potential Hazard to Life: moderate
Potential Hazard to Property: moderate
FEMA/DWR 100-yr Floodplain: no
Preliminary Emergency: Early warning system
Protective Measures

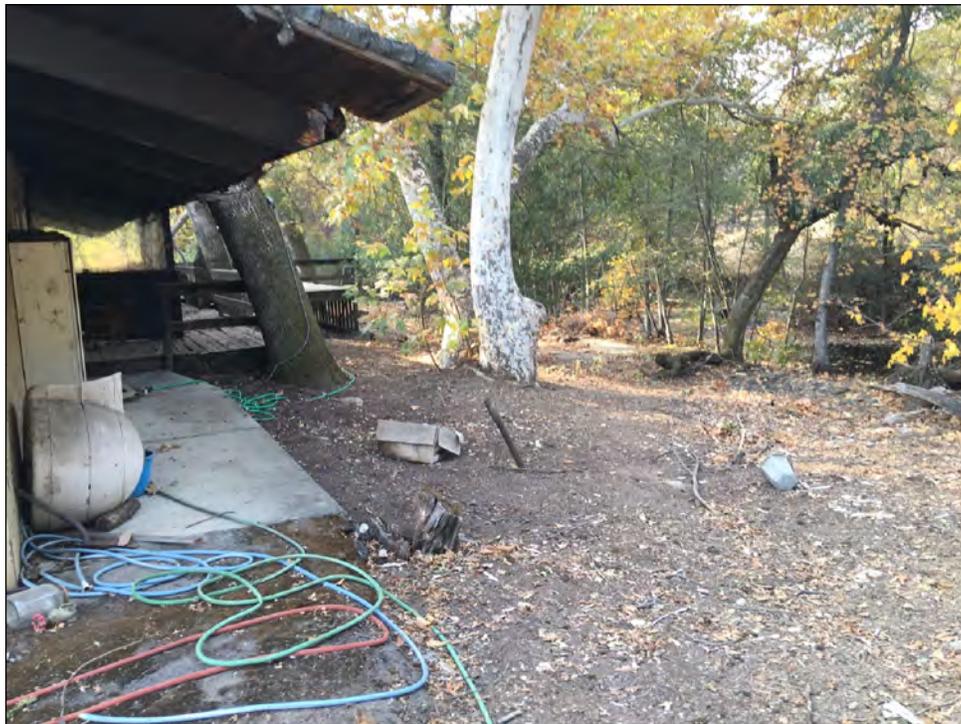
Potential Hazard to Life: moderate
Potential Hazard to Property: moderate
FEMA/DWR 100-yr Floodplain: yes
Preliminary Emergency: Early warning system
Protective Measures

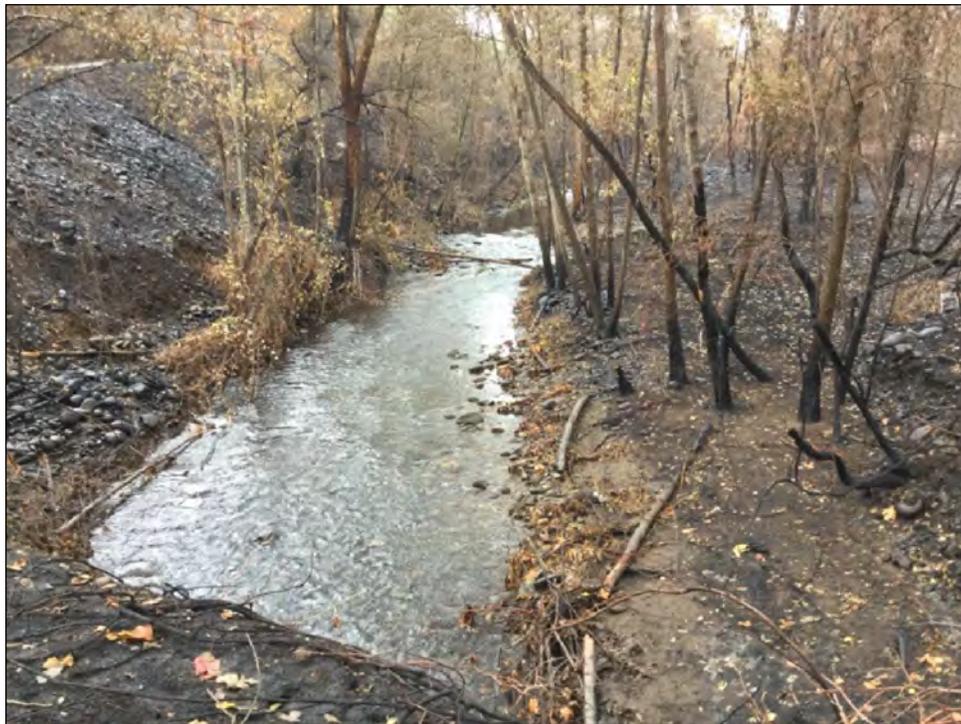
Potential Hazard to Life: low
Potential Hazard to Property: high
FEMA/DWR 100-yr Floodplain: yes
Preliminary Emergency: Storm patrol
Protective Measures

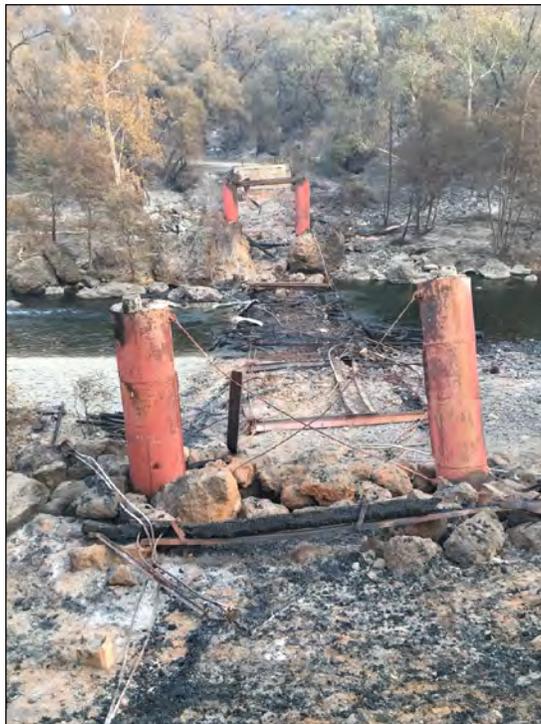
Potential Hazard to Life: moderate
Potential Hazard to Property: moderate
FEMA/DWR 100-yr Floodplain: yes
Preliminary Emergency: Storm patrol
Protective Measures

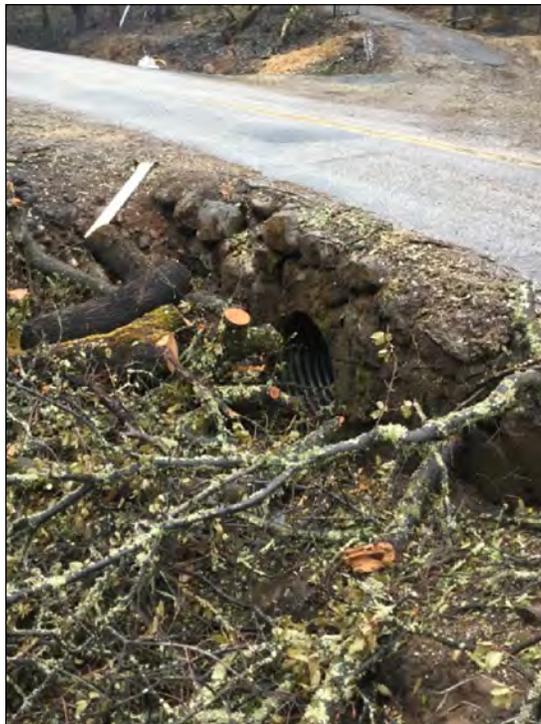
Potential Hazard to Life: moderate
Potential Hazard to Property: moderate
FEMA/DWR 100-yr Floodplain: no
Preliminary Emergency: Early warning system
Protective Measures

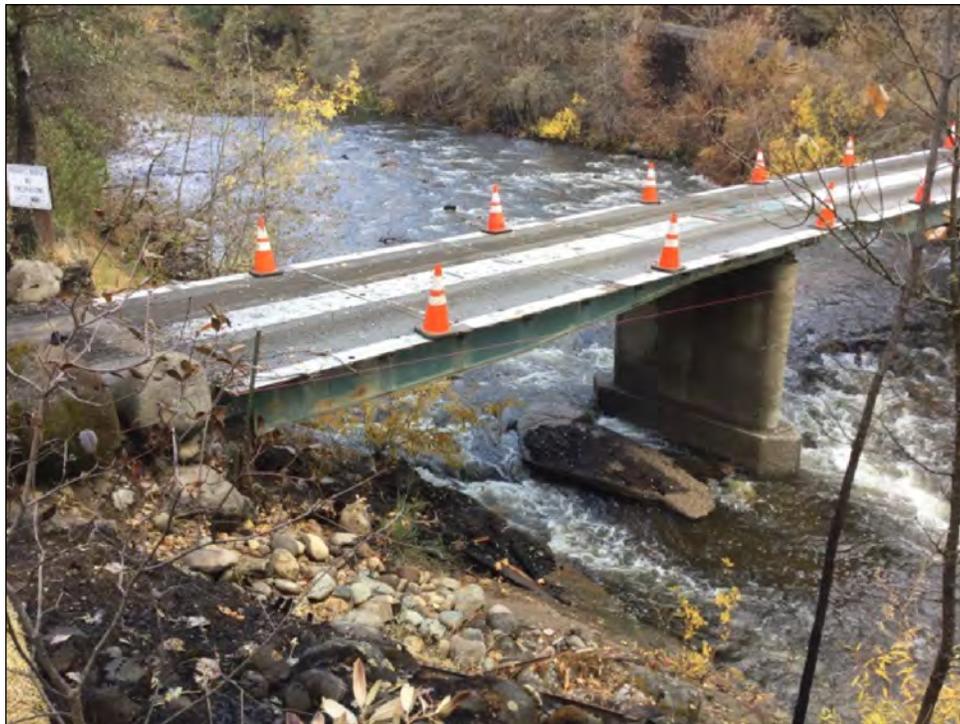
Potential Hazard to Life: low
Potential Hazard to Property: moderate
FEMA/DWR 100-yr Floodplain: yes
Preliminary Emergency: Early warning system and storm patrol
Protective Measures

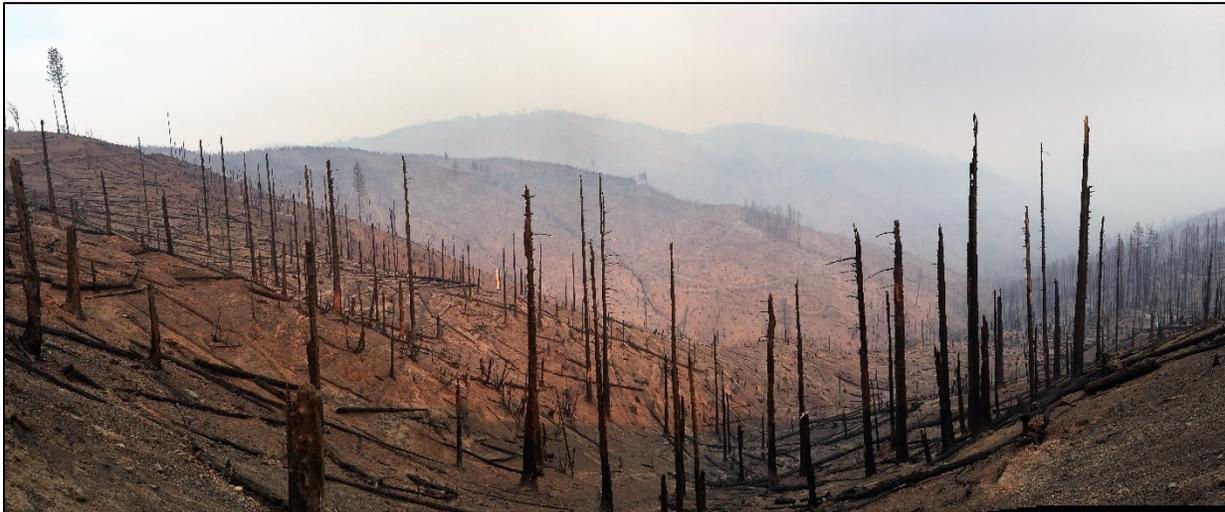
High soil burn severity in Flea Valley Creek canyon above Pulga, CA.

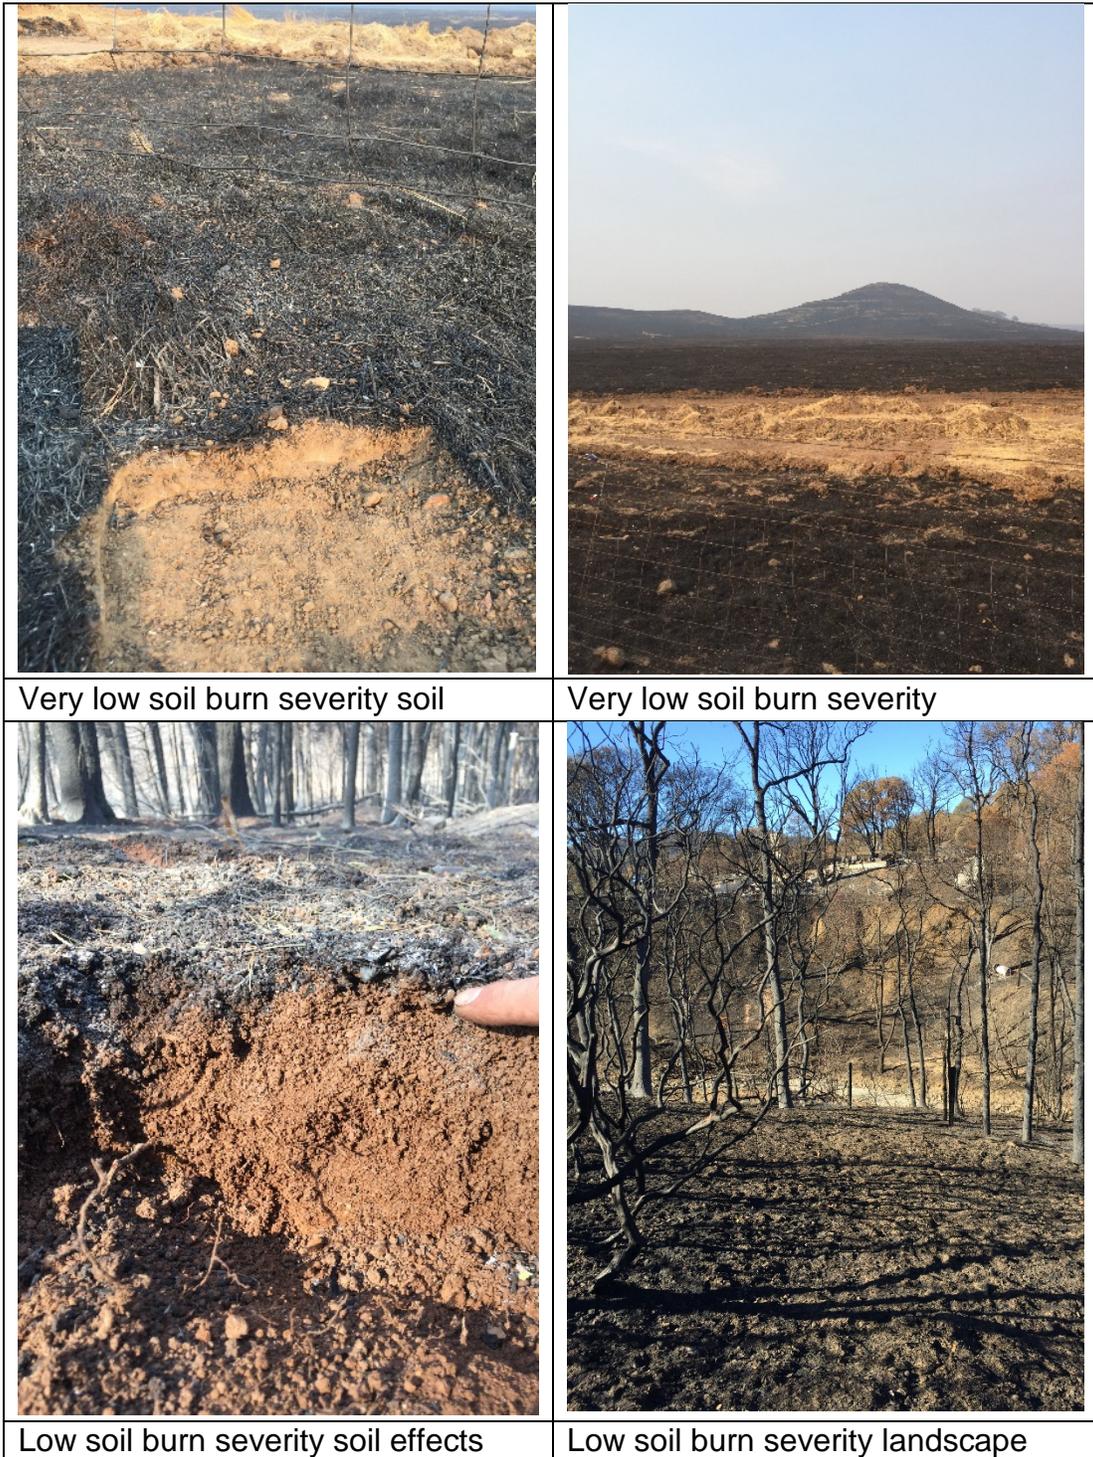
For very low soil burned severity landscapes, soils only had grass removal with black ash with no soil char or soil effects. Green grass was starting to resprout (see pictures above).

For low soil burn severity areas, there was very shallow soil char with no damage to the soil, low to moderate surface water repellency with only black ash and partial (timbered areas) to complete removal (chaparral) of cover (see pictures above).

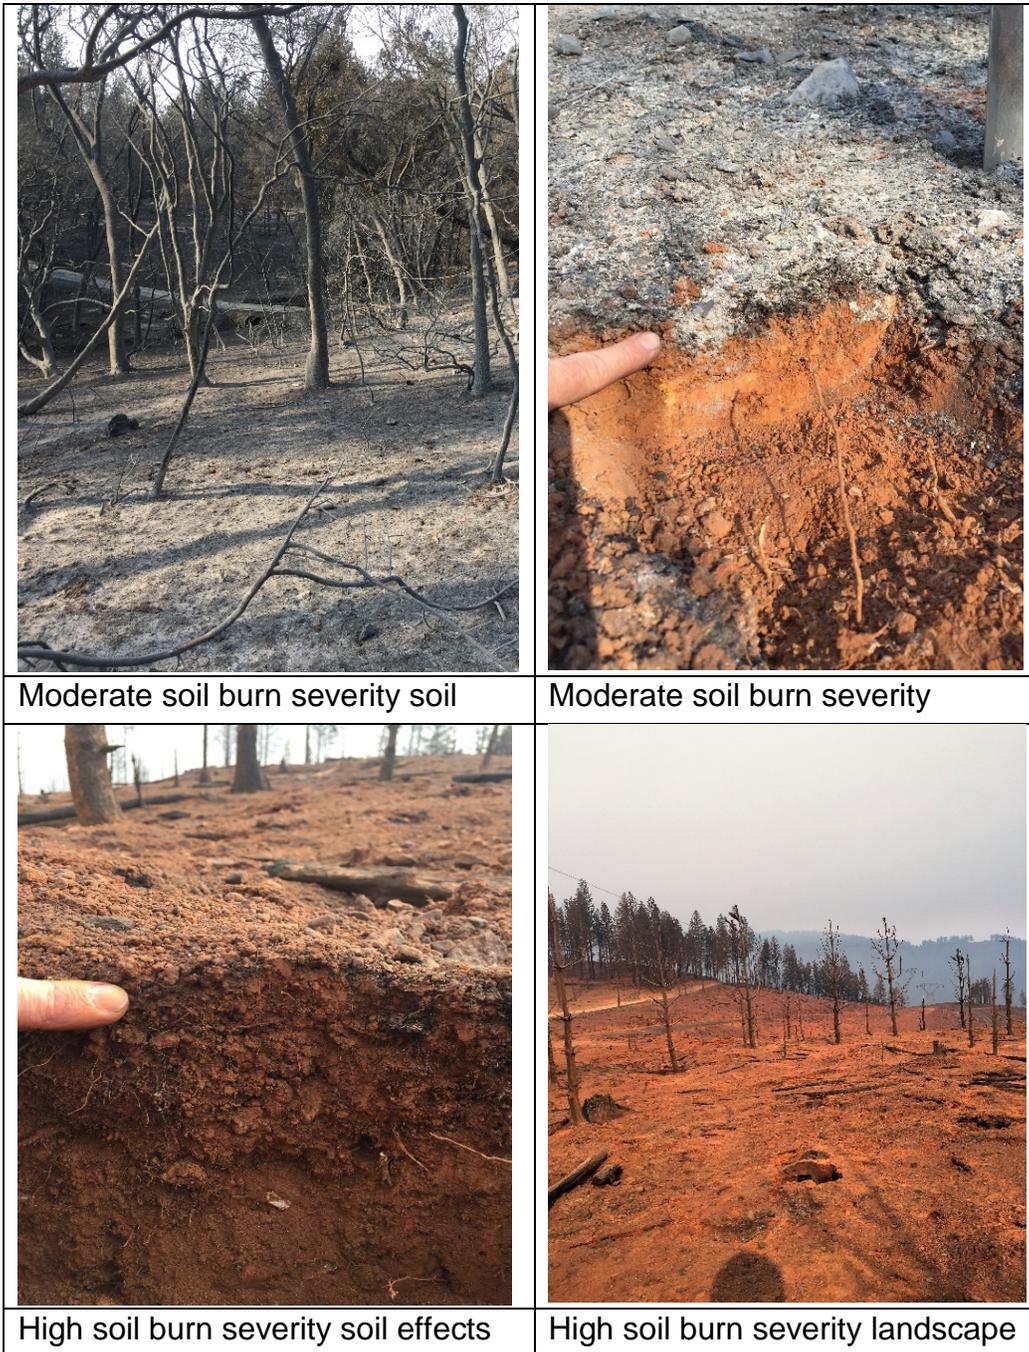
For moderate soil burned severity landscapes, soils had partial (in timbered areas) to complete removal (in chaparral areas) of cover with black to gray ash with shallow to moderate soil char destroying fine roots and soil aggregate stability. This caused a water
