Forest Management and Restoration Practices: Effects on Stream Health and Function

Herger-Feinstein Quincy Library Group Pilot Project

HFQLG Stream Monitoring: Focus and Methods

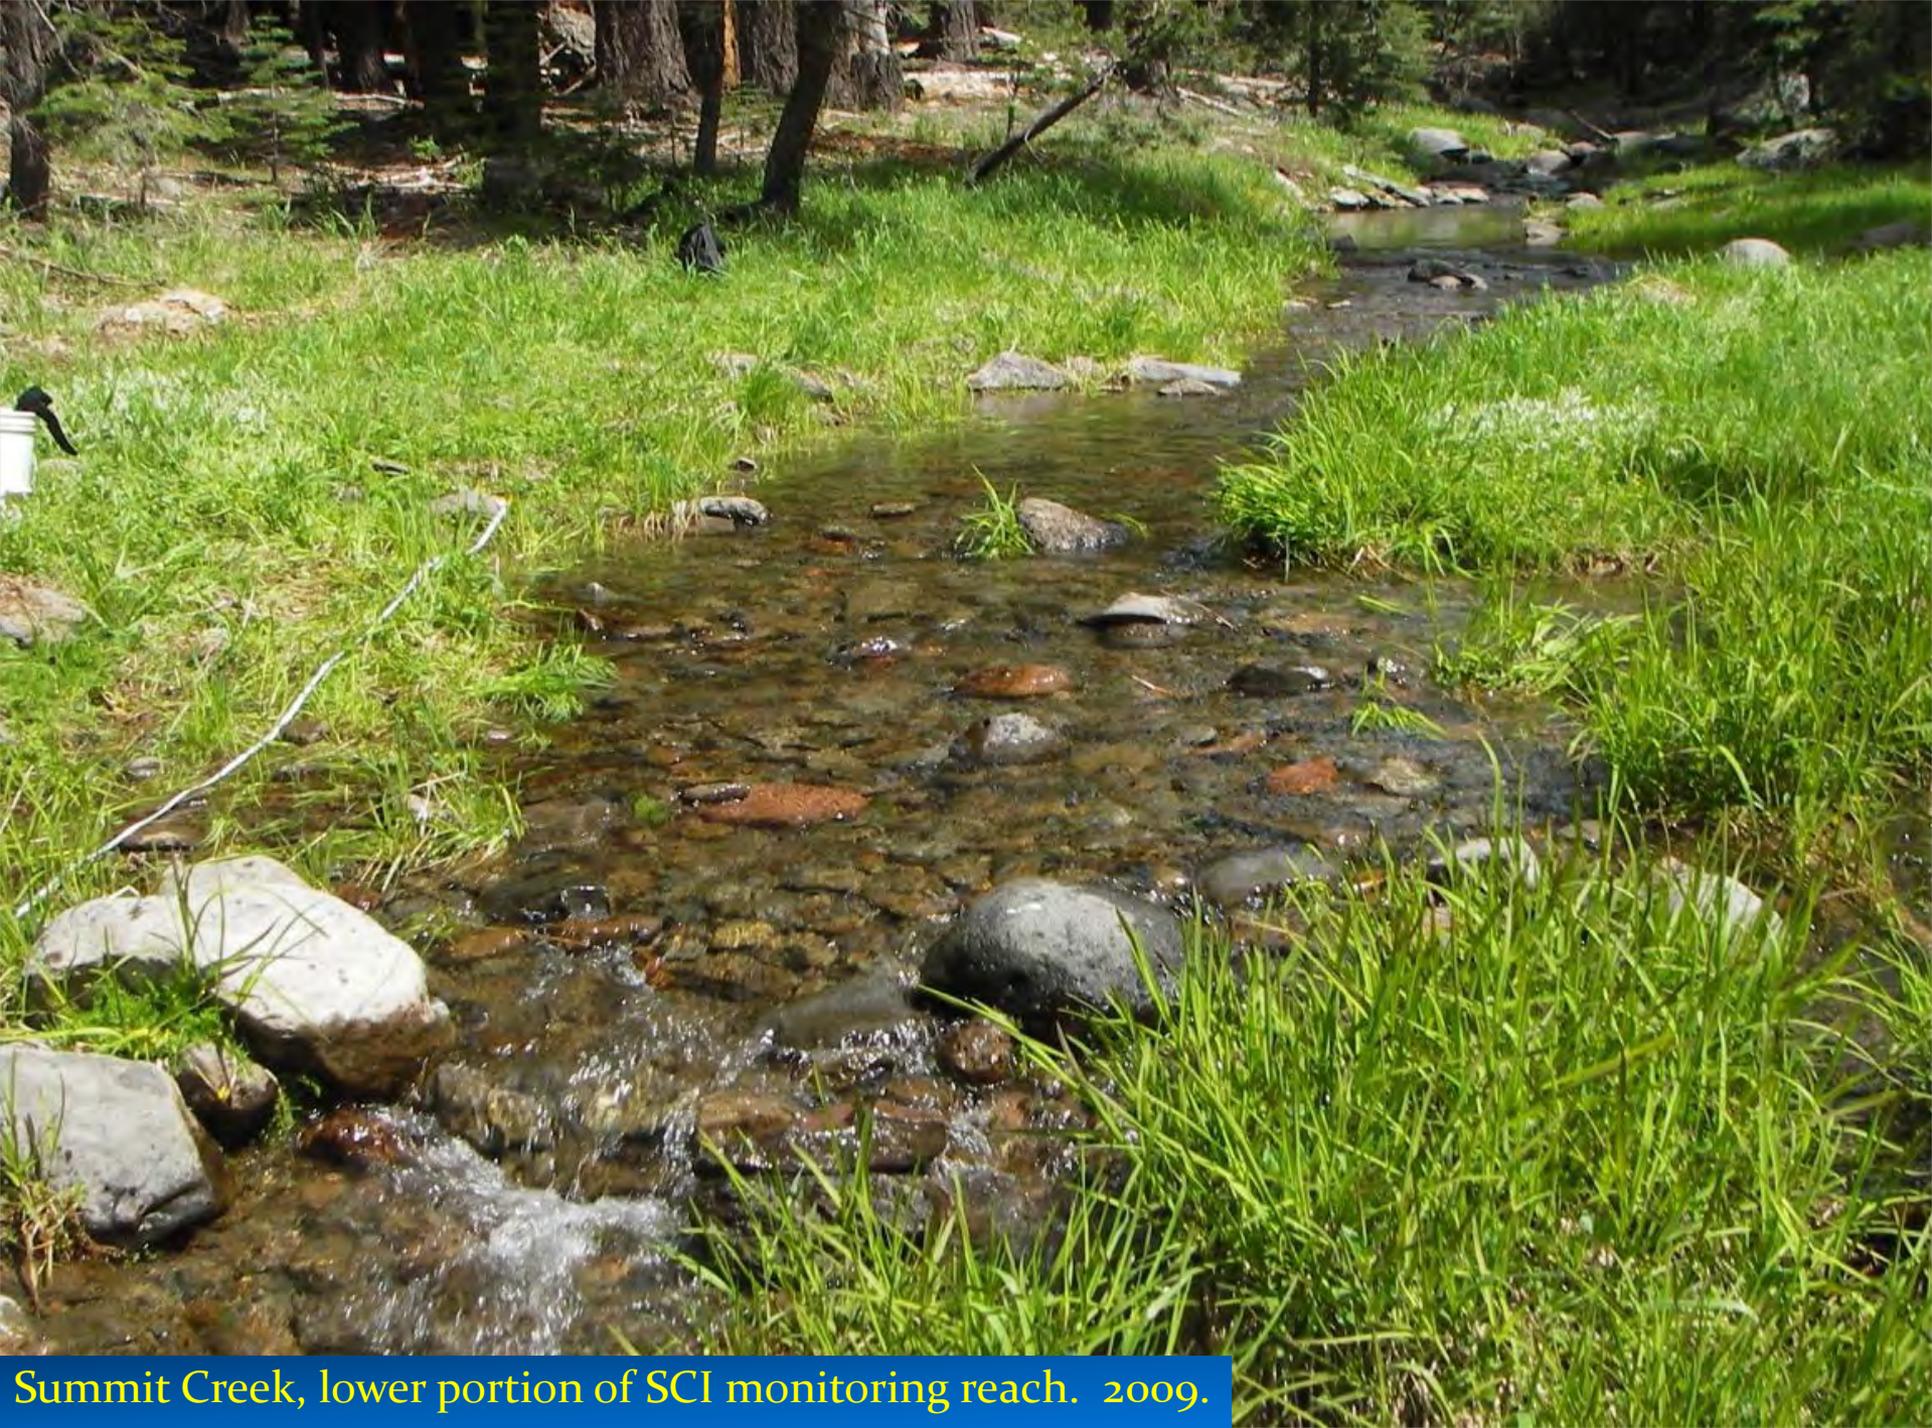
Summit Creek, lower portion of SCI monitoring reach. 2009.

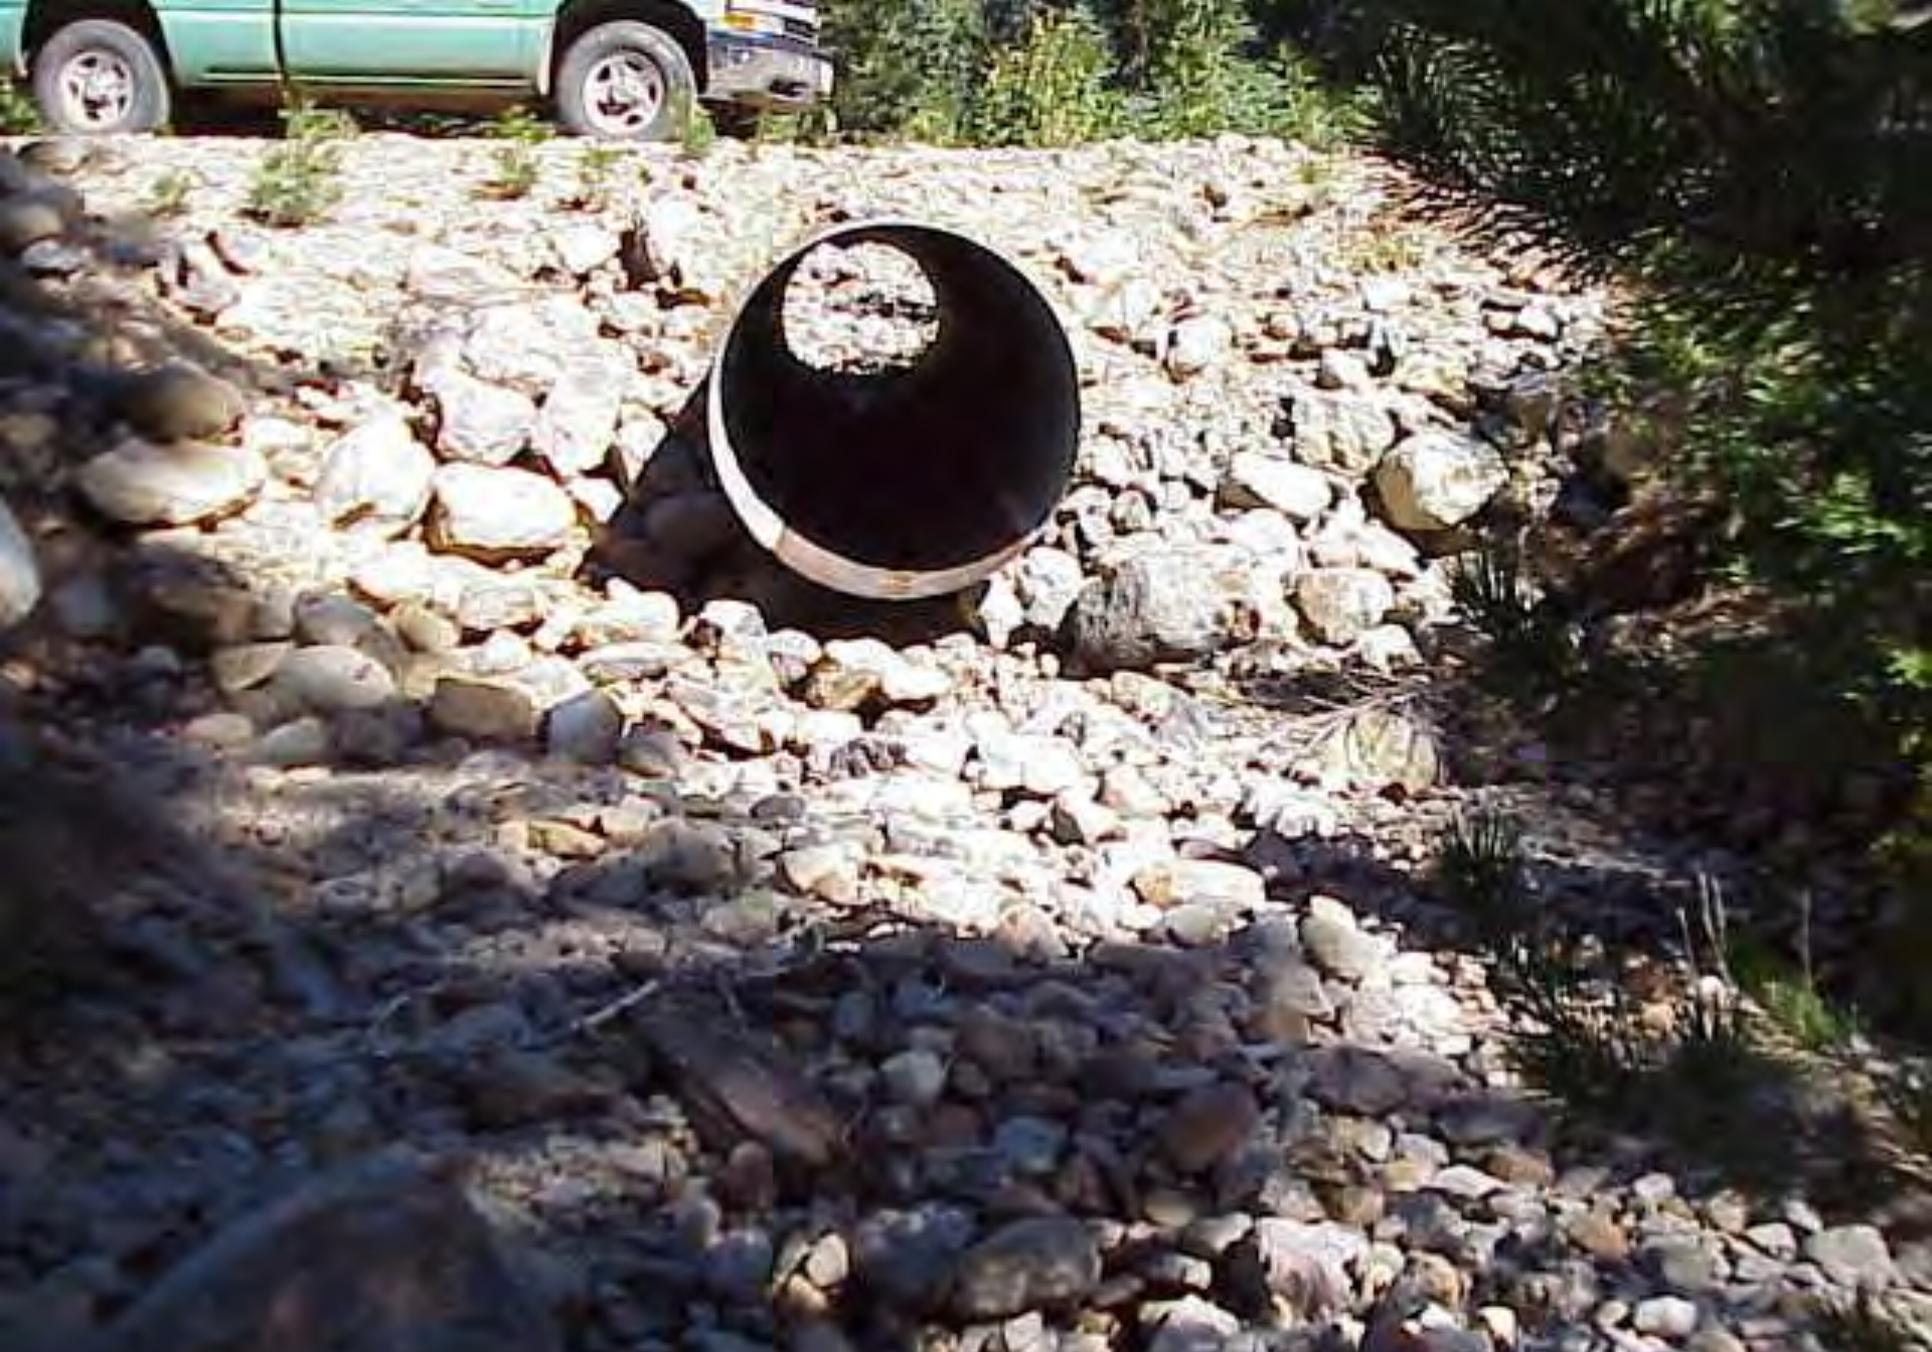
Culvert over Summit Creek, 0.3 miles upstream of the SCI monitoring reach. 2003.

- 2006: significant increase in sediment
 - 2003 pool tail fines: 4%
 - 2006 pool tail fines: 10%
 - Likely due to culvert failure upstream.
- Small increases in stream channel shade from 2003 to 2010.
 - Not attributed to project activities.
- No change/positive change in macroinvertebrate indices.

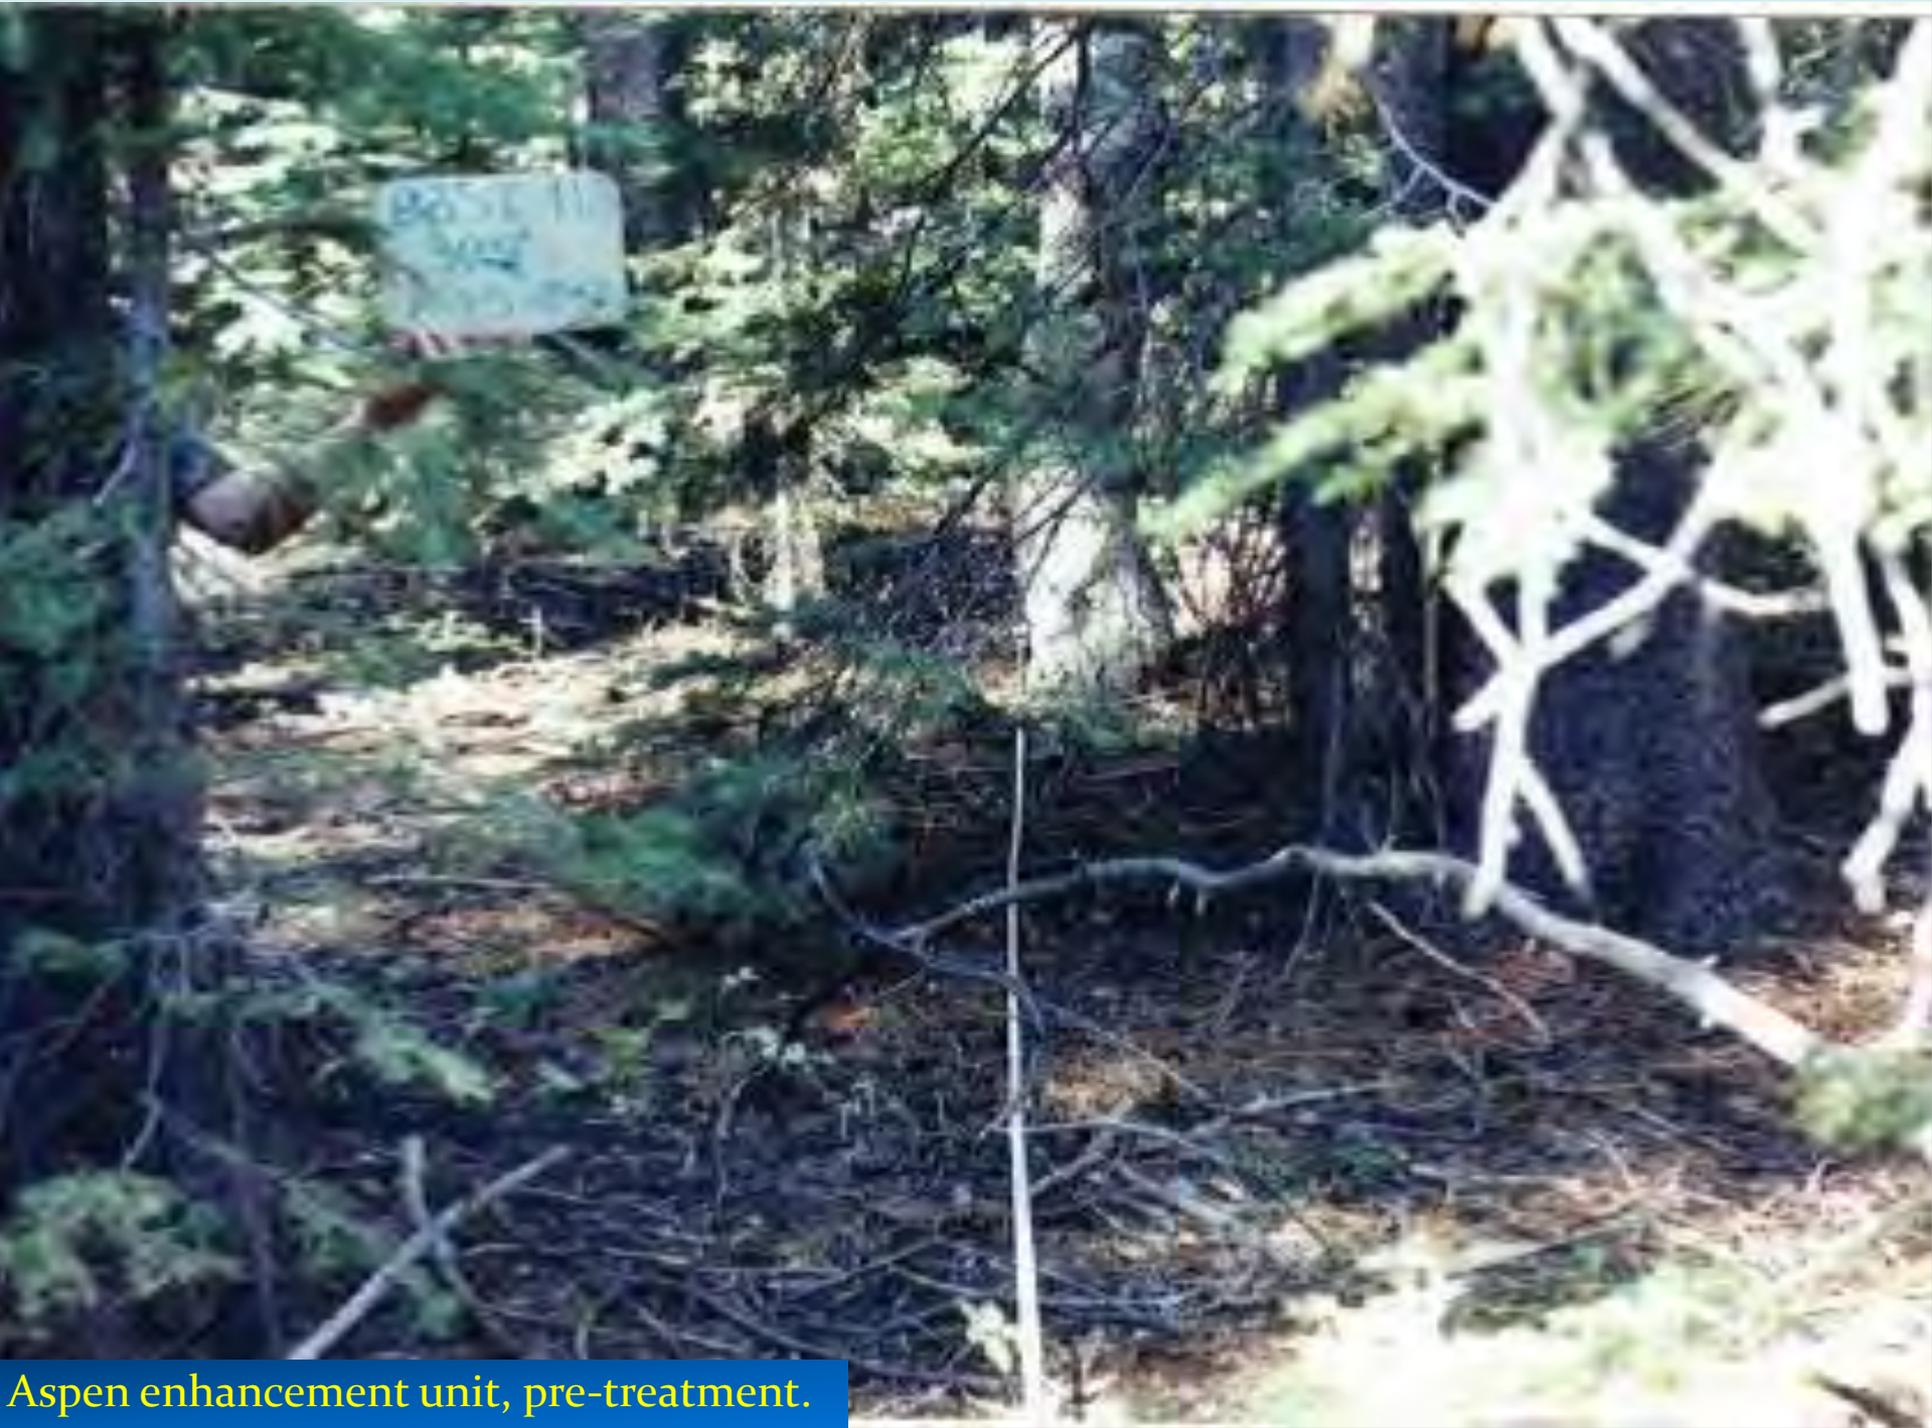
Aspen enhancement unit, pre-treatment.

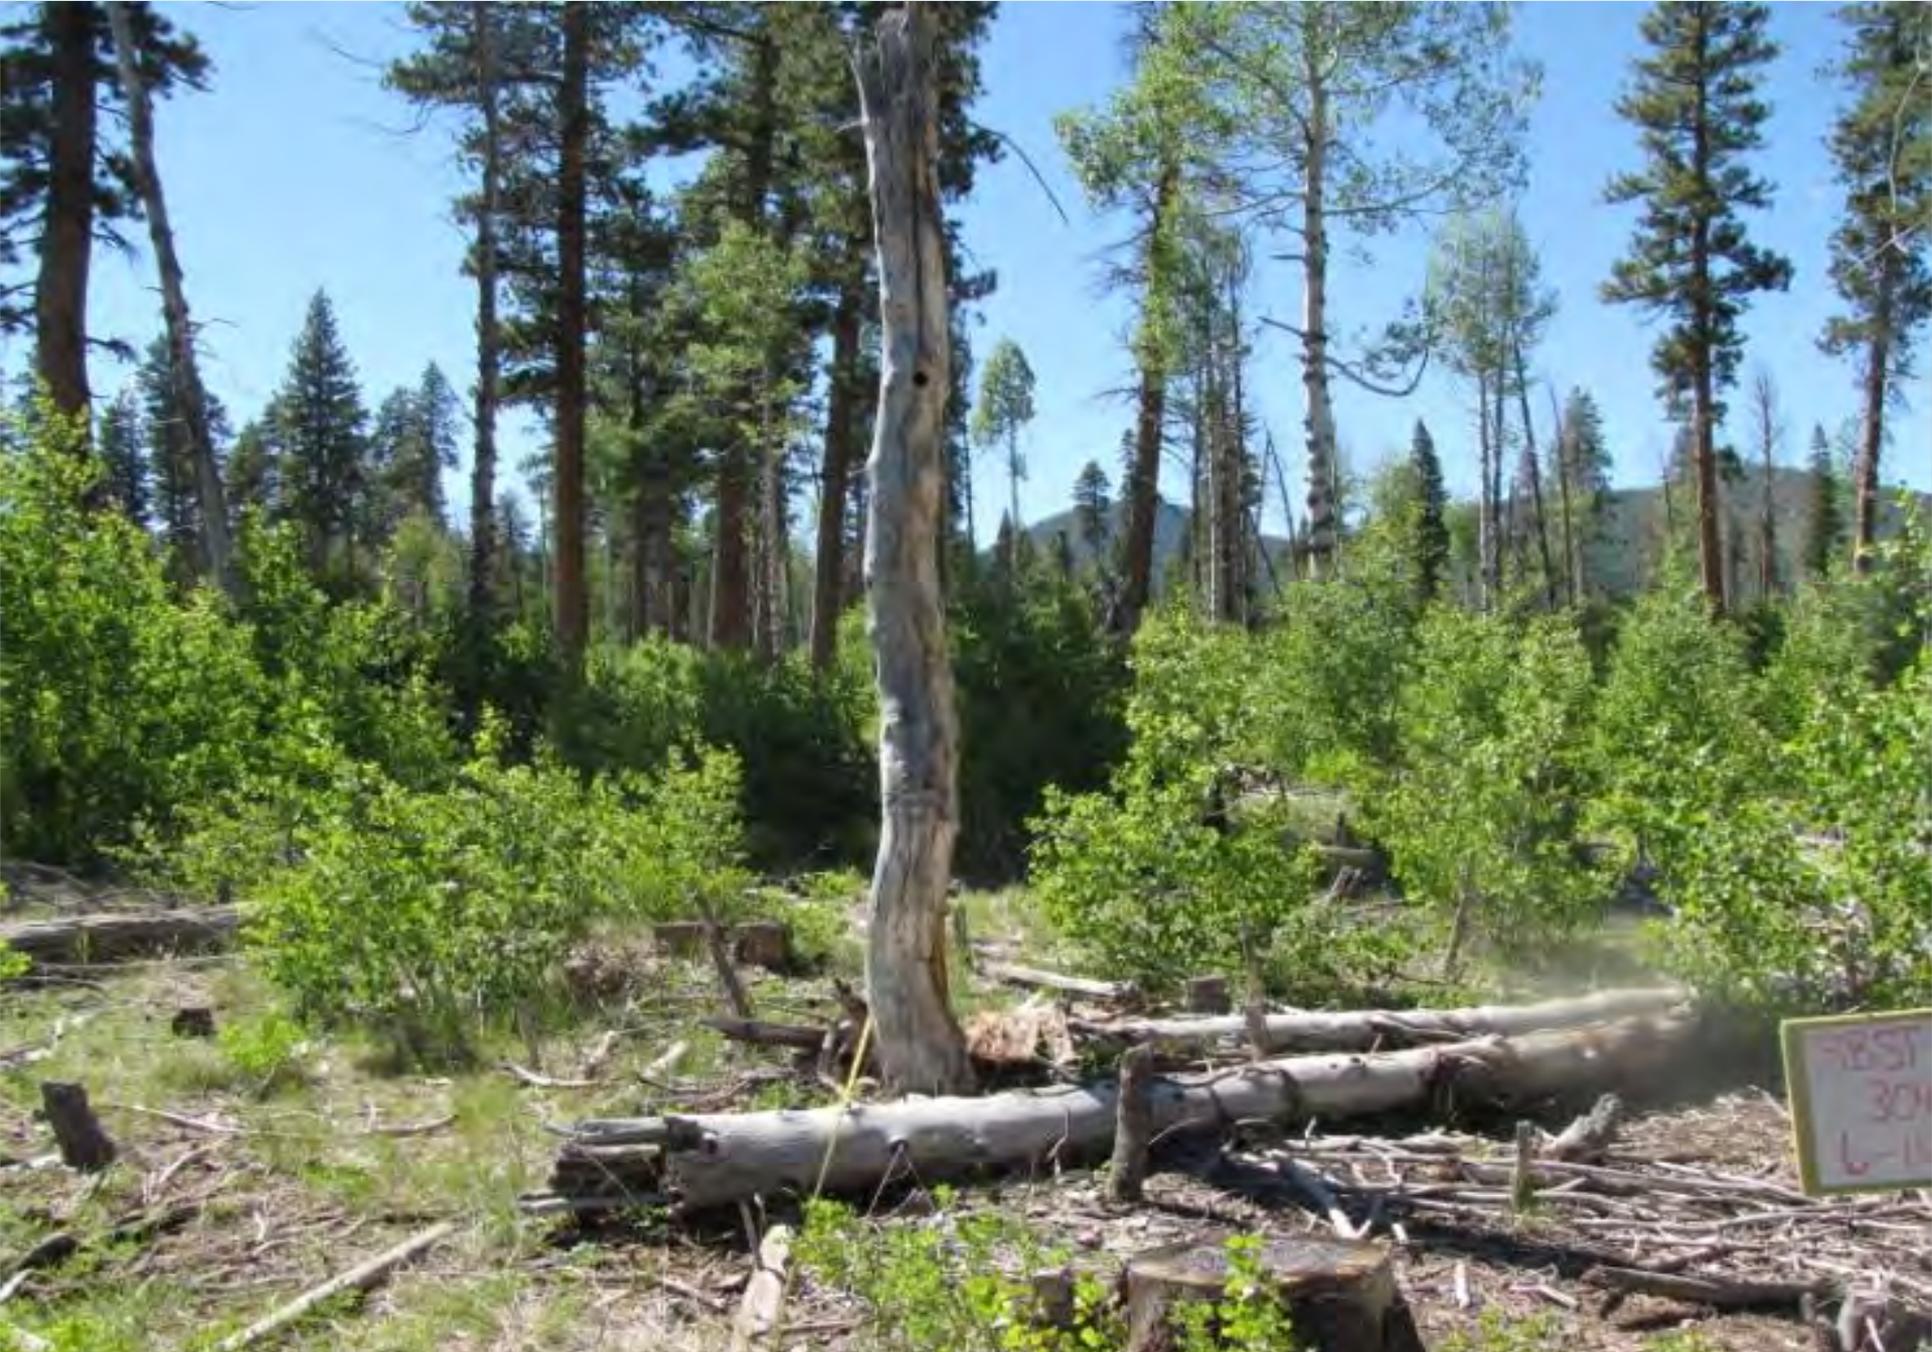
Aspen enhancement unit, eight years after treatment.

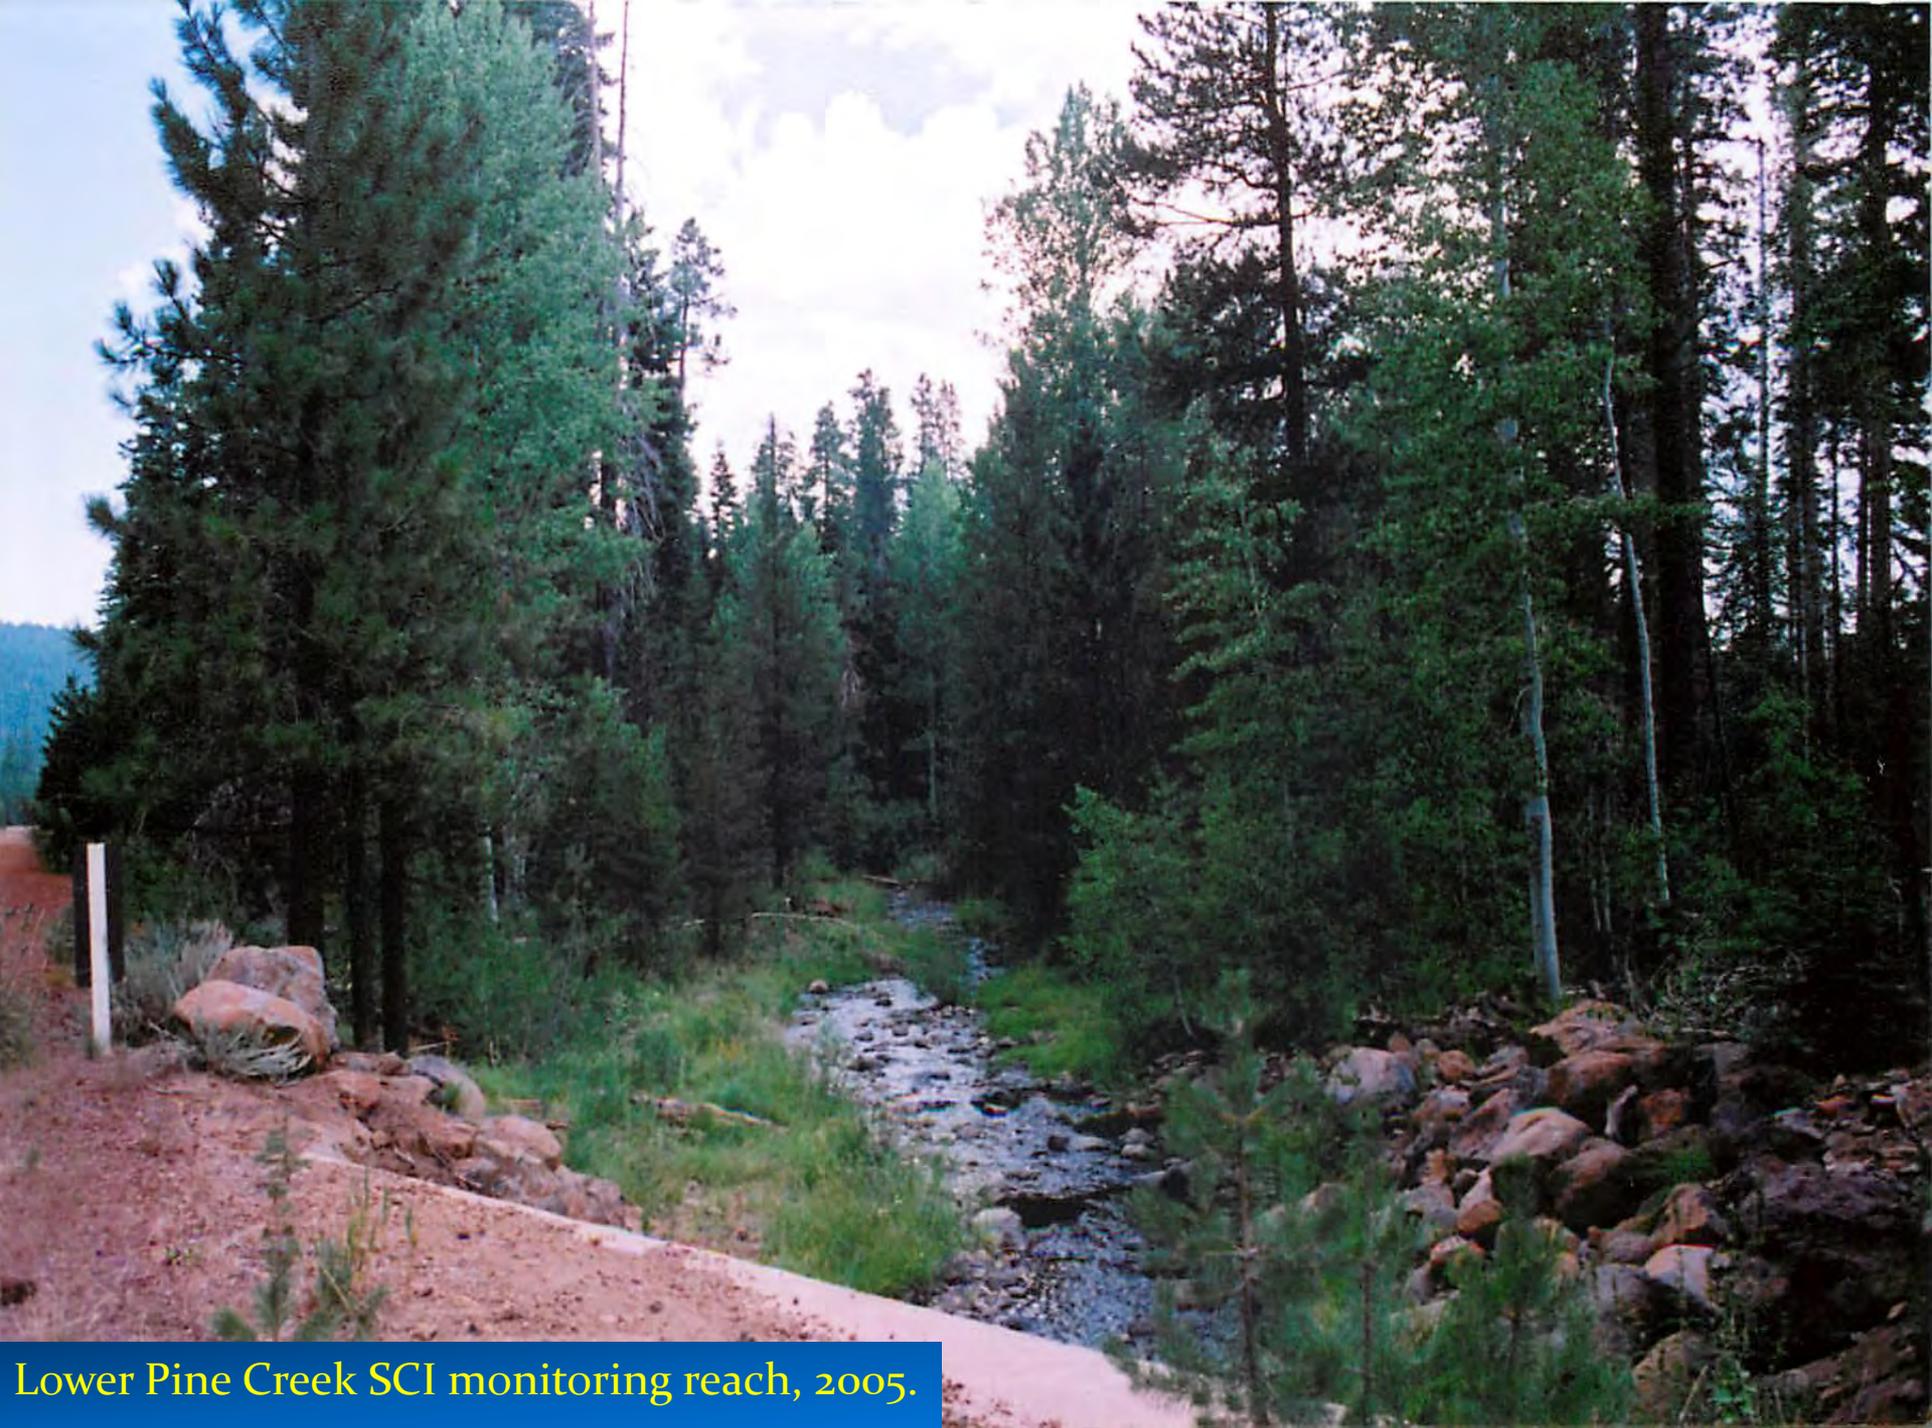
Lower Pine Creek SCI monitoring reach, 2005.

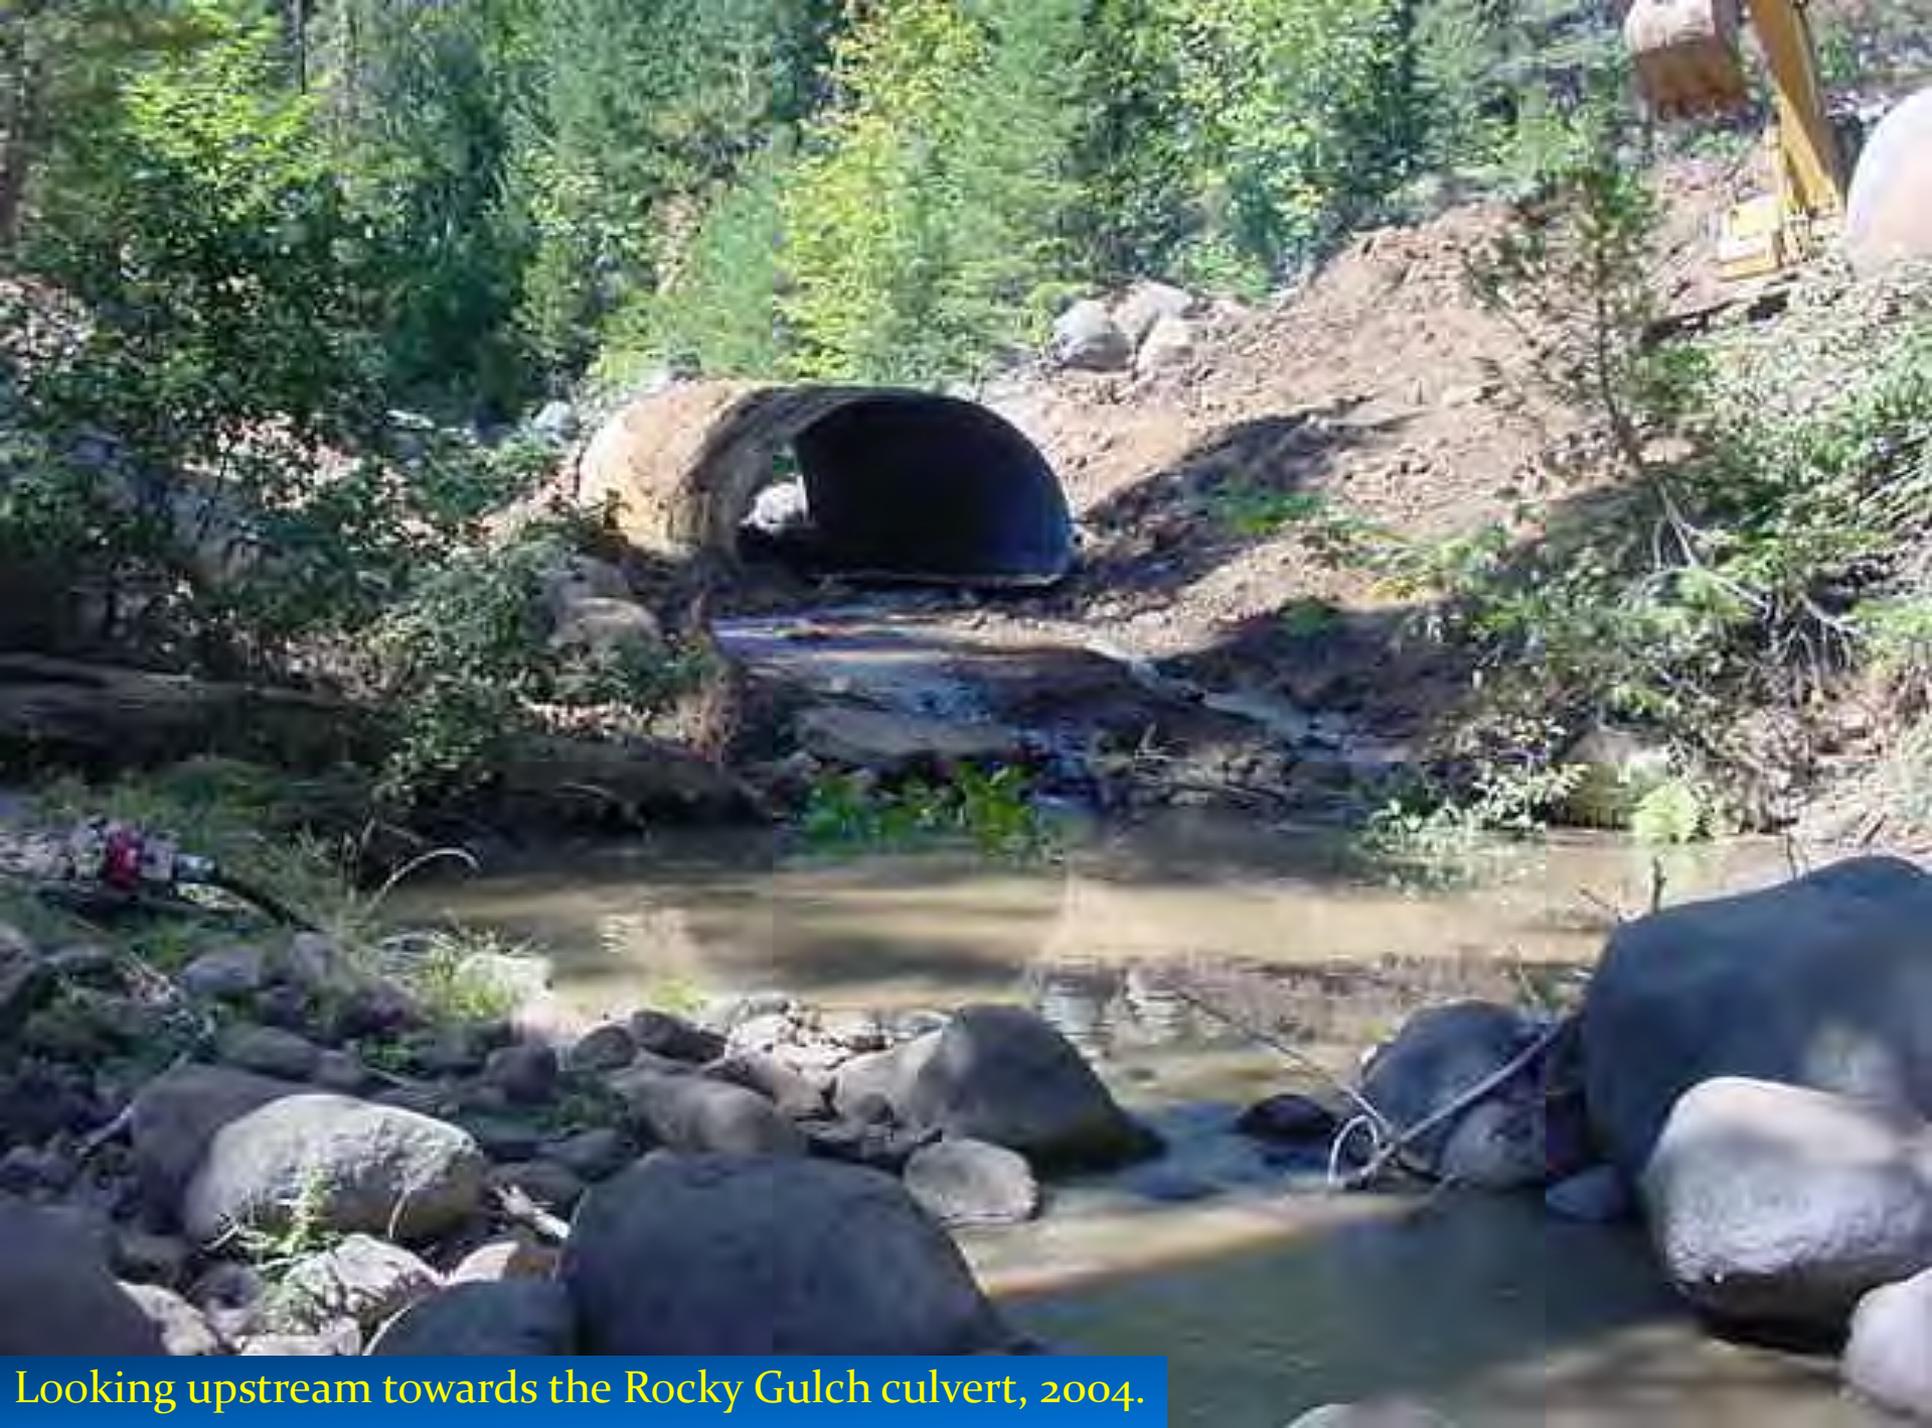
Looking upstream towards the Rocky Gulch culvert, 2004.

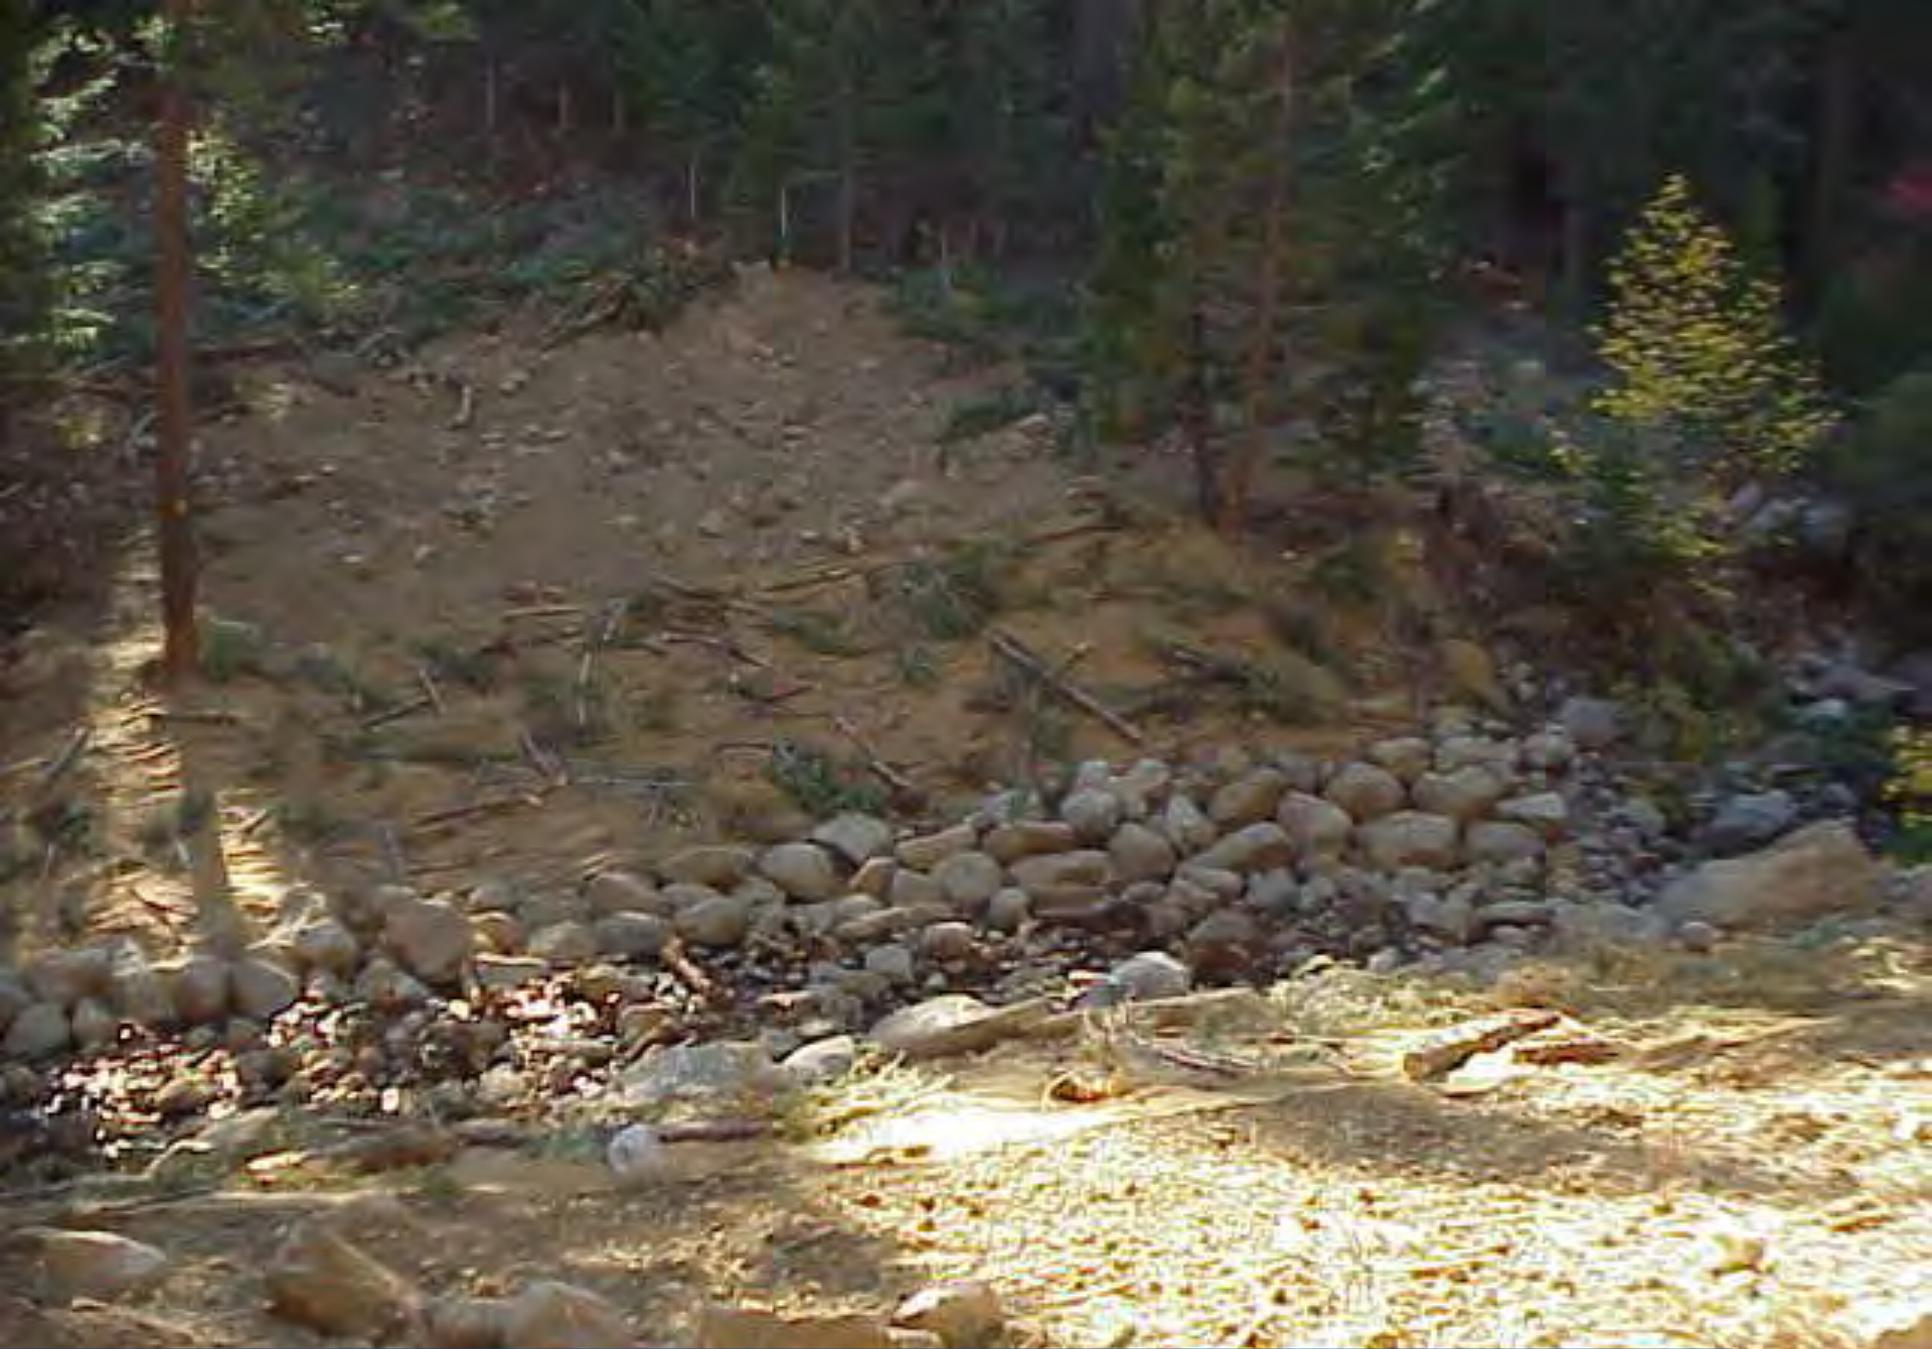
Site of Rocky Gulch culvert removal, with erosion control measures in place. Fall 2004.

- Post-project surveys completed immediately after culvert removal (2004) and one year later (2005).
- Pool tail fines showed slight changes:
 - 2002: 1%
 - 2004: 4%
 - 2005: 2%
- No significant changes in pool depths.

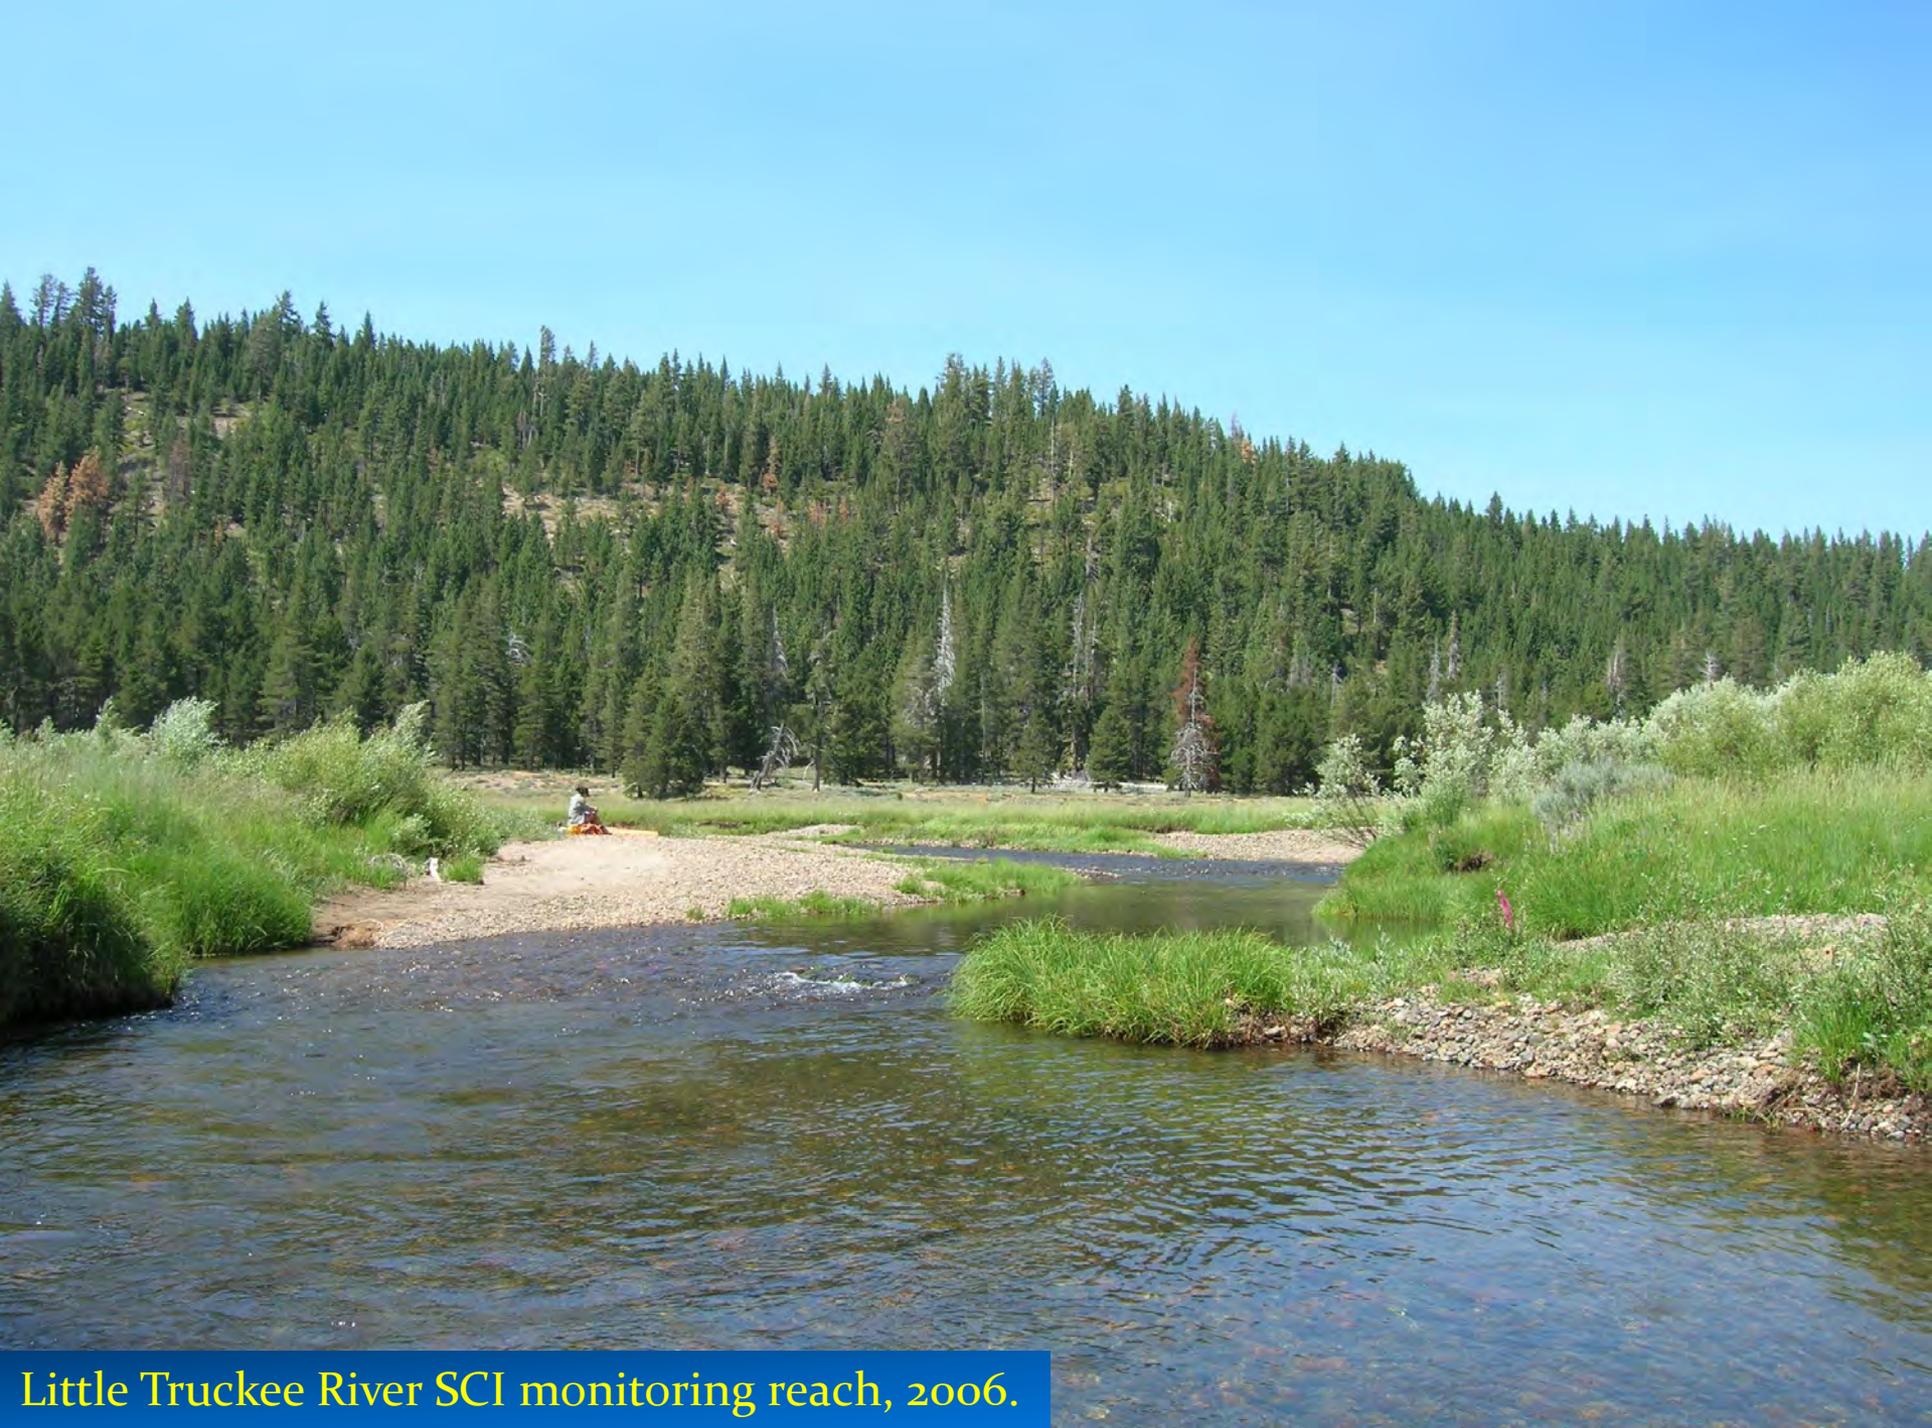
Little Truckee River SCI monitoring reach, 2006.
