Forest Management and Restoration Practices: Effects on Stream Health and Function

Herger-Feinstein Quincy Library Group Pilot Project

HFQLG Stream Monitoring: Focus and Methods

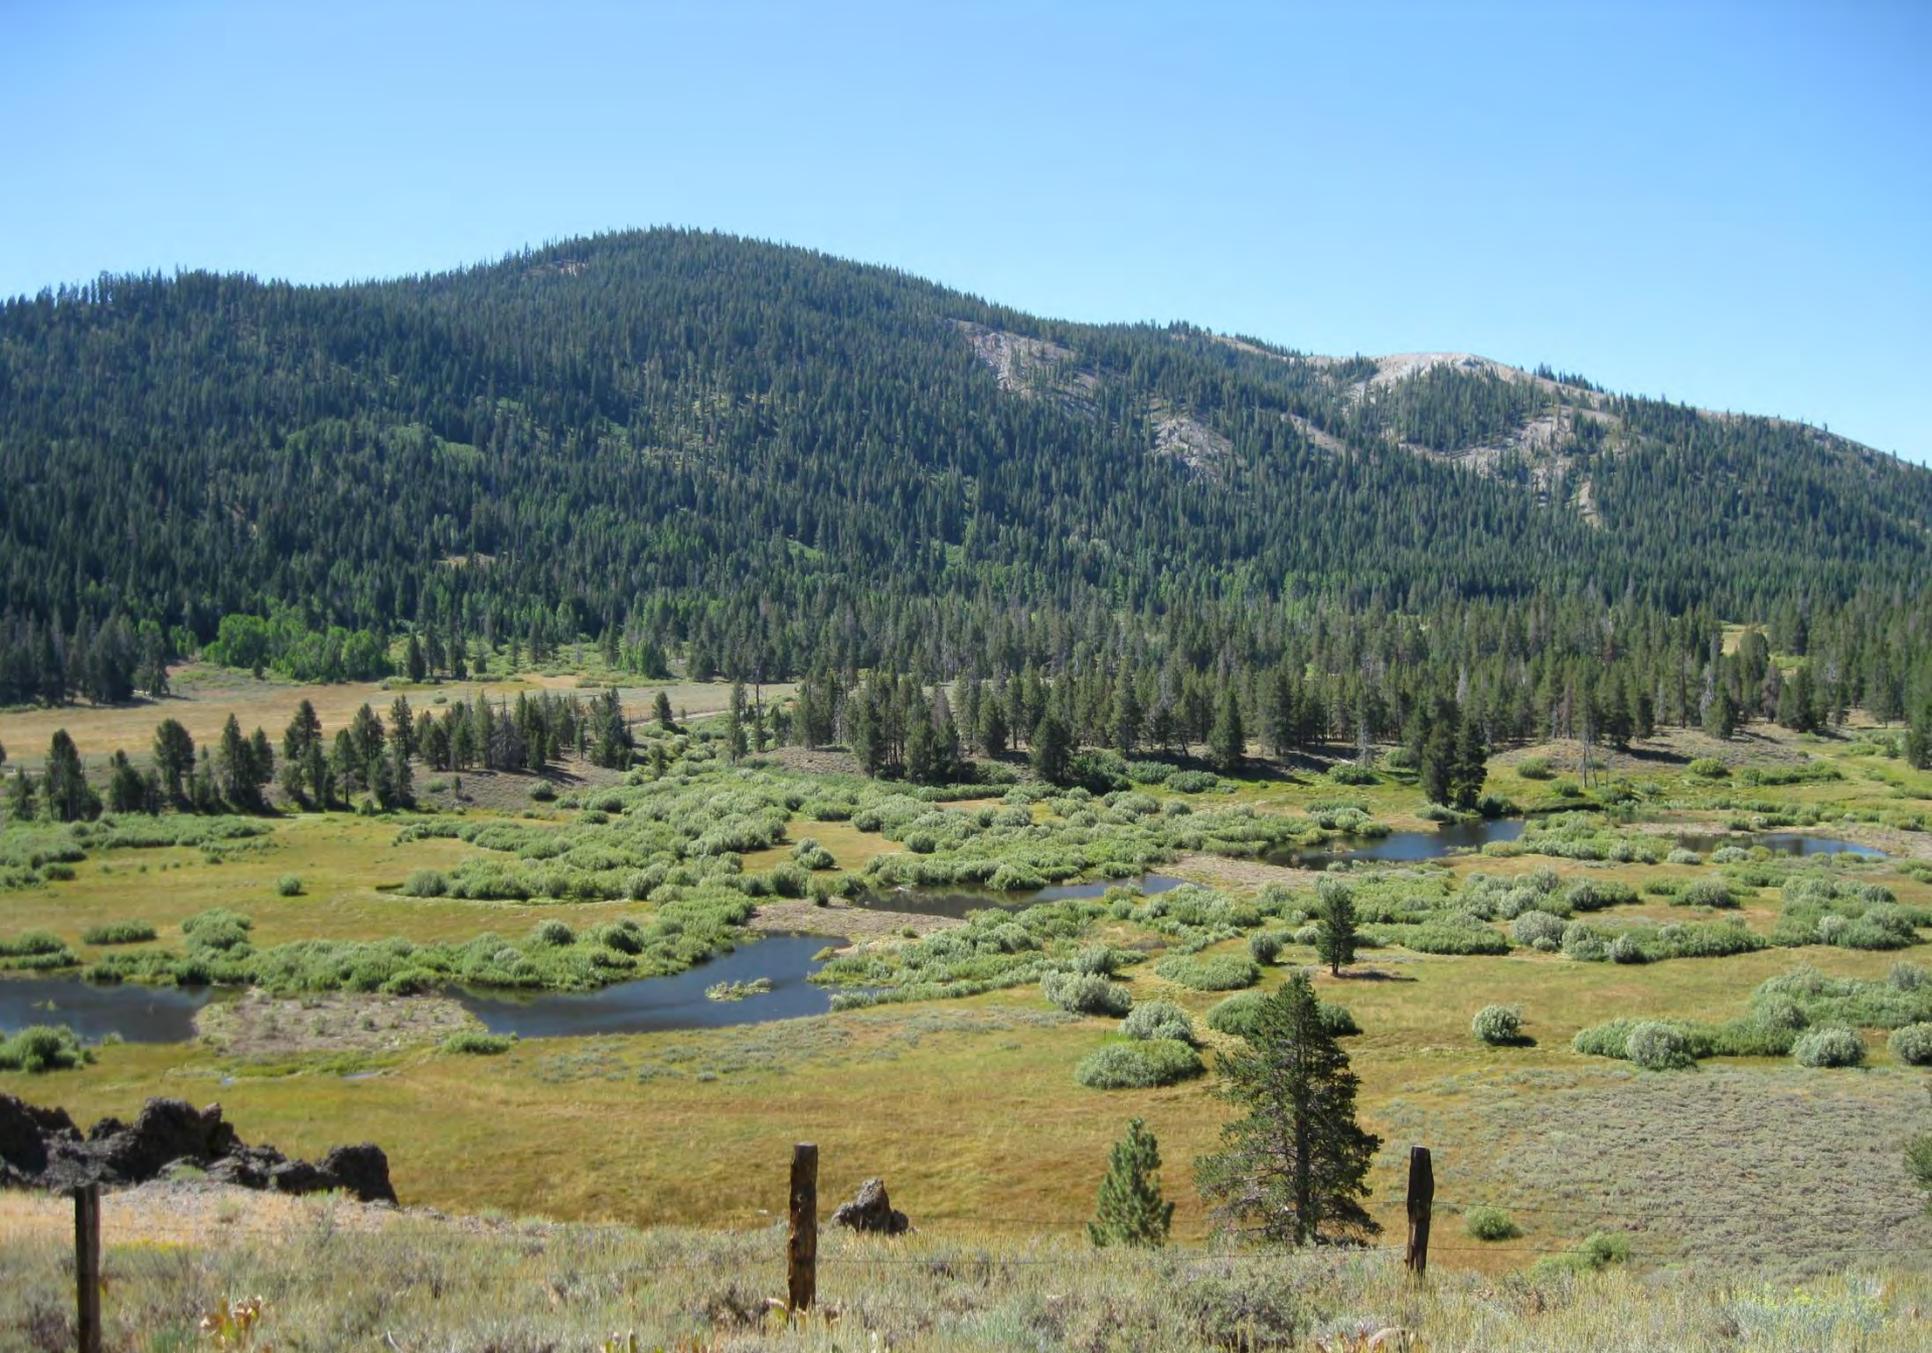
Perazzo Meadows pond-and-plug restoration site. 2010.

- Significant increase in fine sediment downstream of the project area.
 - 2006: 3% pool tail fines
 - 2010: 34% pool tail fines
 - Duration of increased sediment...?
- No change in stream channel shade.
- Macroinvertebrate indices showed no effect.

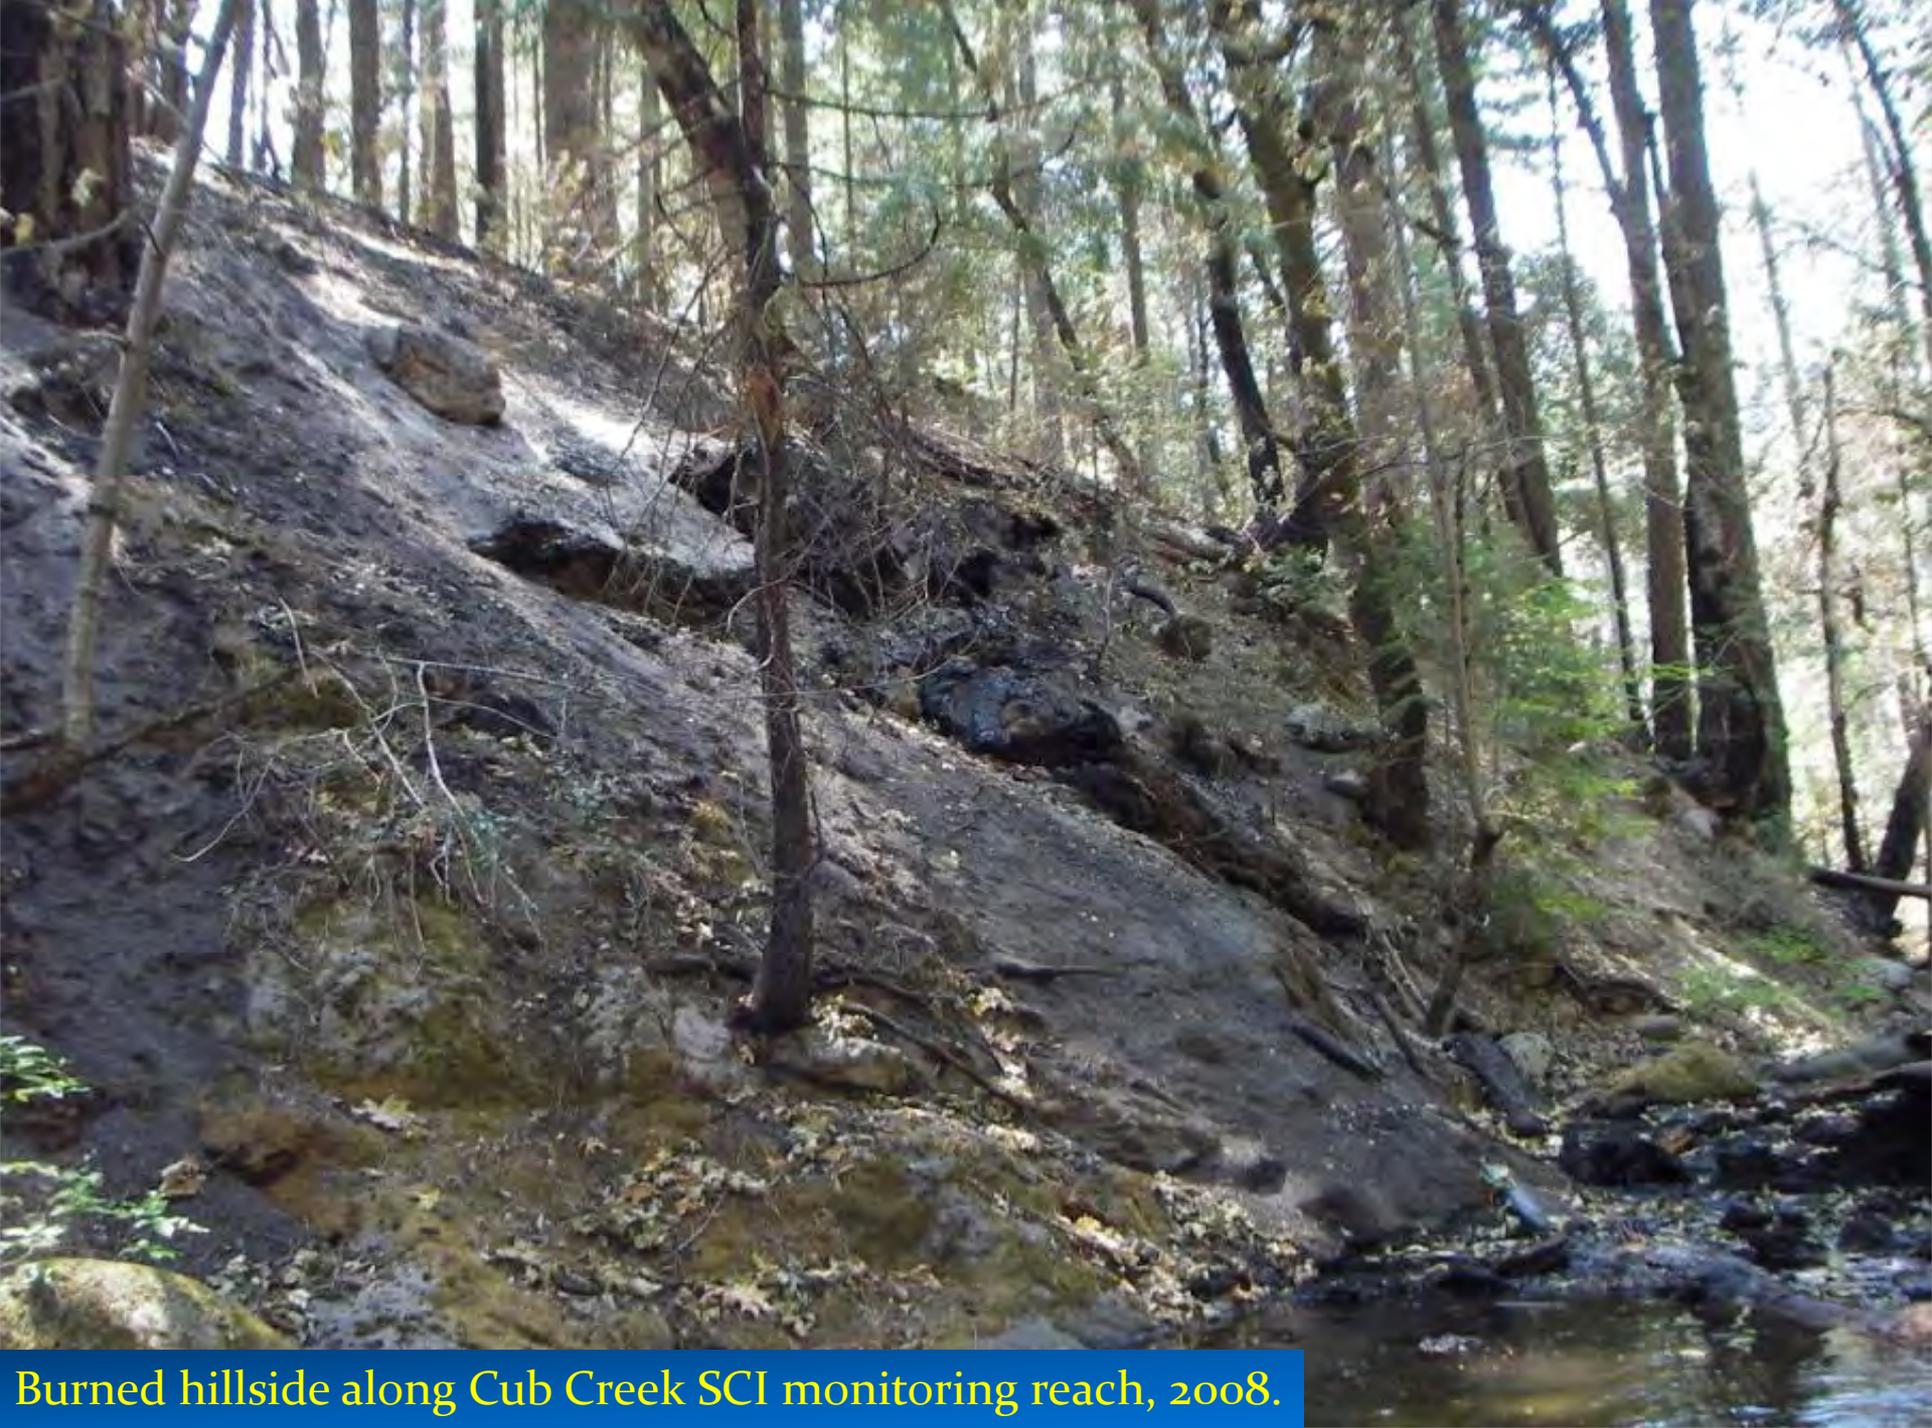
Burned hillside along Cub Creek SCI monitoring reach, 2008.

- Fine sediment increased following the fire.
 - Average pool tail sediment pre-fire: 3%
 - Average pool tail sediment post-fire: 11%
 - 2012: 10%
- Channel shade declined post-fire.
 - Average shade pre-fire: 95%
 - Average shade 2009: 89%
 - Average shade 2012: 95%
- Little/no change in large woody debris in channel
- Little/no change in macroinvertebrate indices in first two years following fire

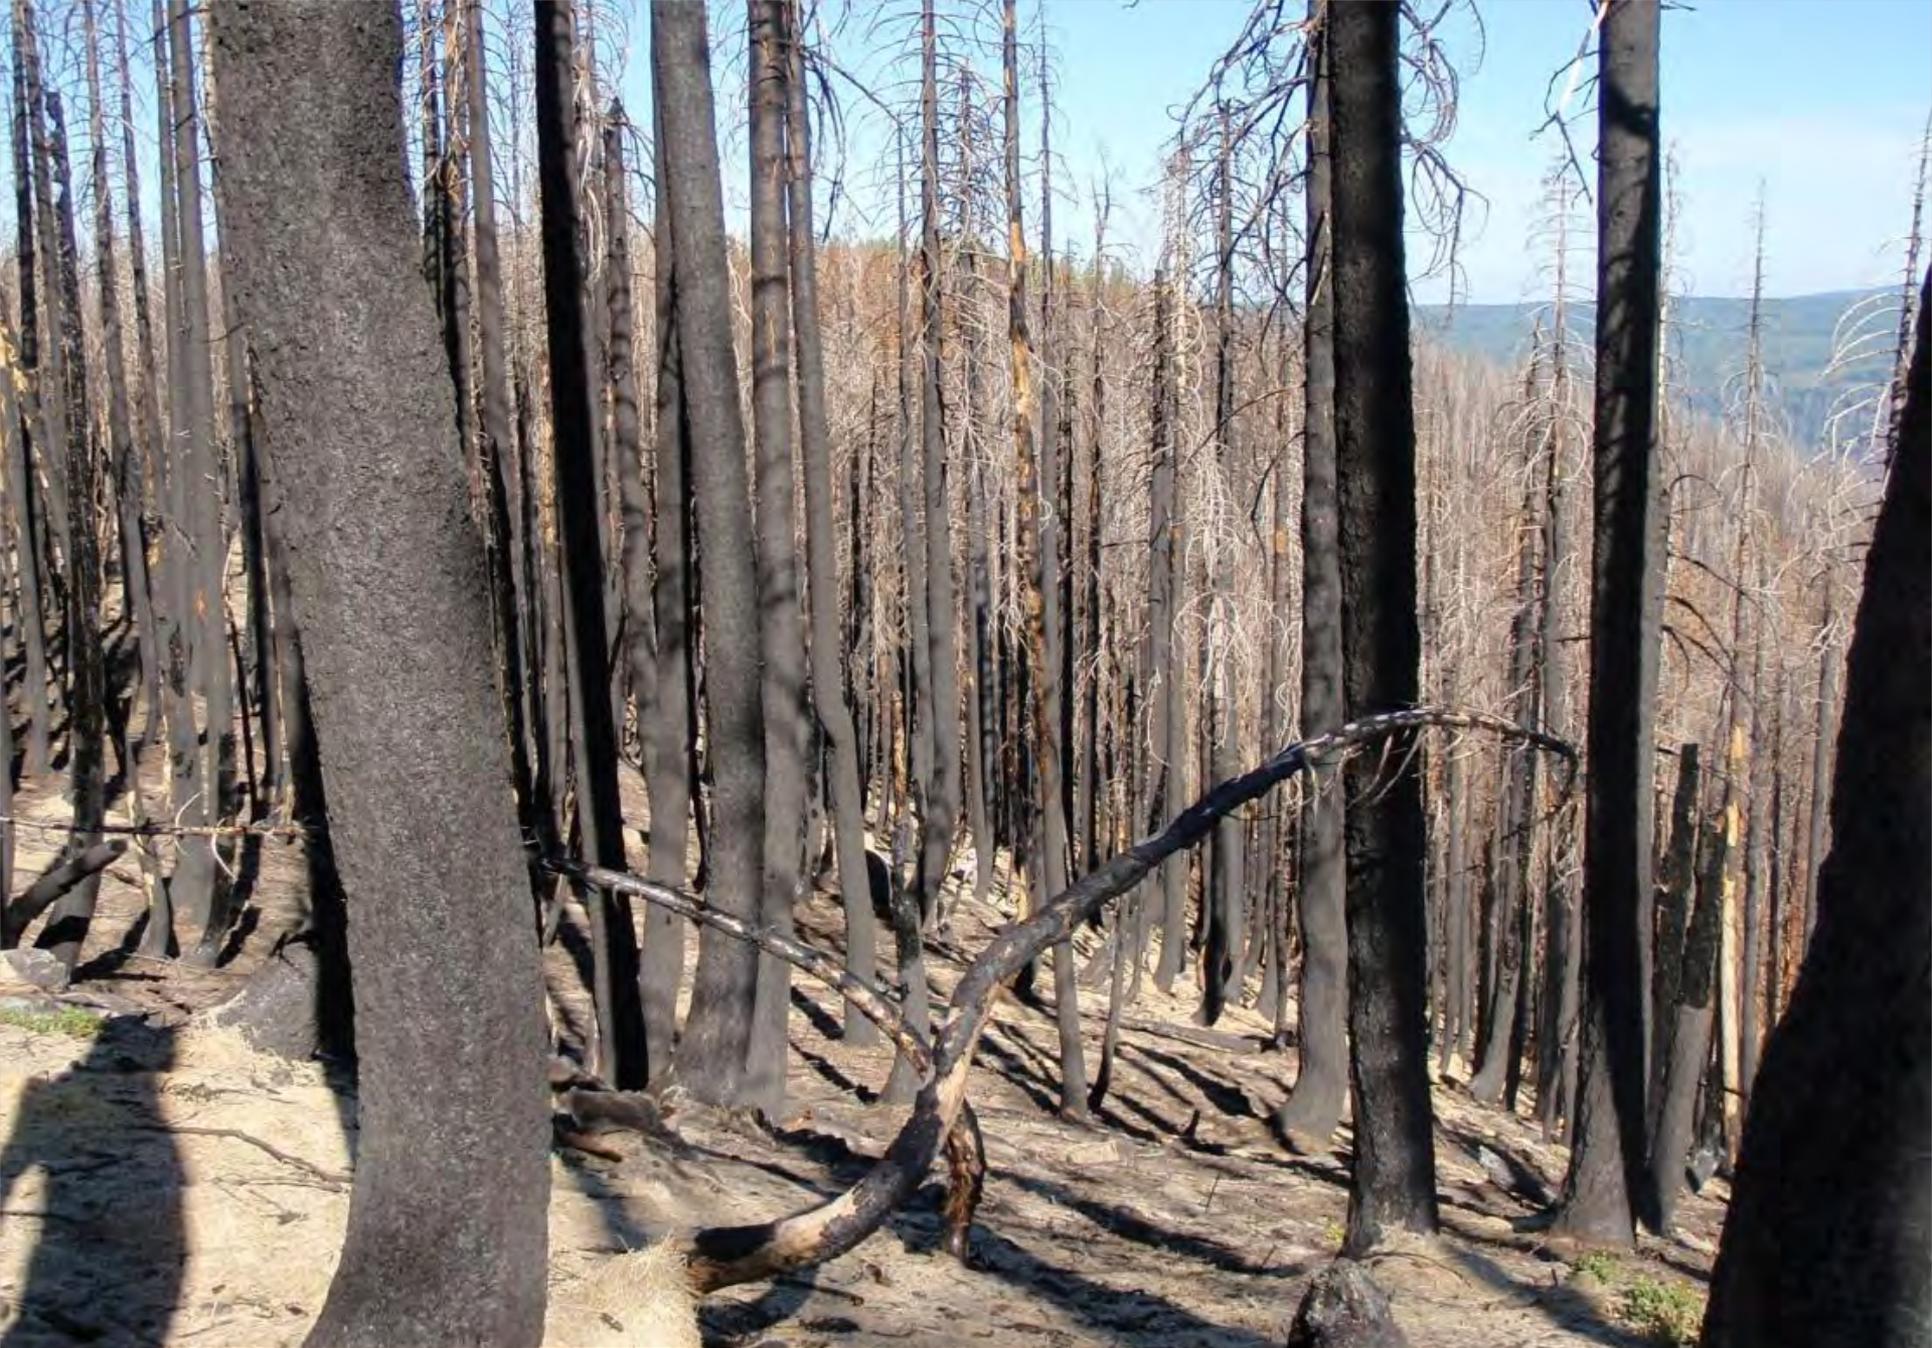
Looking west along the southern ridgeline above Cub Creek. 2009.

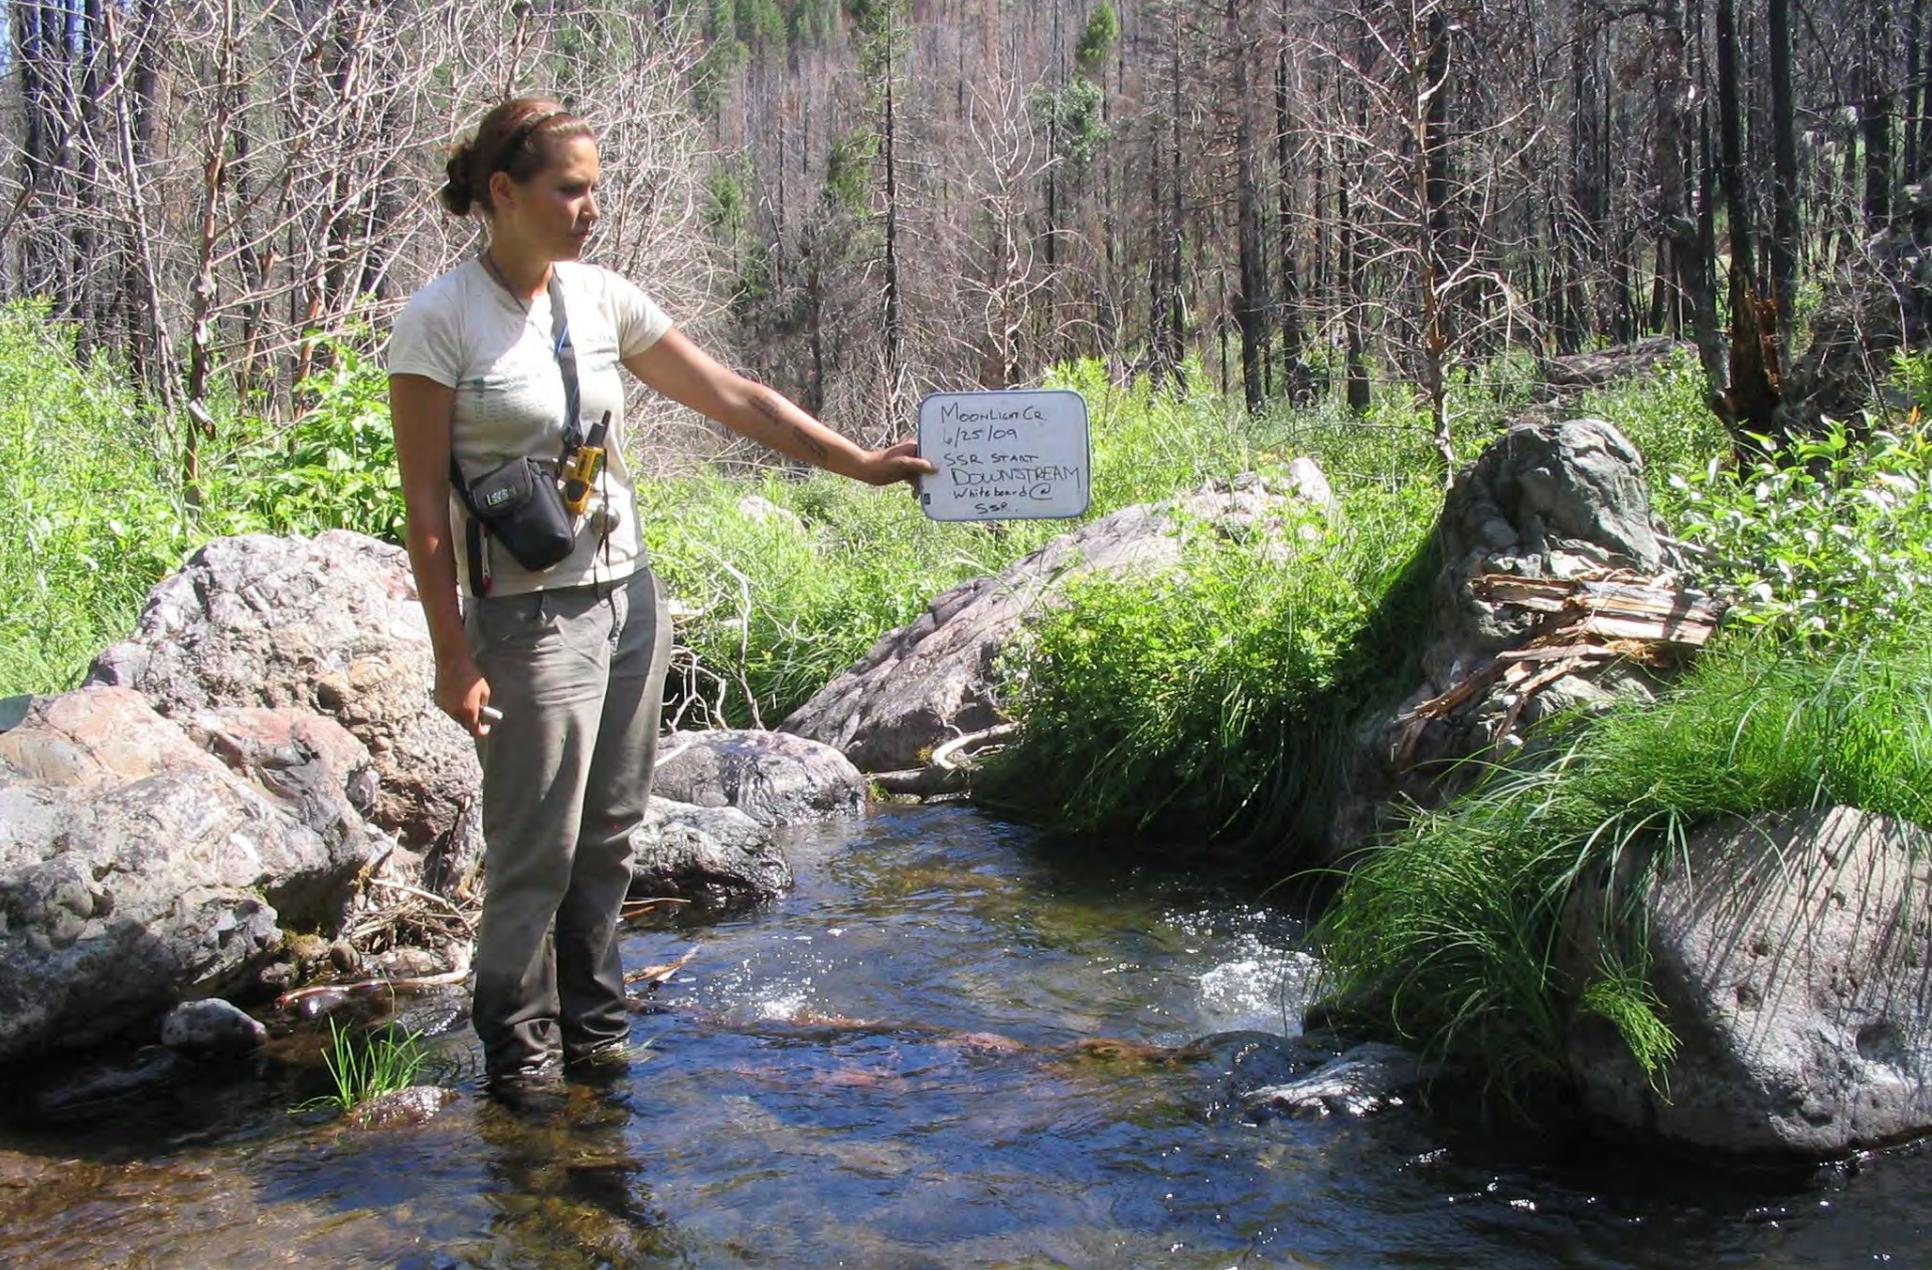
Moonlight Creek SCI monitoring reach, 2009. Two years after the Moonlight Fire. Monitoring showed results similar to those observed on Cub Creek.
