Post-Fire Erosion Control

Mitigating Hillslope Erosion Following a Wildfire

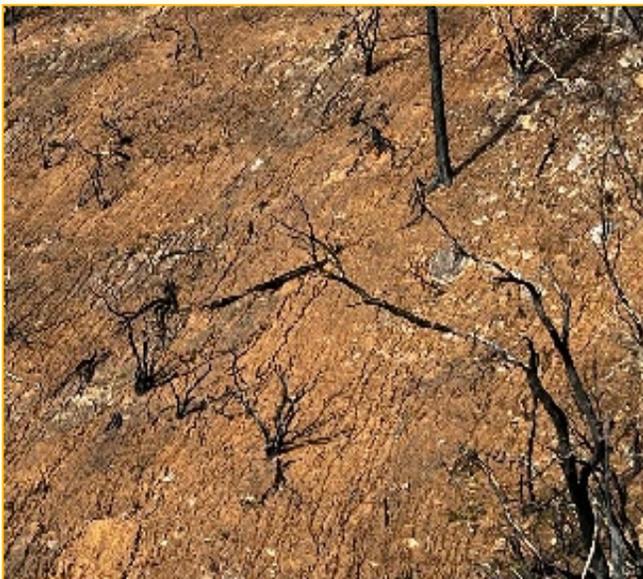
Image 1. Formation of rills following the 2022 Oak Fire
[Credit: Alison Deak]

Hillslope erosion occurs through three processes: (1) rainsplash when raindrops hit bare soil and detach soil particles; (2) sheeting from water flowing over weakened soils and carrying soil particles along with it; and (3) rilling, the process of water becoming concentrated in incisions on the landscape and developing into larger flow paths if not mitigated (Image 1).

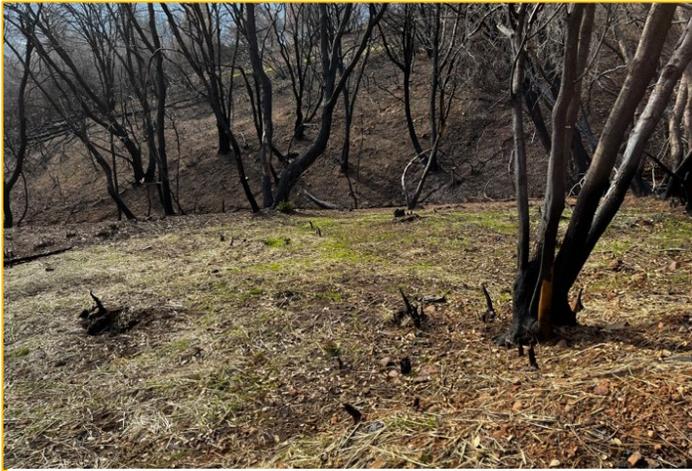
Image 3. A successful straw mulching treatment
[Credit: Alison Deak]

Mulching treatments have been found to be the most effective erosion control technique on hillslopes (Robichaud et al. 2014). These treatments provide ground cover that traps sediment, allows water to infiltrate, and slows the development of concentrated flows. Mulching treatments may be applied using agricultural straw, wood shreds, or wood chips and typically, a mulch application rate of 60 to 70 percent ground cover is ideal for limiting erosion (Prosdociami et al. 2016). Care should also be taken to avoid spreading mulch too thick as it can limit the regeneration of native vegetation (Robichaud et al. 2010)

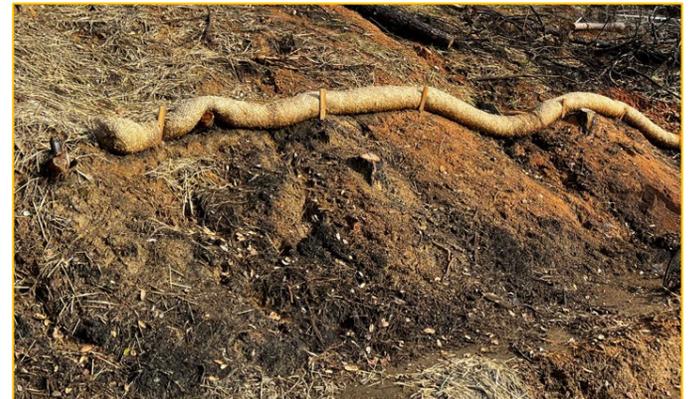
Image 2. A failed erosion barrier that led to channelized flow during a high-intensity rain event [Credit: Alison Deak]

they may be expensive to install if using off-site materials and are likely to fail during short-duration high intensity rainfall events because they do not provide ground cover and can channelize flow if installed incorrectly (Image 3; Robichaud et al 2008). Erosion barriers can be constructed using either contour log felling or straw wattles.
