CAMP FIRE

Watershed Emergency Response Team

Final Report

CA-BTU-016737

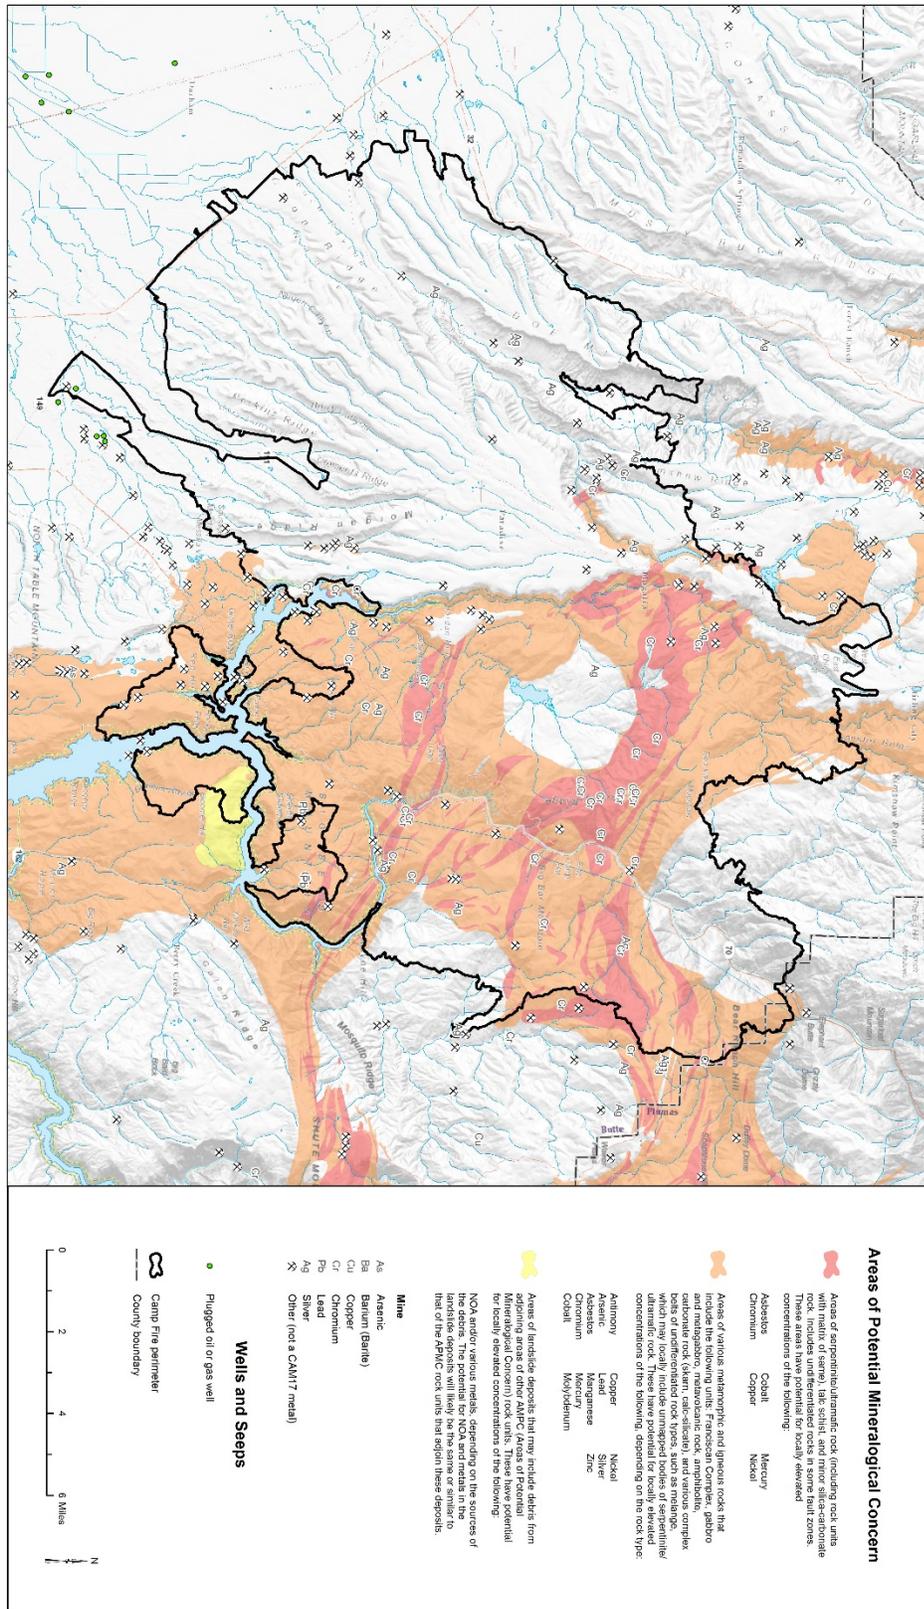
Figure 9. Map of hazardous minerals within or adjacent to the Camp Fire area.

The locations of potential mineralogical hazards, including ultramafic rocks and known mine locations are shown below in the Mineral Hazard Map (Figure 9).

Owing to the extreme relief and potential access limitations following significant rain events, it may be difficult to access known mine sites. See Mineral Hazards map (Figure 9) for a map of mining sites that the WERT is aware of. Additional recommendations are as follows:

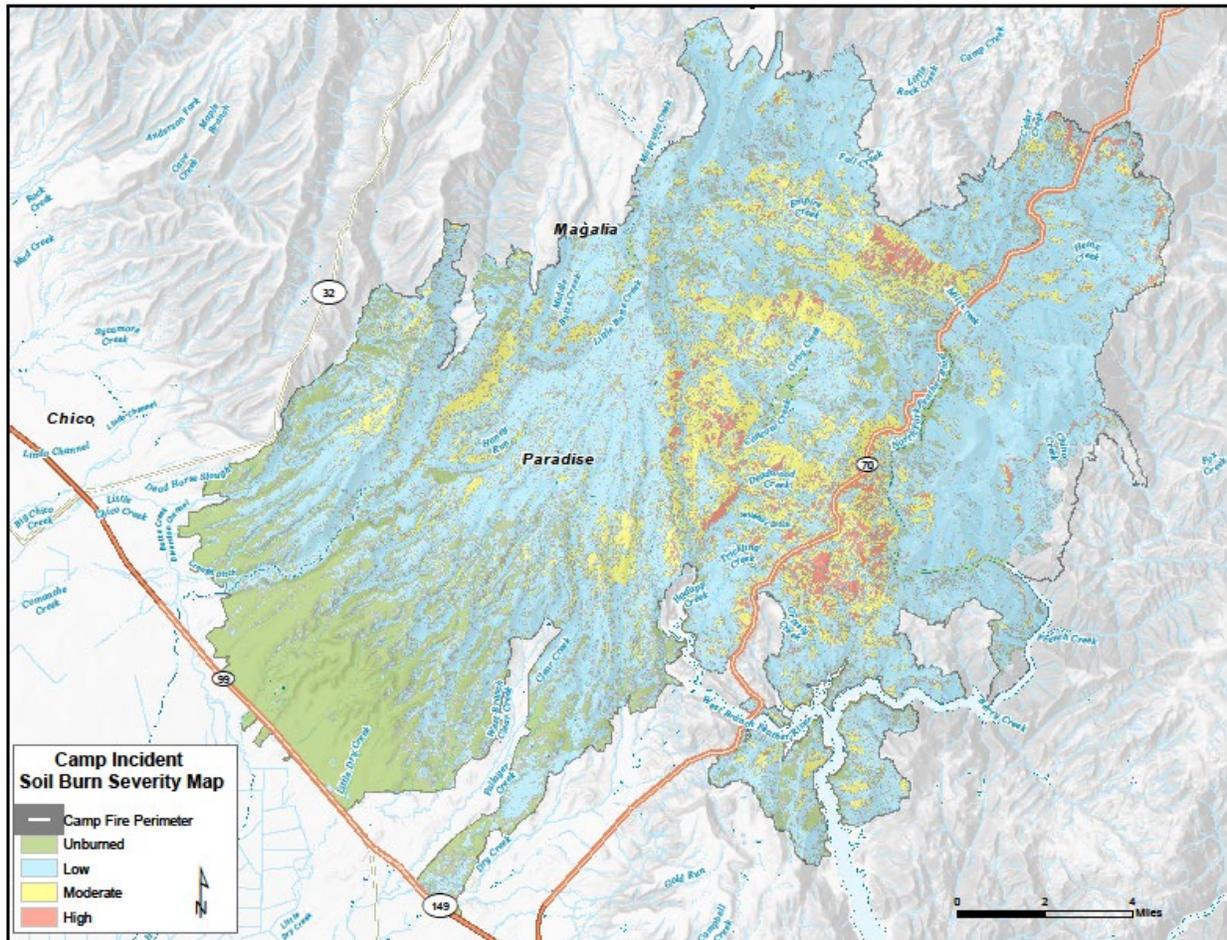
Figure 12. Soil Burn Severity Map of the Camp Fire burn area.

Figure 12 is a map of SBS and shows the spatial pattern of SBS throughout the burn area.

The map exemplifies that the burn area is dominated by very low to low SBS. Areas of high SBS are most common in the areas around Concow, Jordan Hill, Yankee Hill, and upslope of Pulga.

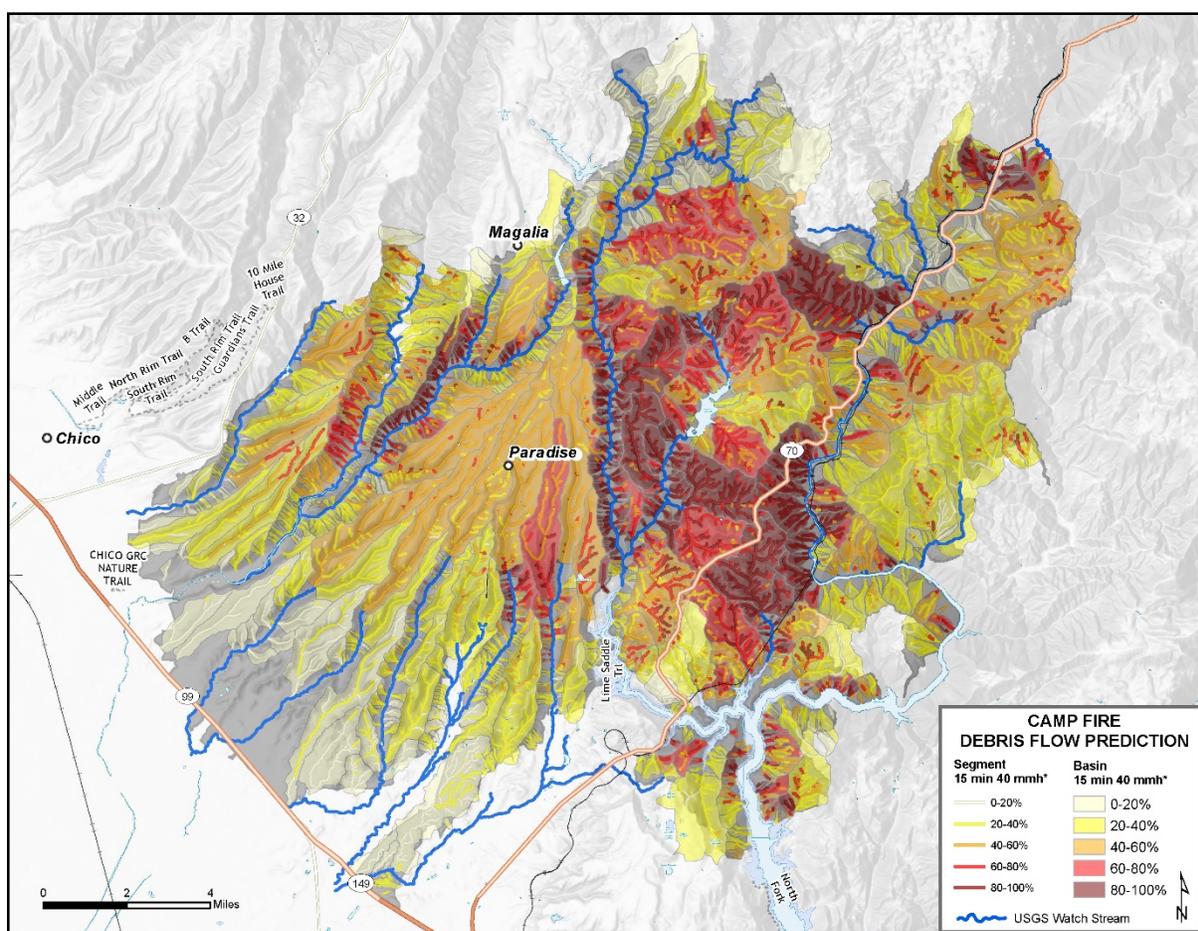
Figure 13. Combined basin and stream segment debris flow hazard for a 15-minute, 1.6 in hr⁻¹ (40 mm hr⁻¹) storm event.

The debris flow likelihood maps based design storm with a peak 15-minute intensity of 1.6 inches/hour (40 mm/hr) design rainfall are presented in Figure 13 and Appendix D, and illustrate the likelihood of debris flows occurring in response to a 1- to 2-year annual

Based on our experience and field observations on past WERT assignments, it appears that the debris flow model results generally tend to overpredict the probability of debris flows in the region. As stated above, the majority of slopes within the Camp Fire burn area are gentle to moderate (less than 40 percent slopes) with rolling topography and do not appear conducive to the production of debris flows (see Figure 4, Slope Map).

Generally, steeper slopes within the burn area were interpreted by the model as having a high probability of producing debris flows. The dissected steep slopes observed along Butte Creek and in other areas within the burn area were interpreted by the model as debris flow producing basins. As stated above, the slopes along Butte Creek appear to have been modified by historical hydraulic mining and these landscapes have supported steep slopes over long periods and multiple fires without evidence of significant mass wasting. Along the West Branch and North Fork Feather River, bedrock is generally competent, supports moderate to steep slopes, and is mostly mantled by shallow, gravel-rich soils. While these steep slopes within the burn area are likely to produce additional erosion and rock fall as a result of post-fire effects, no obvious visible geomorphic evidence of substantial historic debris flows were observed in these areas.

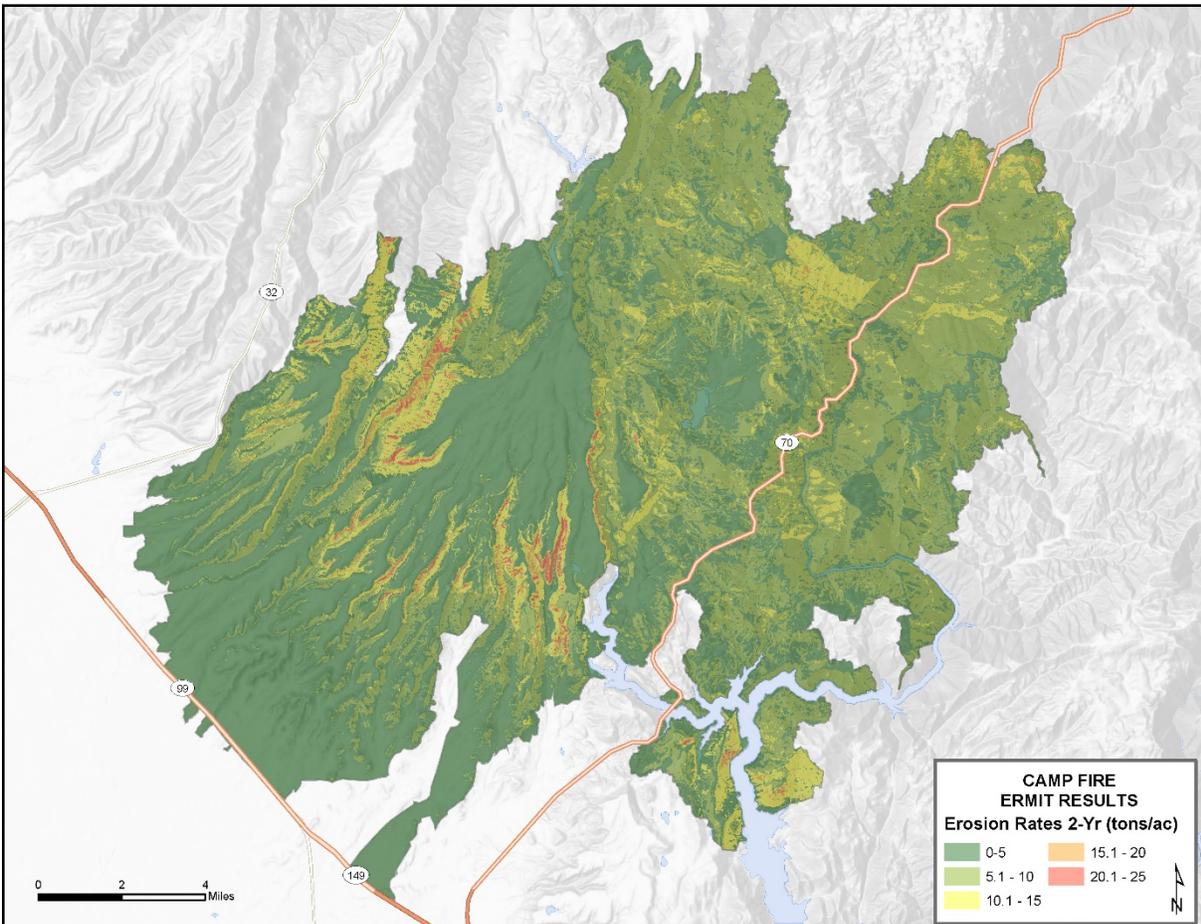
Figure 14. ERMiT Results Map showing Erosion Rates for a 2-year storm event.

year recurrence interval storm (Figure 14). Areas that show elevated increased erosion potential (between 20 to 25 tons per acre) included the very steep soils along the upper reaches of Butte Creek, Dry Creek, Clear Creek, and other smaller drainages to Butte Valley and along the West Branch Feather River.

The average rate of modelled post-fire sediment erosion is approximately 4 times higher than the decadal scale sedimentation rates estimated from data from Oroville Dam (see Section 3.3.4).

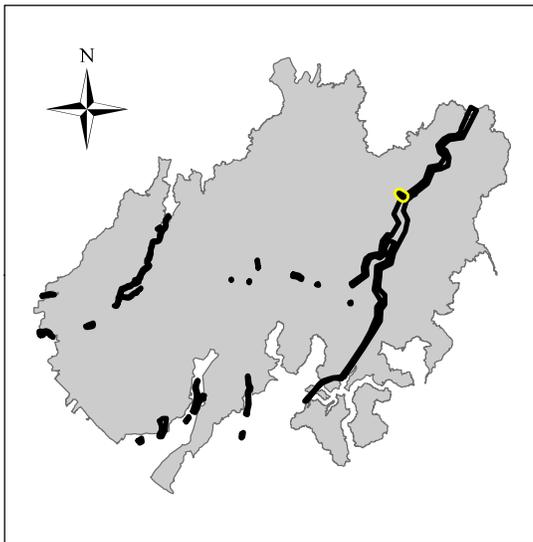
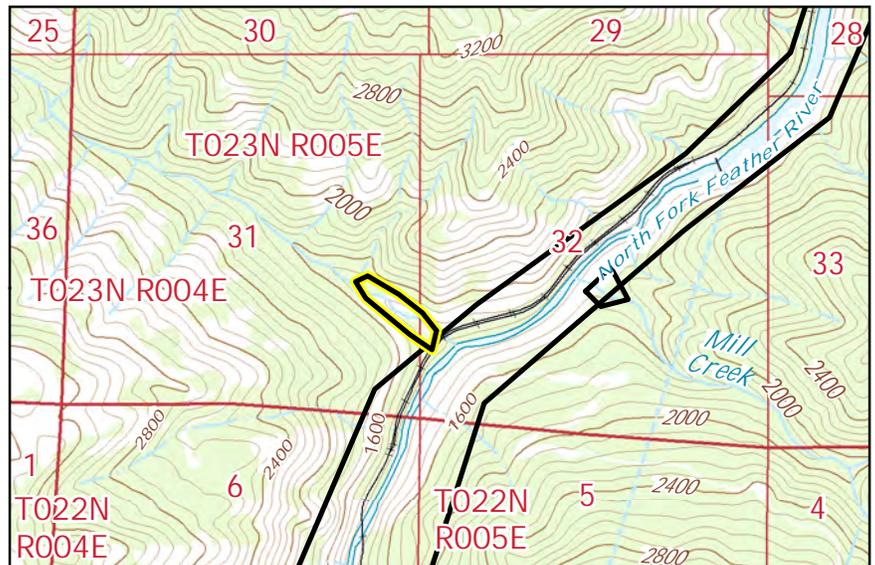
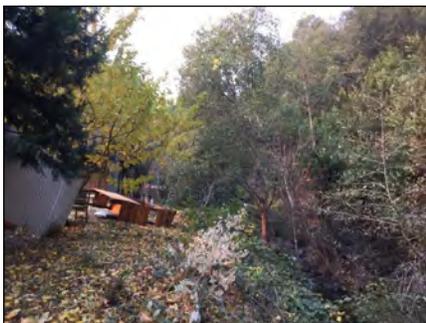
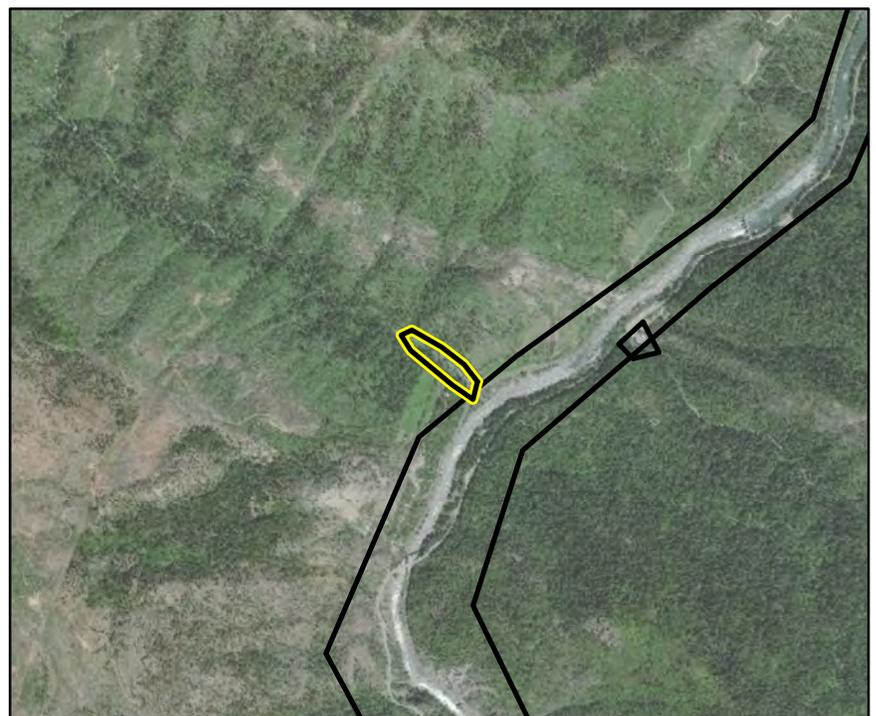
Potential Hazard to Life: high

Potential Hazard to Property: high

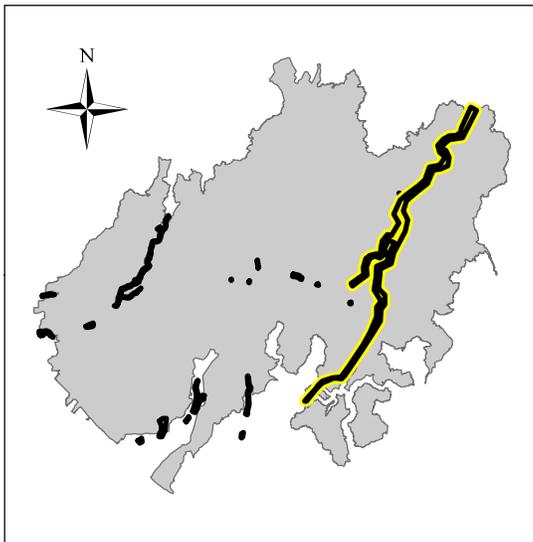
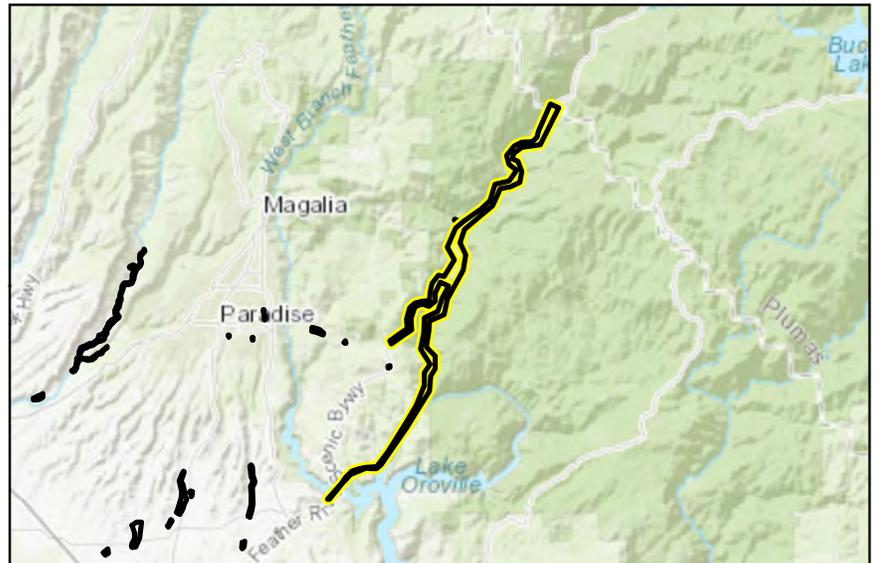
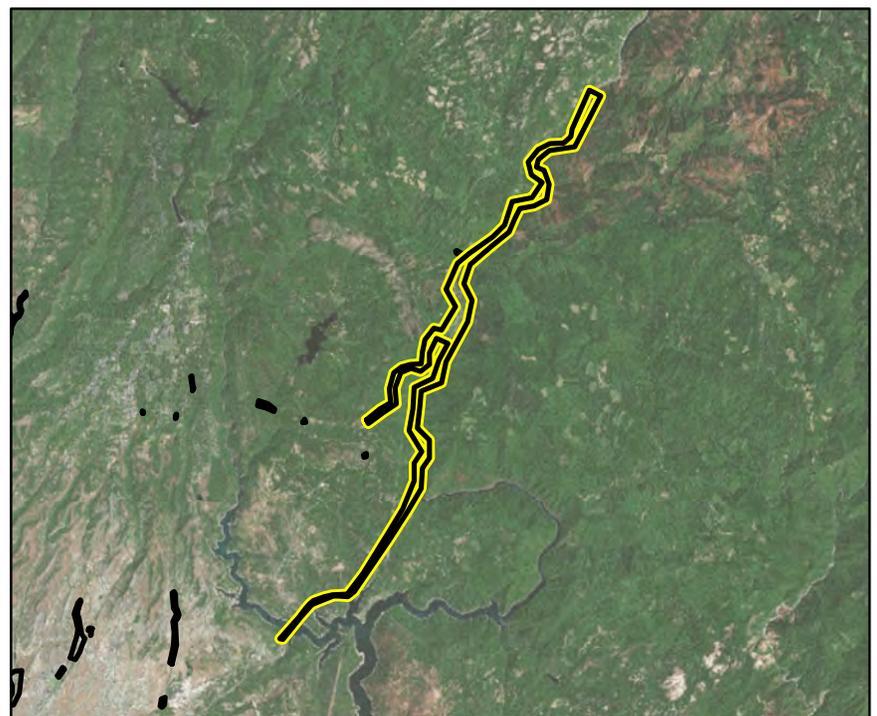
Potential Hazard to Life: low
Potential Hazard to Property: moderate
FEMA/DWR 100-yr Floodplain: Yes
Preliminary Emergency: Early warning system
Protective Measures

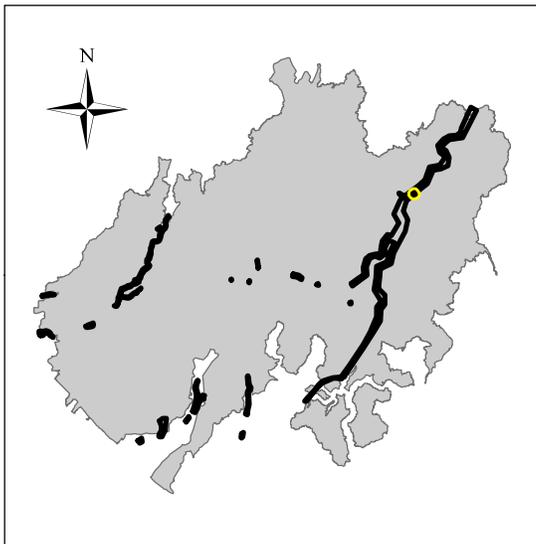
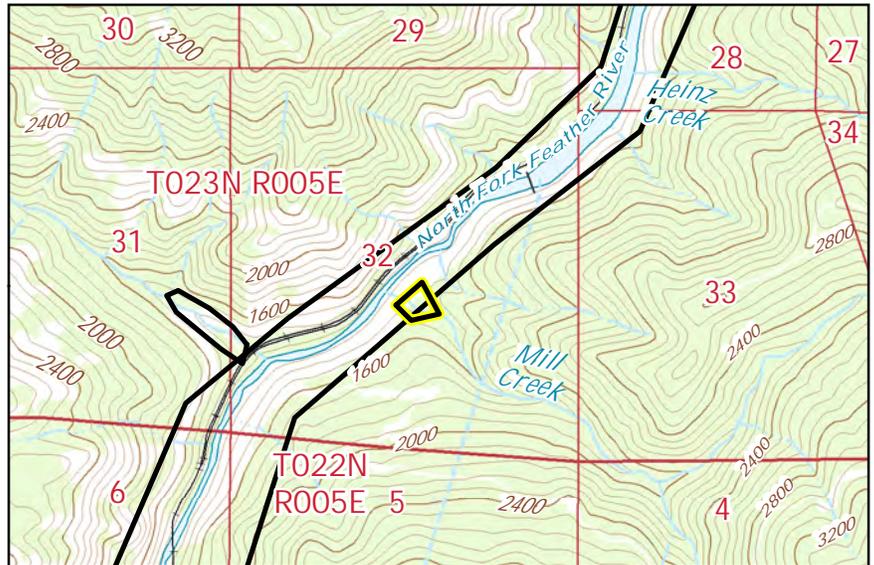
Potential Hazard to Life: low

Potential Hazard to Property: moderate

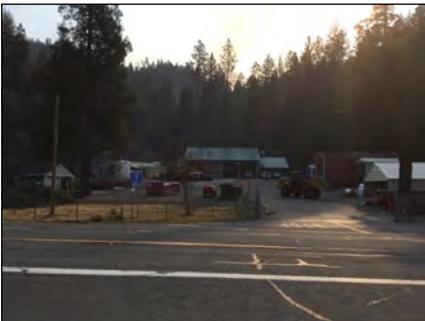
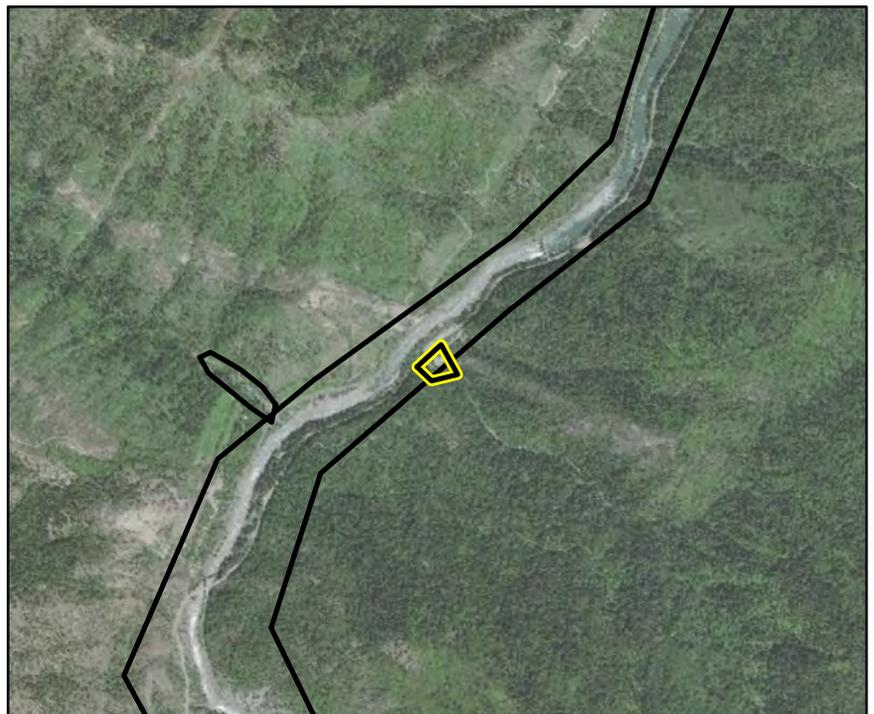
Field Observation: Burned house and other outbuildings located in channel zones, could be impacted by debris and/or flood. Site is located on moderate probability debris flow segment.

Potential Hazard to Life: moderate

Potential Hazard to Property: moderate

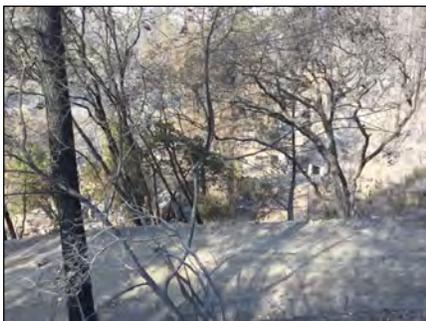
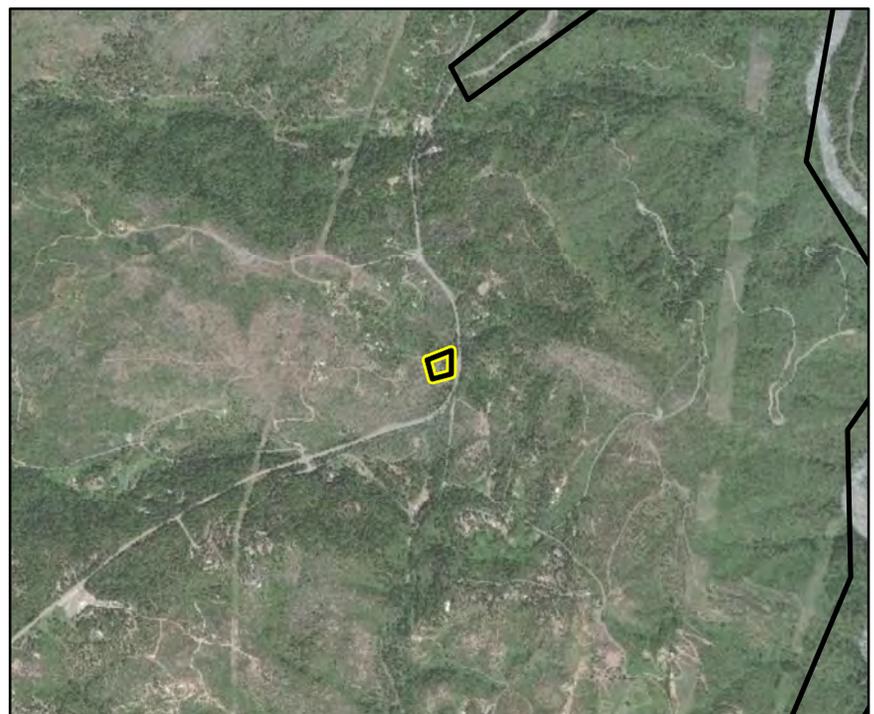
Potential Hazard to Life: low
Potential Hazard to Property: moderate
FEMA/DWR 100-yr Floodplain: No
Preliminary Emergency: Early warning system
Protective Measures

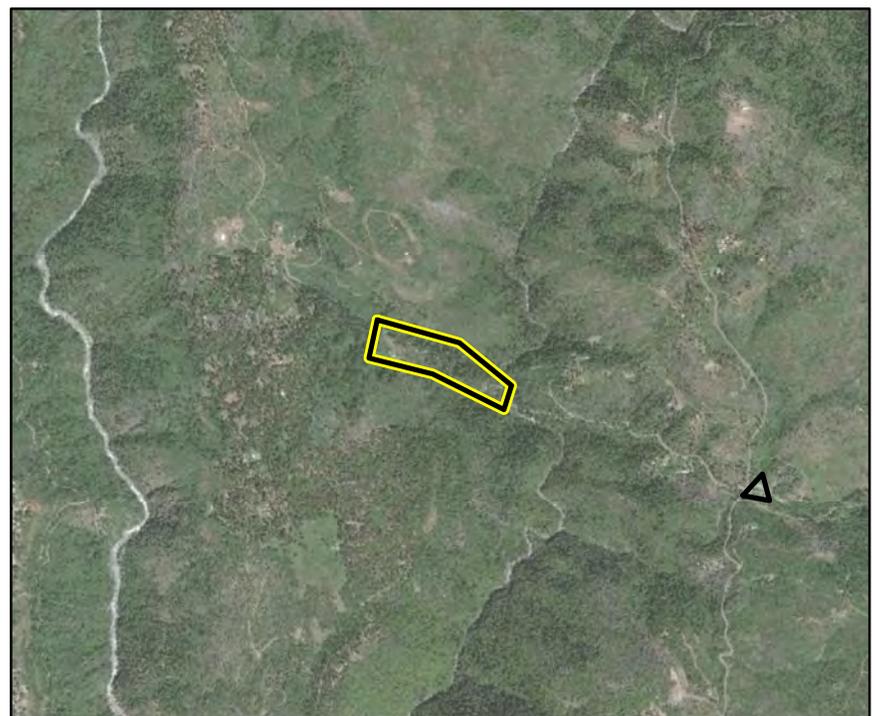
Potential Hazard to Life: low
Potential Hazard to Property: low
FEMA/DWR 100-yr Floodplain: Yes
Preliminary Emergency: Early warning system
Protective Measures

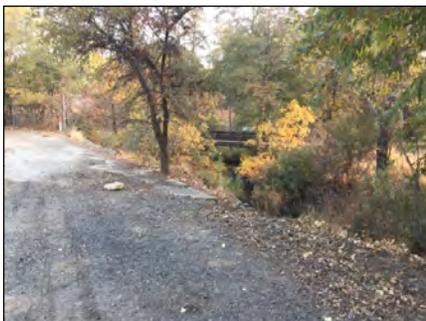
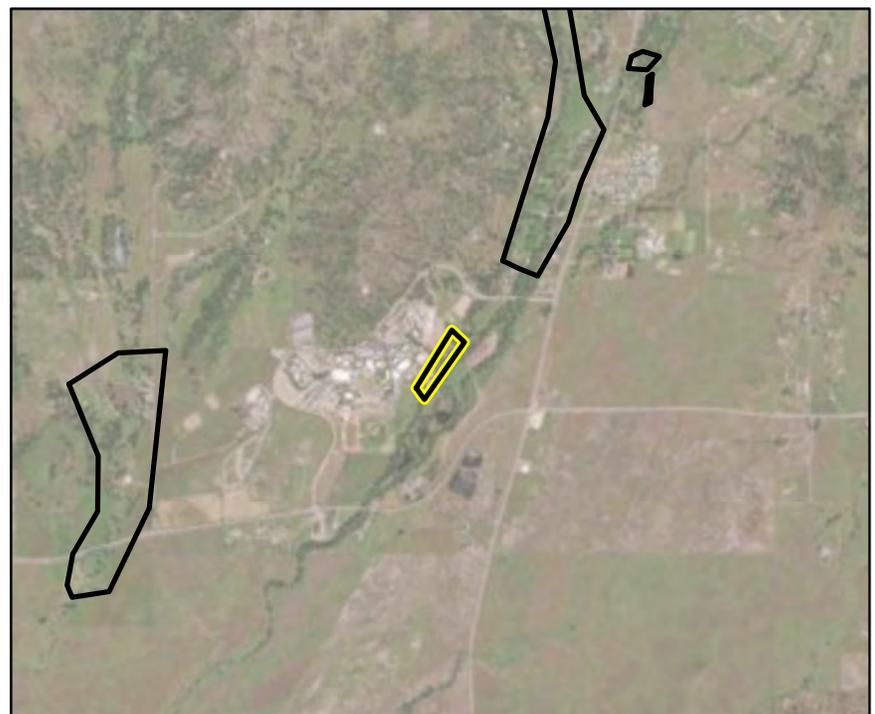
Field Observation: Several homes located within mapped FEMA flood hazard area. Several small private bridges located along creek may be at risk of failure.

Potential Hazard to Life: low

Potential Hazard to Property: moderate

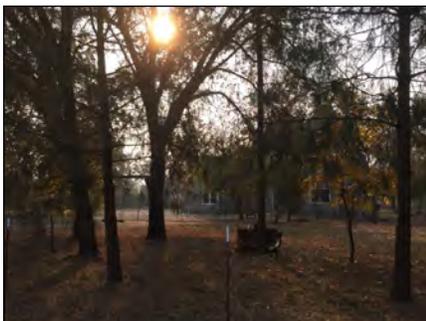
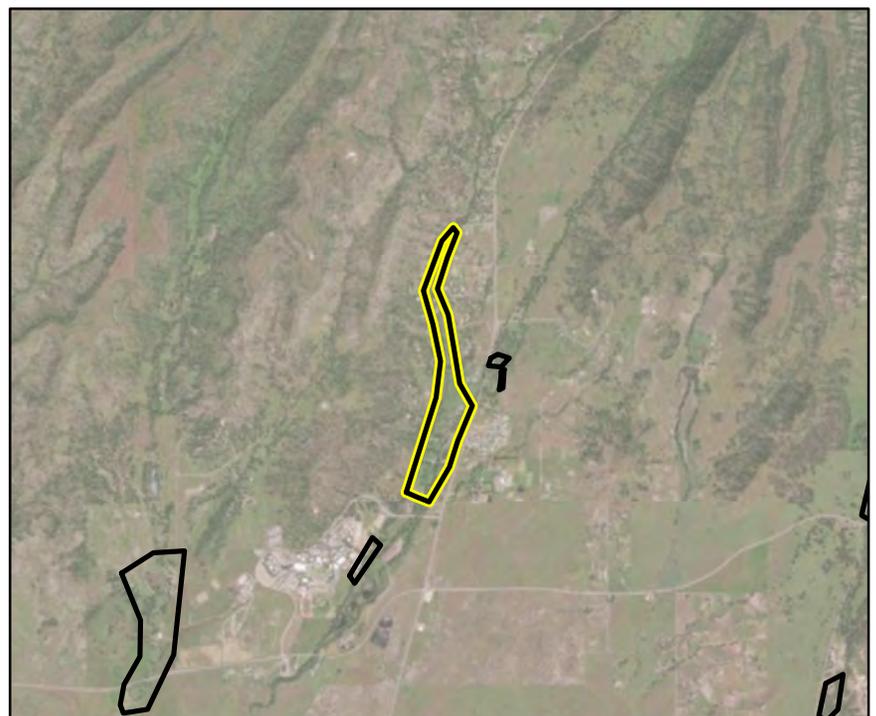
Community: Butte Valley
Site Number: 23
Feature: Houses and outbuildings
Feature Category: flood
Field Observation: Houses located within mapped FEMA flood hazard area. Structures appear to be located on terraces

Potential Hazard to Life: low
Potential Hazard to Property: low
FEMA/DWR 100-yr Floodplain: Yes
Preliminary Emergency: Early warning system
Protective Measures

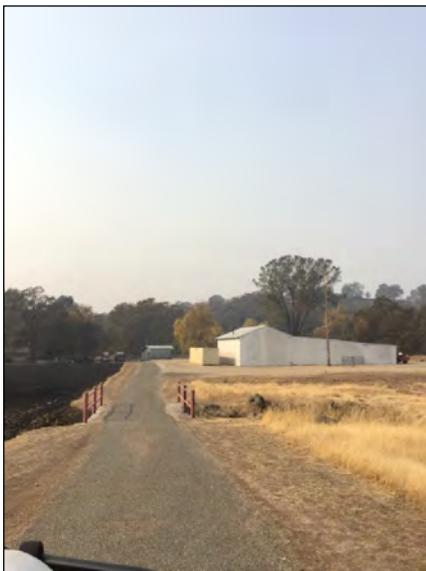
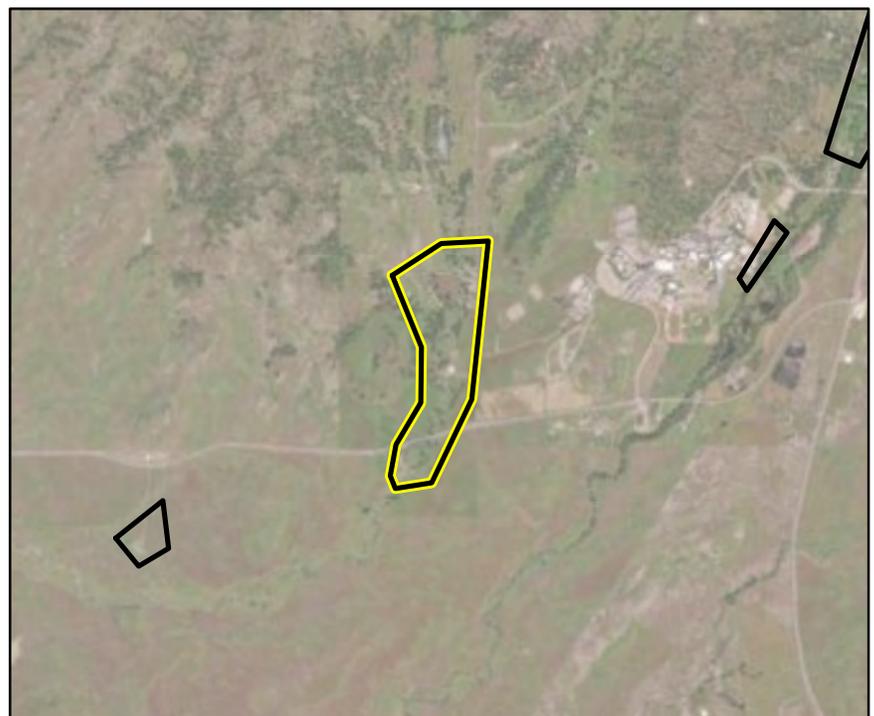
Potential Hazard to Life: low
Potential Hazard to Property: low
FEMA/DWR 100-yr Floodplain: Yes
Preliminary Emergency: Early warning system
Protective Measures

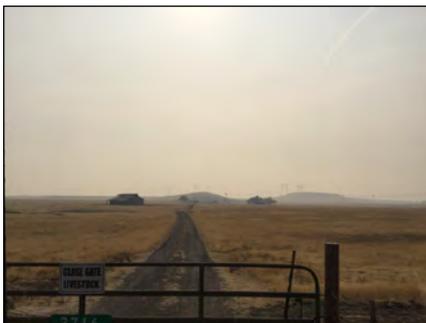
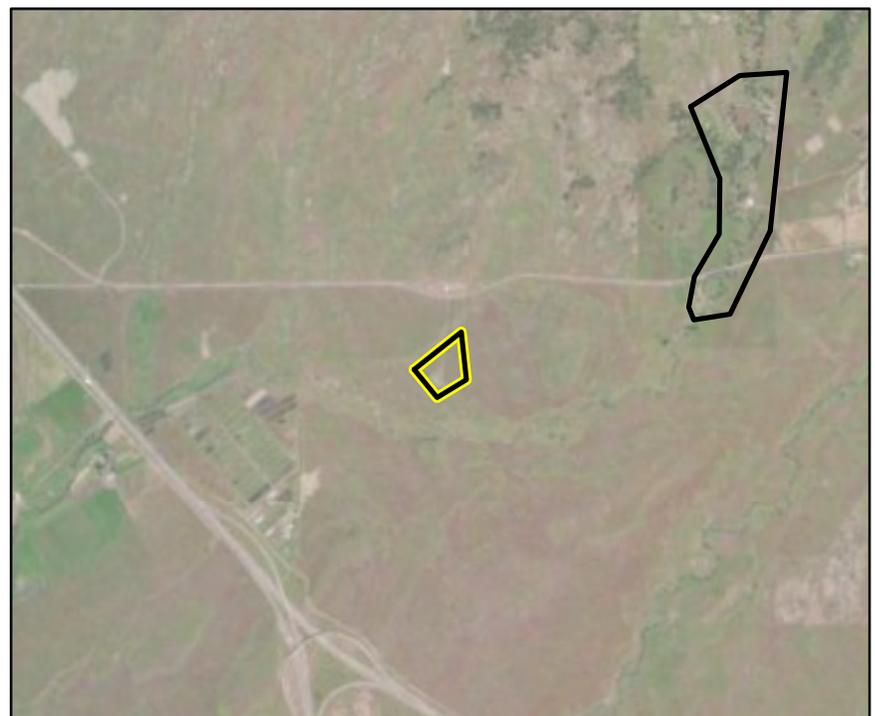
Field Observation: Houses located within mapped flood zone. Structures appear to be located on terraces. Private bridges within the flood zone may be prone to failure.

Potential Hazard to Life: low

Potential Hazard to Property: low

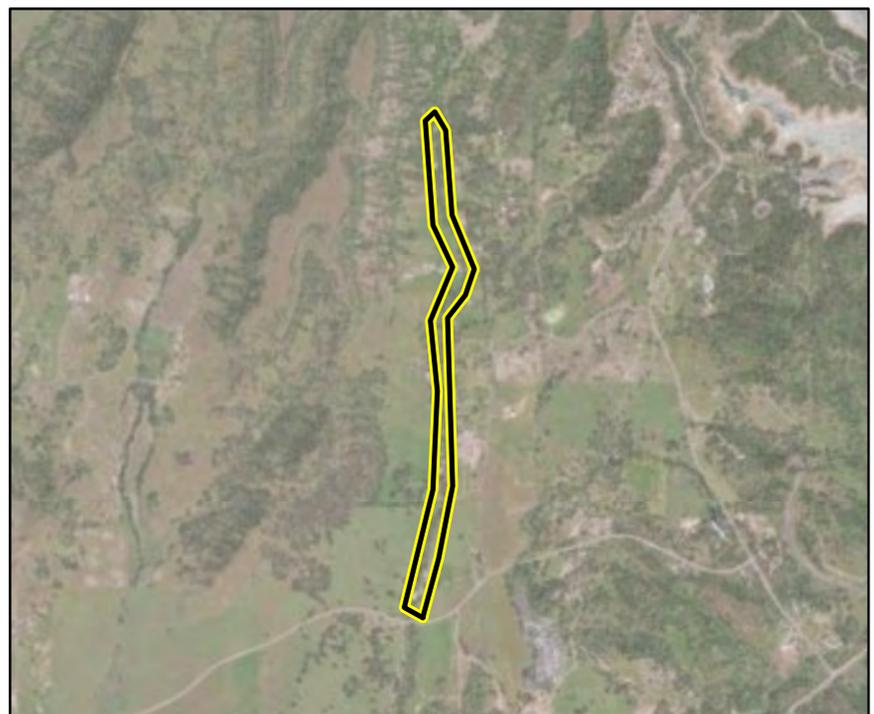
Potential Hazard to Life: low
Potential Hazard to Property: low
FEMA/DWR 100-yr Floodplain: Yes
Preliminary Emergency: Early warning system
Protective Measures

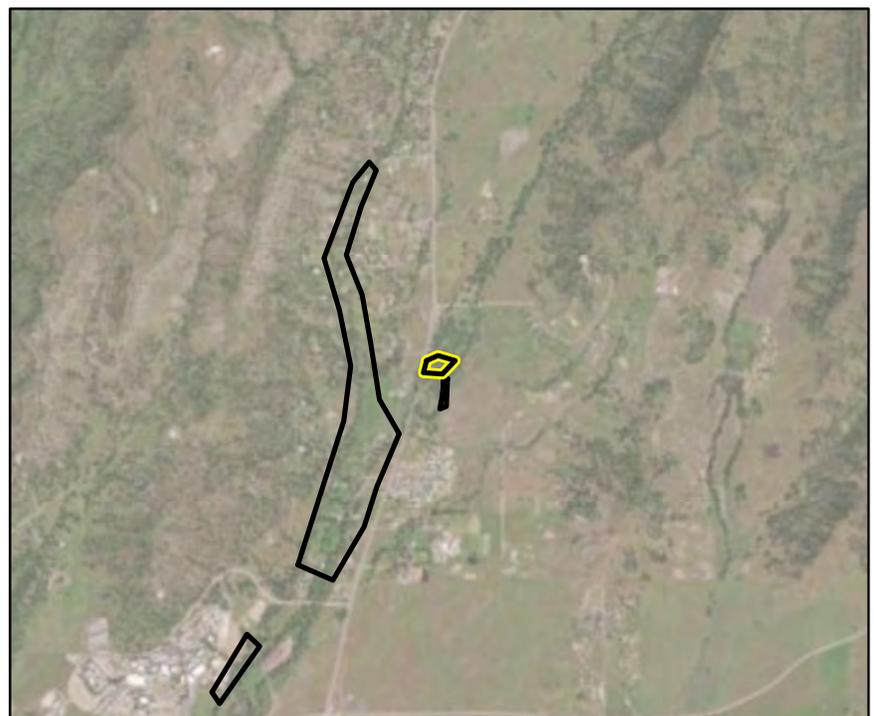
Community: **Butte Valley**
Site Number: 28
Feature: Bridge and Road
Feature Category: flood
Field Observation: Bridge and Road located in mapped flood hazard area

Potential Hazard to Life: low
Potential Hazard to Property: low
FEMA/DWR 100-yr Floodplain: Yes
Preliminary Emergency: Early Warning System
Protective Measures

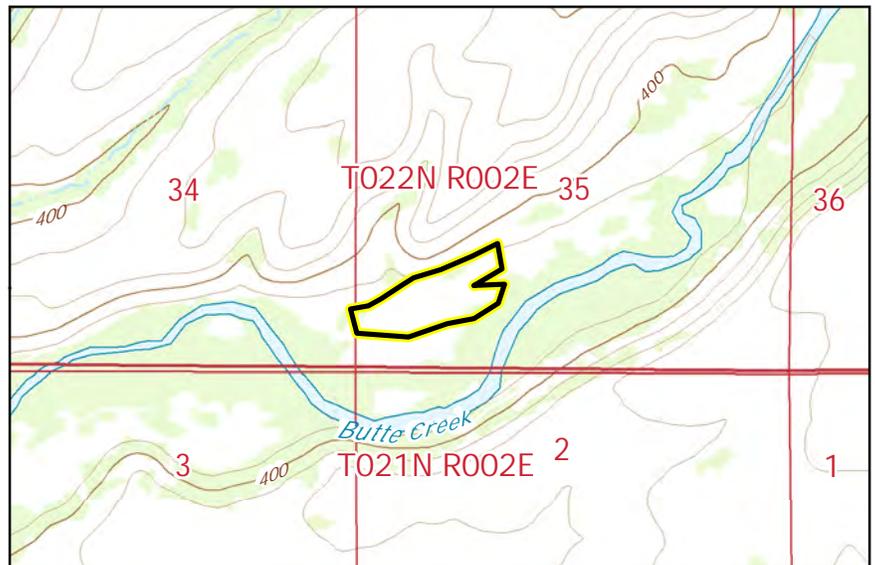
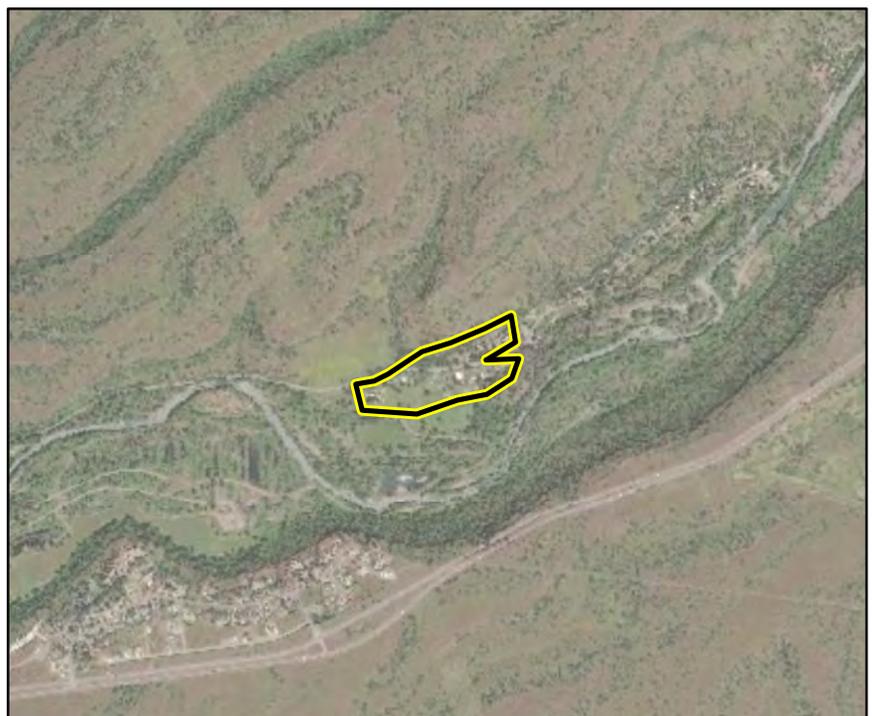
Community: **Butte Canyon**
Site Number: 42
Feature: Homes
Feature Category: flood
Field Observation: Residential structures located in mapped flood hazard area.

Potential Hazard to Life: low
Potential Hazard to Property: moderate
FEMA/DWR 100-yr Floodplain: Yes
Preliminary Emergency: Early warning system
Protective Measures

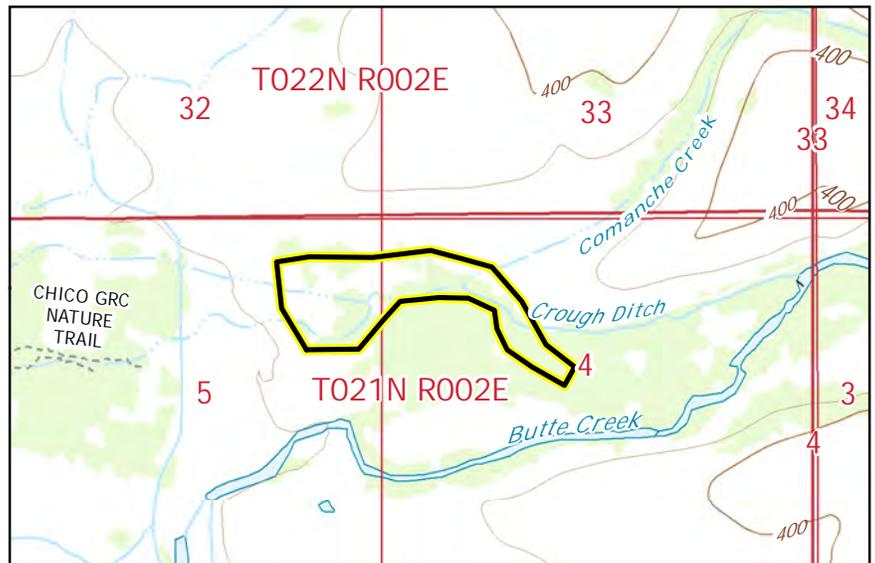
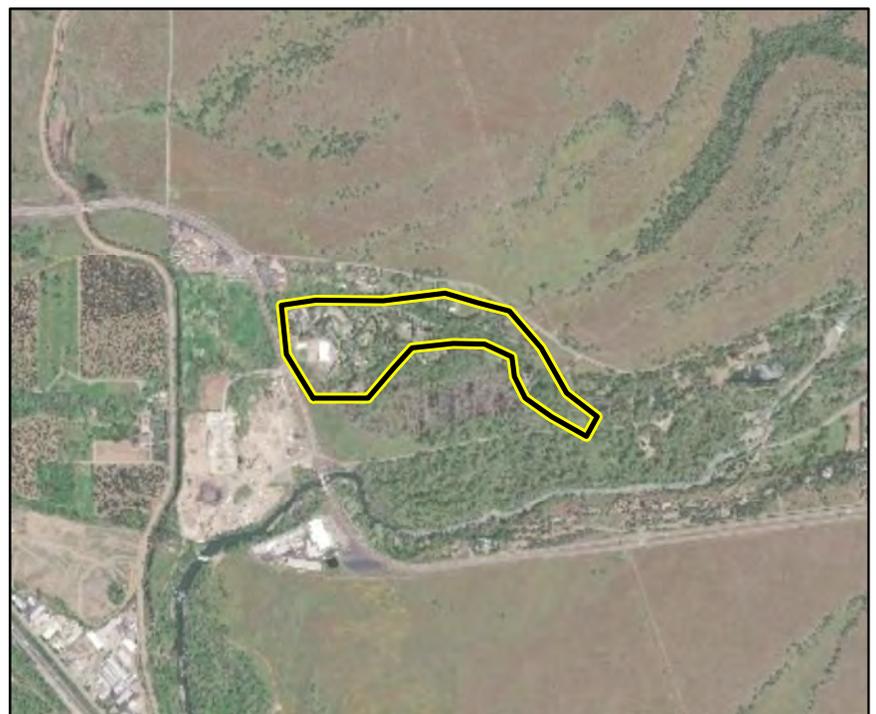
Community: Butte Canyon
Site Number: 43
Feature: Homes and structures
Feature Category: flood
Field Observation: Residential structures located in mapped flood hazard area.

Potential Hazard to Life: low
Potential Hazard to Property: low
FEMA/DWR 100-yr Floodplain: Yes
Preliminary Emergency: Early warning system
Protective Measures

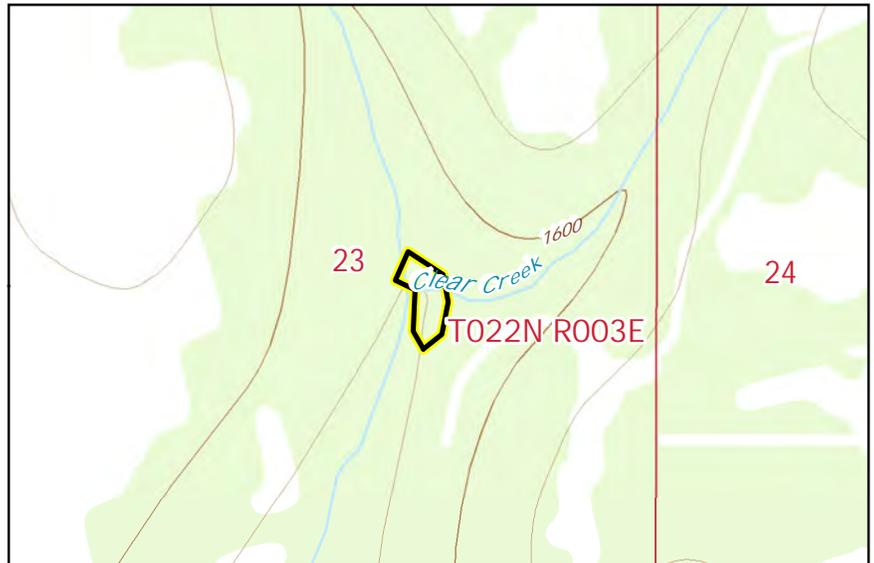
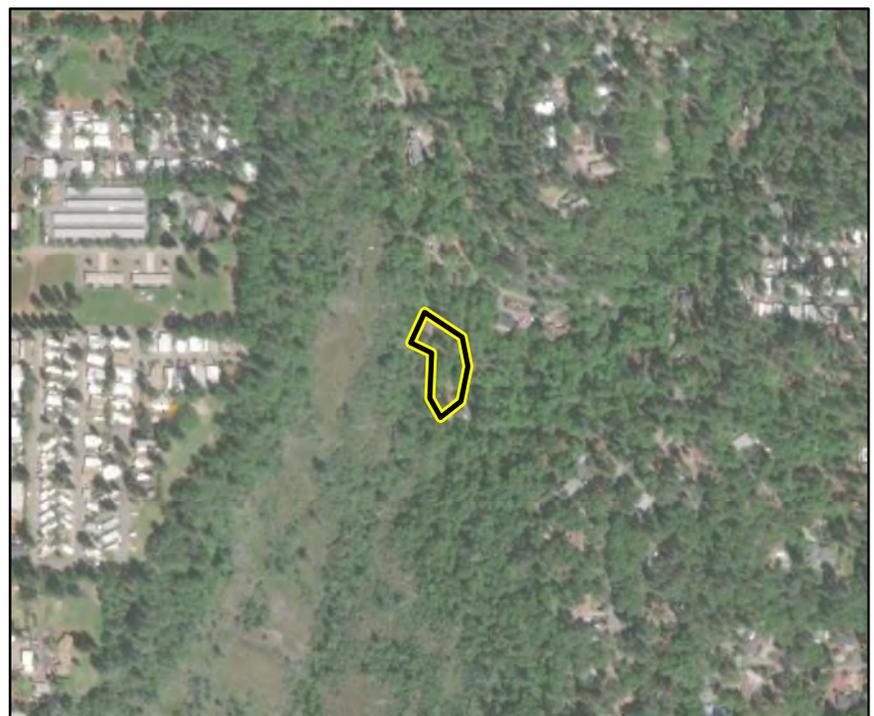
Community: Paradise
Site Number: 058
Feature: Homes
Feature Category: flood
Field Observation: Homes in close proximity of Clear Creek and tributaries. Watercourse observed running through homesite, unsure if it is by design.

Potential Hazard to Life: low
Potential Hazard to Property: moderate
FEMA/DWR 100-yr Floodplain: No
Preliminary Emergency: Early warning system.
Protective Measures

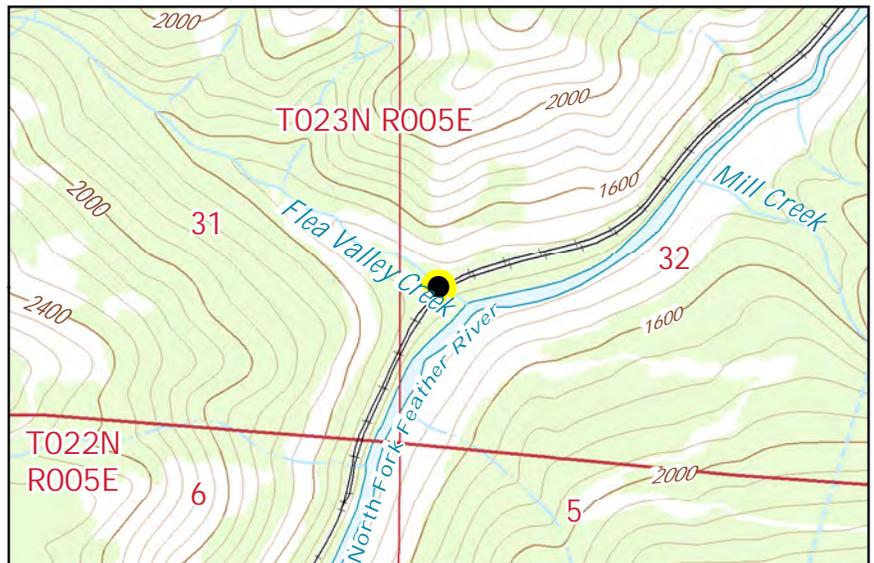
Community: Highway 70
Site Number: 04
Feature: Railroad bridge crossing
Feature Category: debris flow / flood
Field Observation: Railroad trestle bridge crossing on Flea Creek at risk of debris flow. Observed apparent utility line across upstream side of bridge.

Potential Hazard to Life: low
Potential Hazard to Property: high
FEMA/DWR 100-yr Floodplain: yes
Preliminary Emergency: Storm patrol
Protective Measures

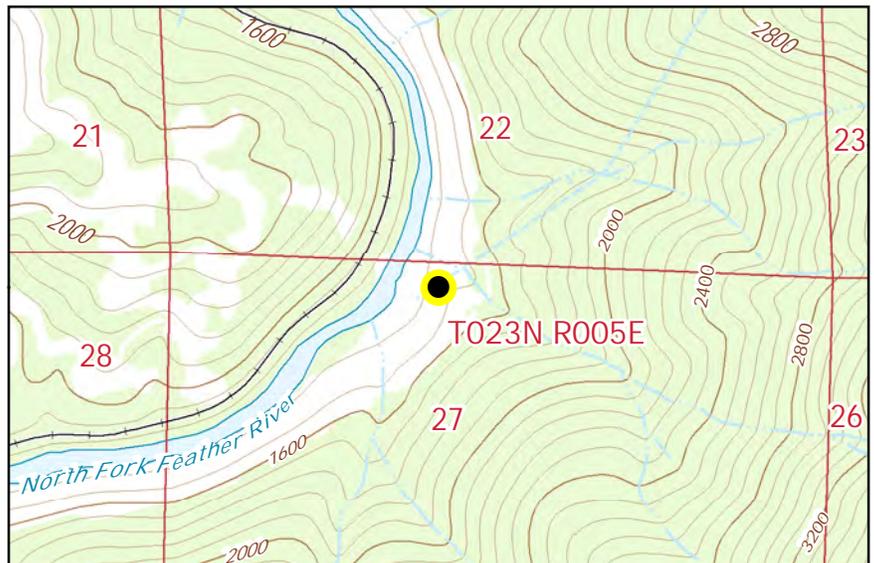
Community: Highway 70
Site Number: 06
Feature: Cresta Powerhouse and penstocks
Feature Category: debris flow / flood
Field Observation: Cresta Powerhouse located within mapped Flood Hazard Area. Potential for debris flow impacts to powerhouse and penstocks.

Potential Hazard to Life: low
Potential Hazard to Property: low
FEMA/DWR 100-yr Floodplain: no
Preliminary Emergency: Early warning system. Notify PG&E.
Protective Measures

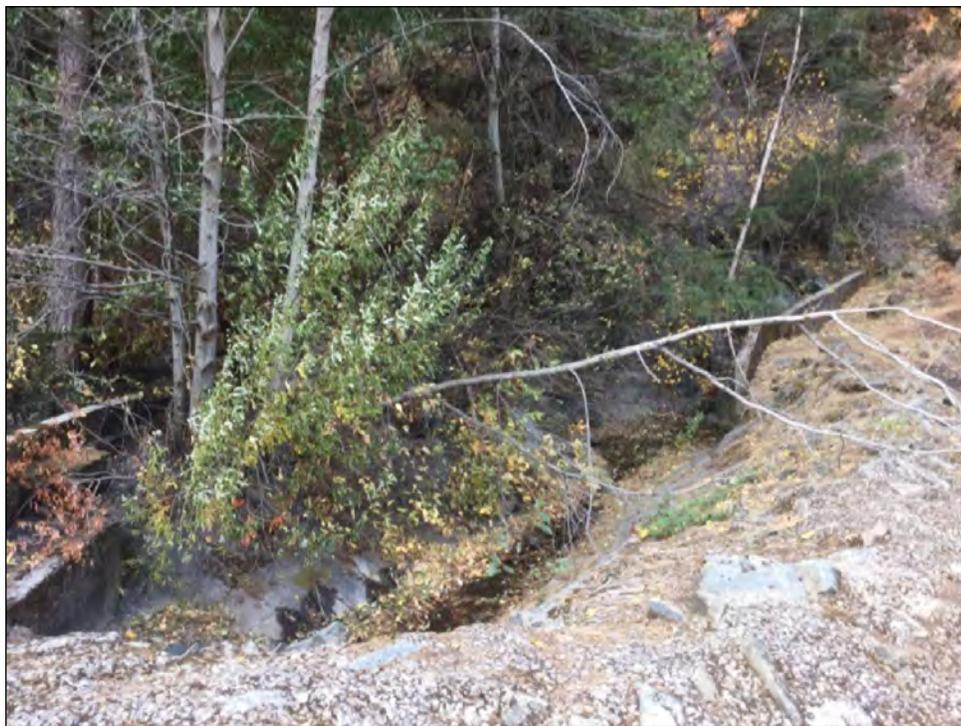
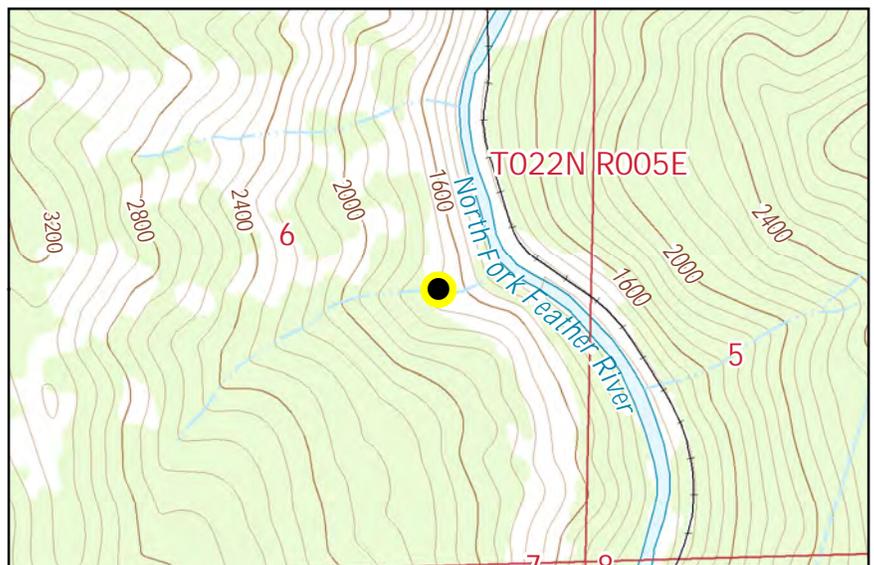
Field Observation: Historical foundation / homesite located at mouth of steep concave hill slope. Culvert crossing located upslope of pad. Observed building foundation adjacent to culvert. Site appears unoccupied

Potential Hazard to Life: low

Potential Hazard to Property: moderate

Preliminary Emergency: Early warning system
