CAMP FIRE

Watershed Emergency Response Team

Final Report

CA-BTU-016737

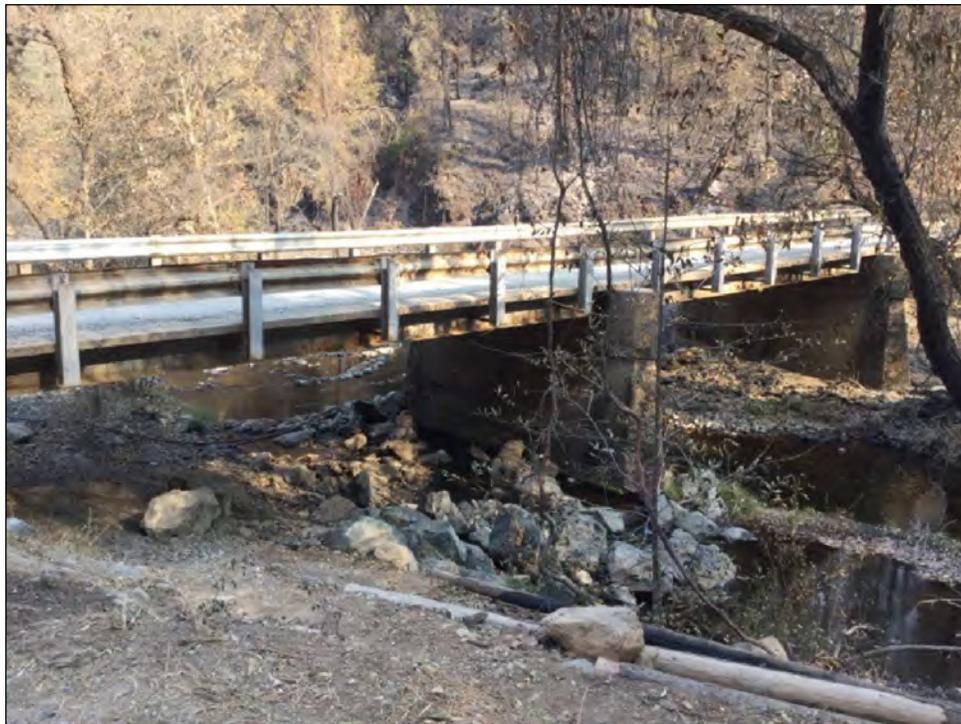
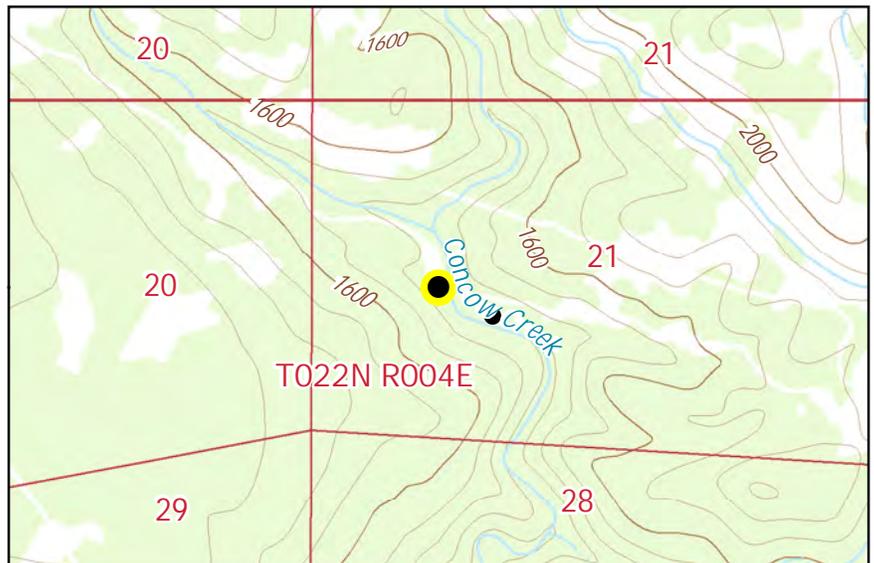
Potential Hazard to Life: low

Potential Hazard to Property: moderate

Preliminary Emergency: Storm patrol

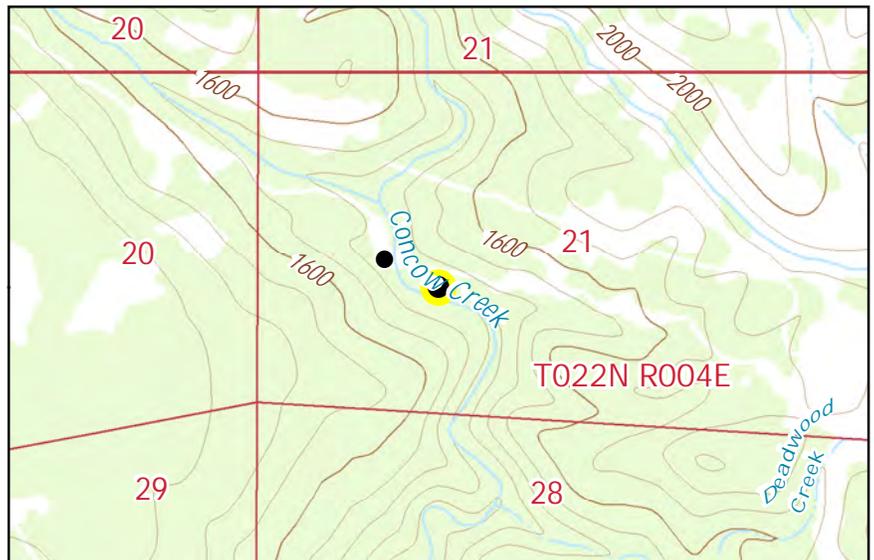
Community: Concow
Site Number: 12
Feature: House foundation
Feature Category: flood
Field Observation: Burned house located adjacent to stream in mapped flood hazard area. Stream is identified as USGS watch stream.

Potential Hazard to Life: low
Potential Hazard to Property: low
FEMA/DWR 100-yr Floodplain: yes
Preliminary Emergency: Early warning system
Protective Measures

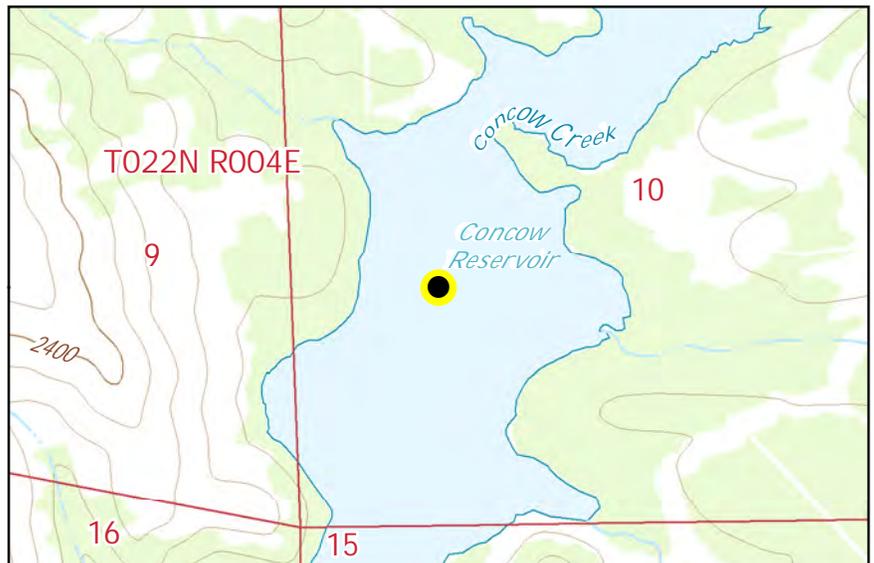
Potential Hazard to Life: no
Potential Hazard to Property: low
FEMA/DWR 100-yr Floodplain: yes
Preliminary Emergency: Notify local water district
Protective Measures

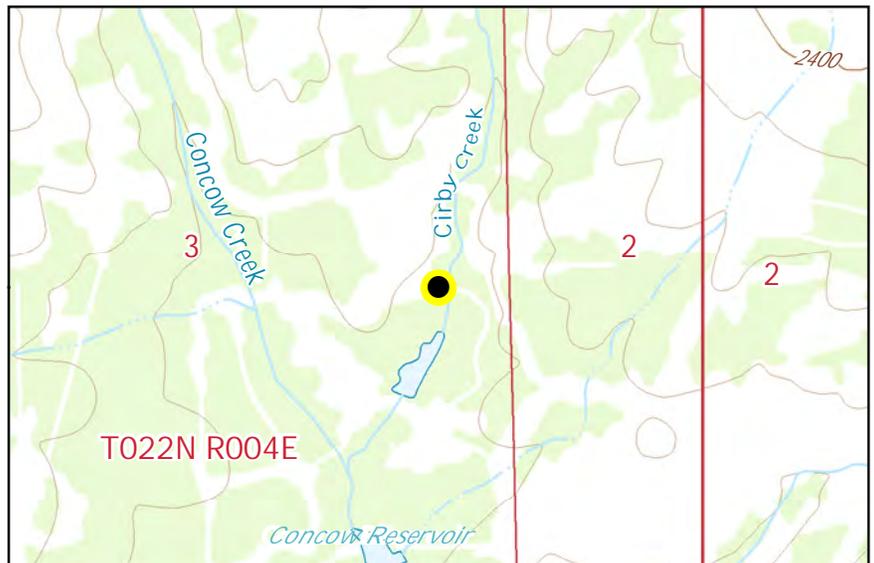
Community: Concow
Site Number: 14
Feature: Box culvert bridge
Feature Category: debris flow / flood
Field Observation: Existing box culvert bridge at risk of plugging. The crossing shows evidence of past failure.

Potential Hazard to Life: low
Potential Hazard to Property: moderate
FEMA/DWR 100-yr Floodplain: no
Preliminary Emergency: Storm patrol
Protective Measures

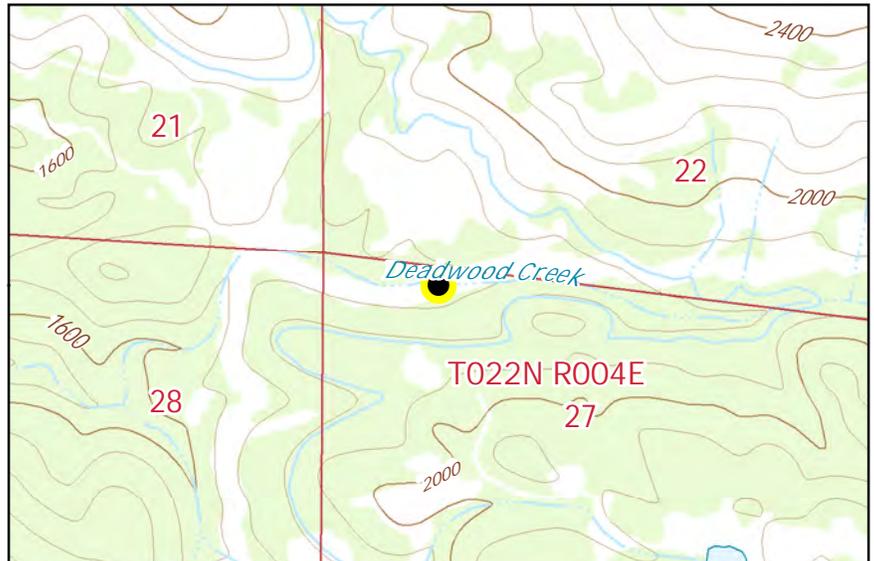
Potential Hazard to Life: low
Potential Hazard to Property: moderate
FEMA/DWR 100-yr Floodplain: no
Preliminary Emergency: Storm patrol
Protective Measures

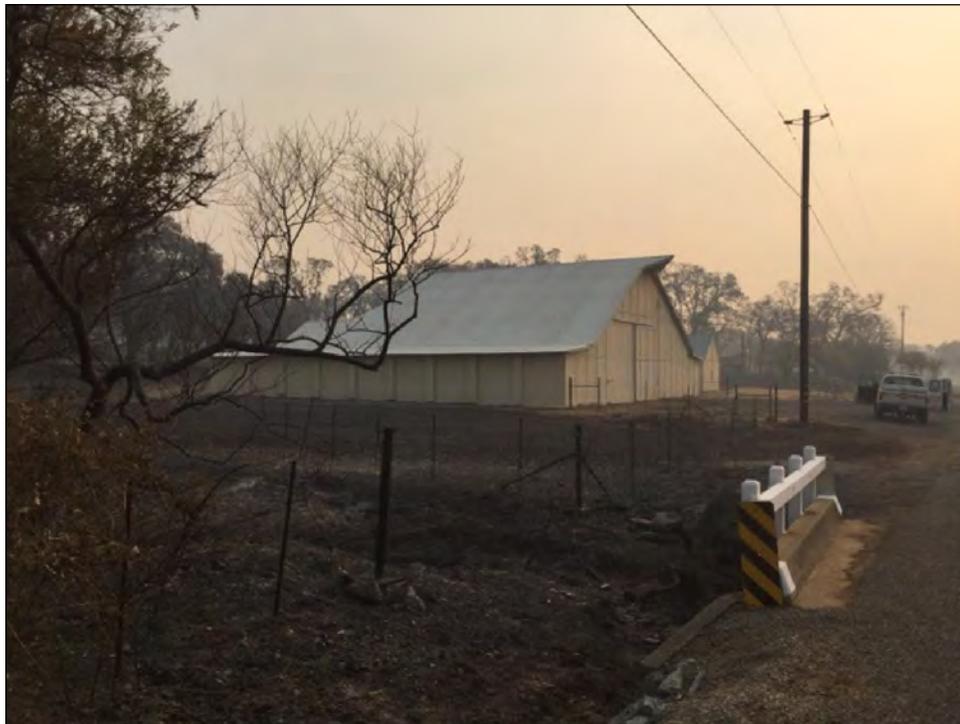
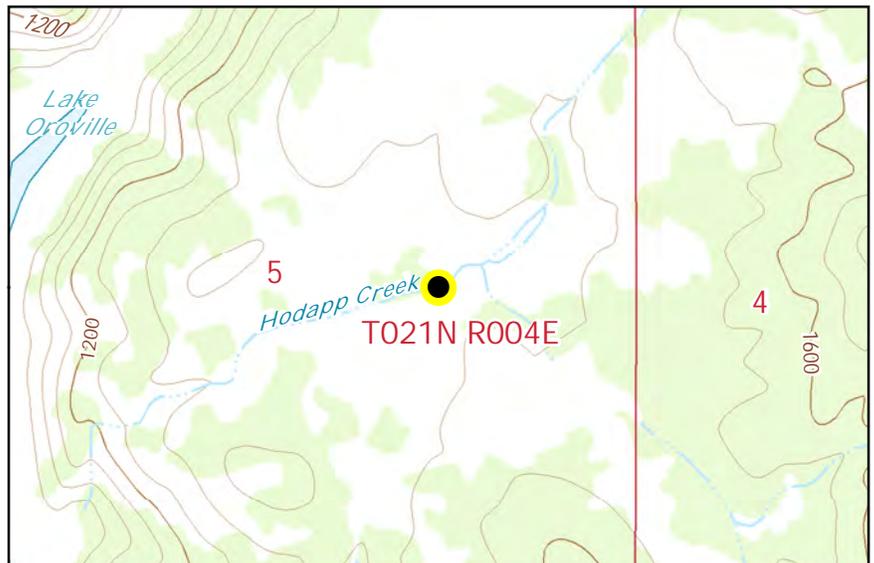
Community: **Concow**
Site Number: 16
Feature: Barn
Feature Category: flood
Field Observation: Barn located adjacent to DWR floodplain awareness zone. Evidence of overland surface flow within the area.

Potential Hazard to Life: low
Potential Hazard to Property: low
FEMA/DWR 100-yr Floodplain: yes
Preliminary Emergency: Early warning system
Protective Measures

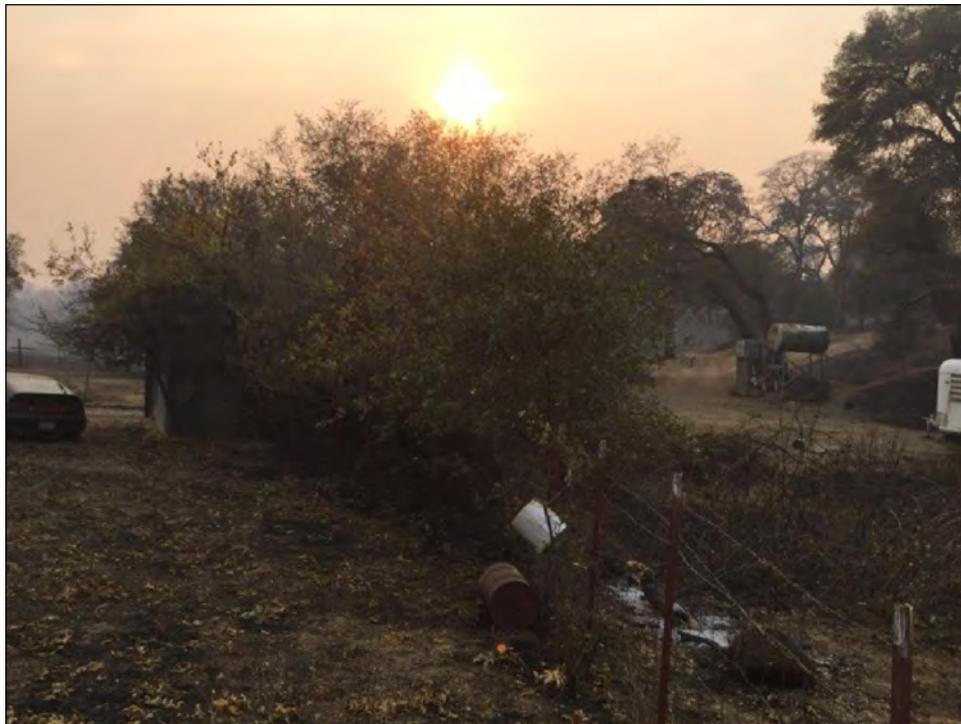
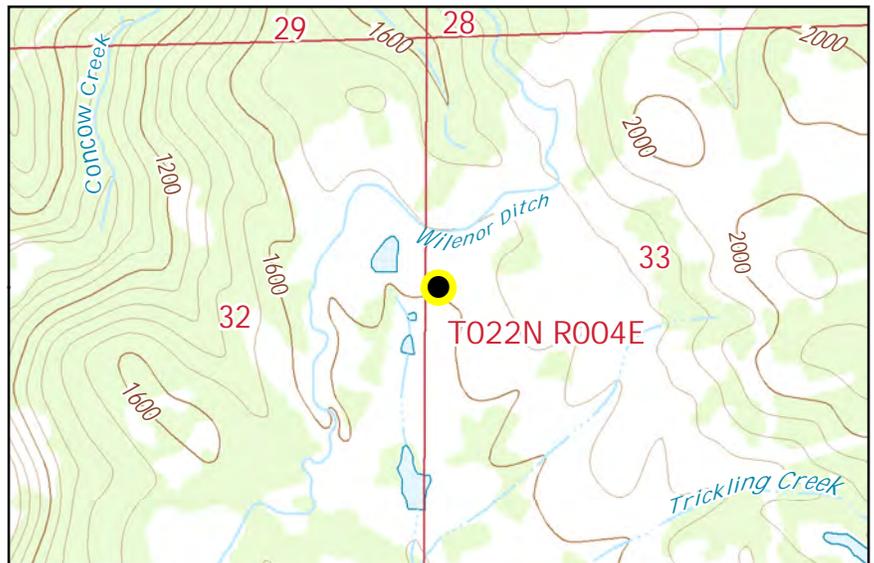
Community: Concow
Site Number: 17
Feature: Shed and gas tank
Feature Category: flood
Field Observation: Garage shed and butane tank located within channel zones. Channel appears highly modified.

Potential Hazard to Life: low
Potential Hazard to Property: low
FEMA/DWR 100-yr Floodplain: no
Preliminary Emergency: Early warning system
Protective Measures

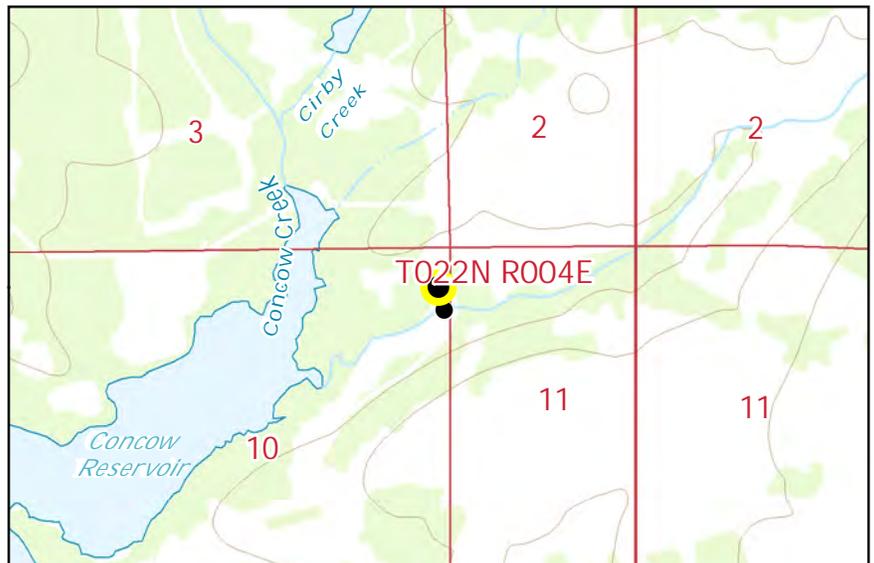
Potential Hazard to Life: moderate
Potential Hazard to Property: moderate
FEMA/DWR 100-yr Floodplain: no
Preliminary Emergency: Early warning system, storm patrol
Protective Measures

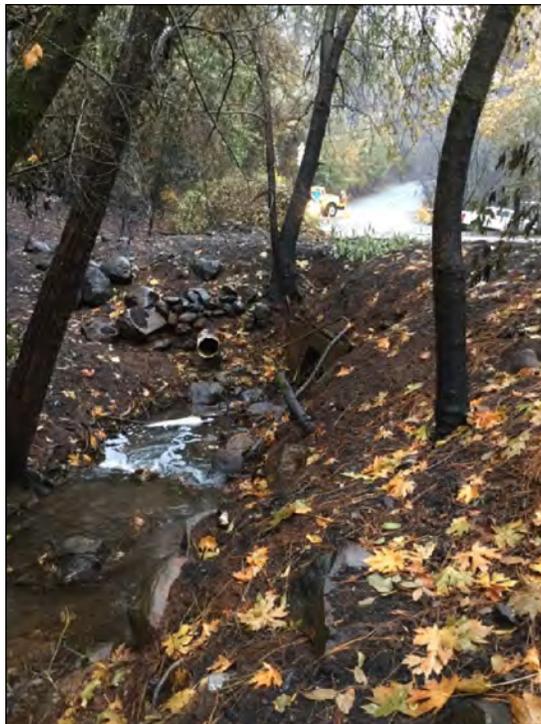
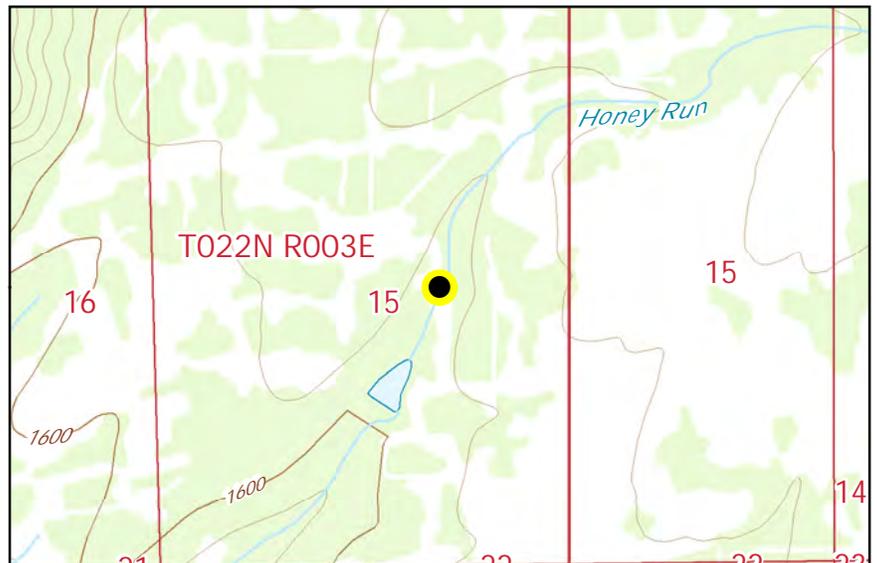
Community: Paradise
Site Number: 20
Feature: Residence, burned down
Feature Category: flood
Field Observation: Culvert could plug and divert towards downstream residence

Potential Hazard to Life: low
Potential Hazard to Property: low
FEMA/DWR 100-yr Floodplain: no
Preliminary Emergency: Storm patrol
Protective Measures

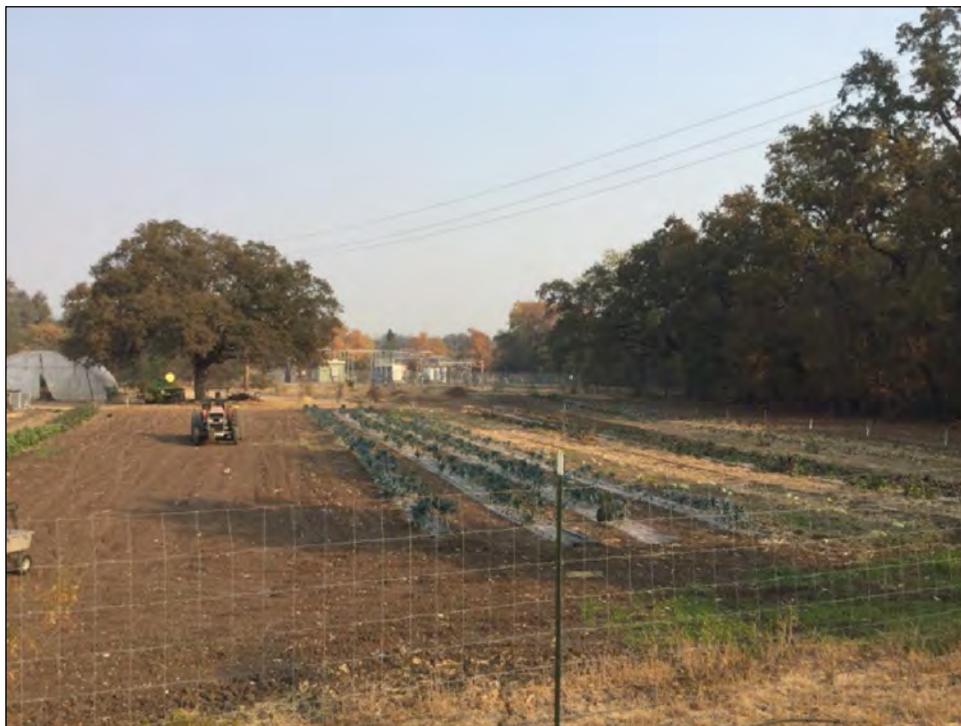
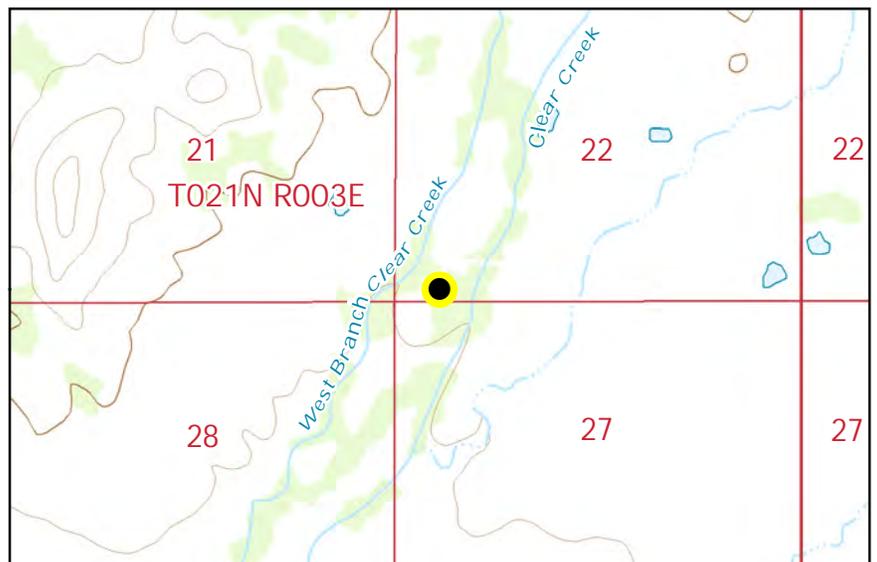
Community: **Butte Valley**
Site Number: 29
Feature: Clark Road Substation
Feature Category: flood
Field Observation: Electrical substation located within flood plain

Potential Hazard to Life: low
Potential Hazard to Property: moderate
FEMA/DWR 100-yr Floodplain: yes
Preliminary Emergency: Early warning system
Protective Measures

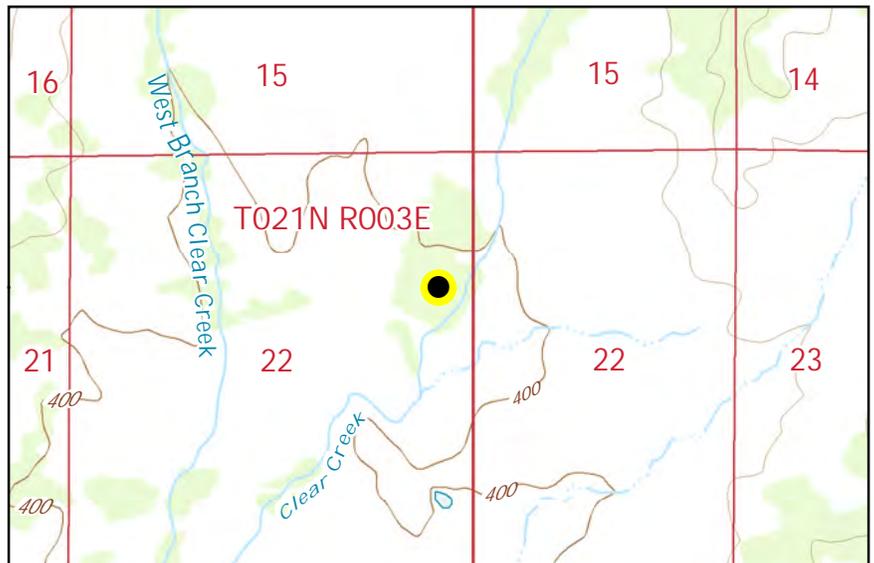
Potential Hazard to Life: moderate
Potential Hazard to Property: moderate
FEMA/DWR 100-yr Floodplain: no
Preliminary Emergency: Early warning system
Protective Measures

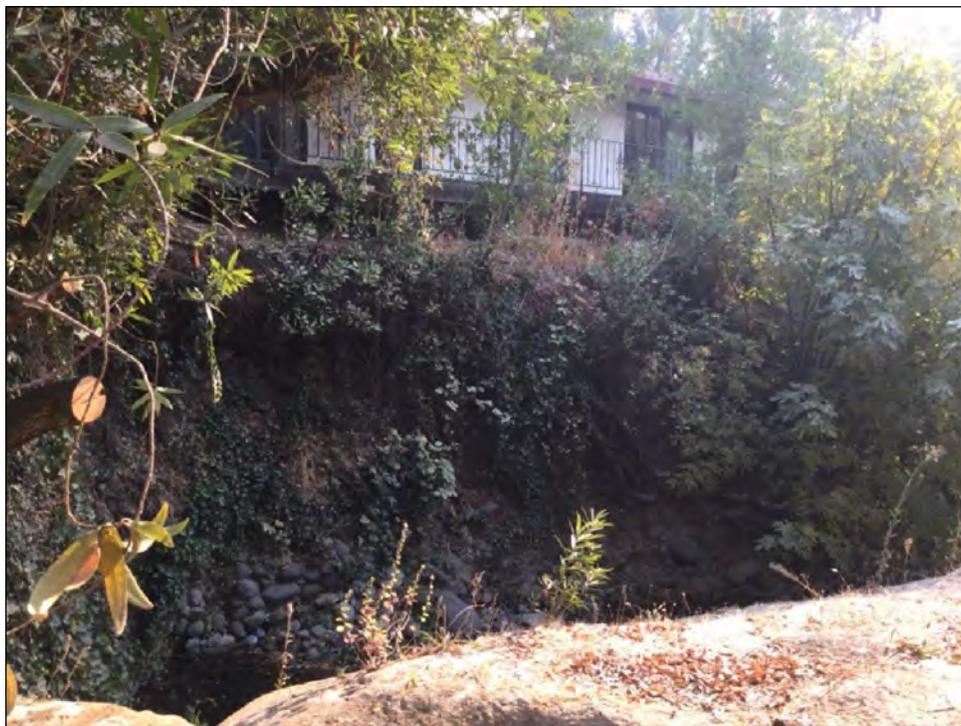
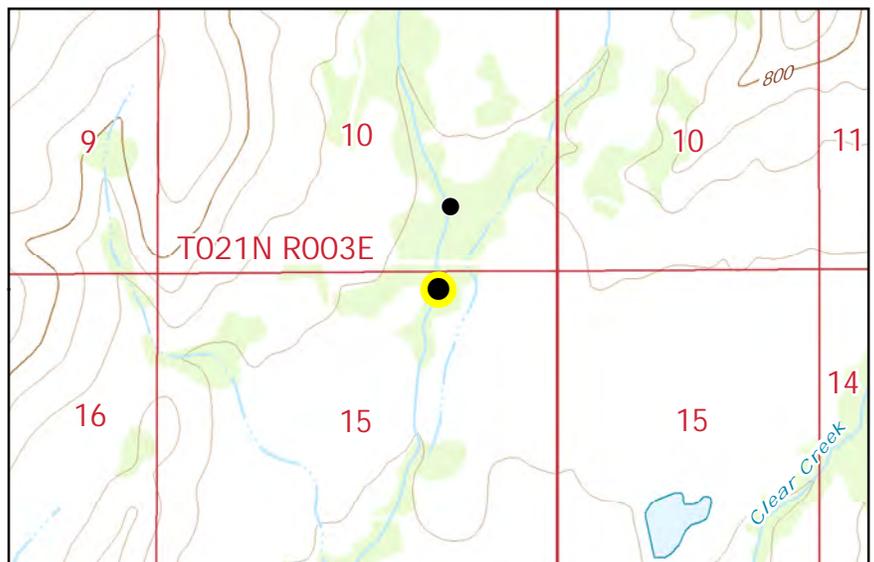
Community: Butte Valley
Site Number: 31
Feature: House
Feature Category: debris flow / flood
Field Observation: House mapped within flood zone. Channel is scoured below house.

Potential Hazard to Life: low
Potential Hazard to Property: moderate
FEMA/DWR 100-yr Floodplain: yes
Preliminary Emergency: Early warning system
Protective Measures

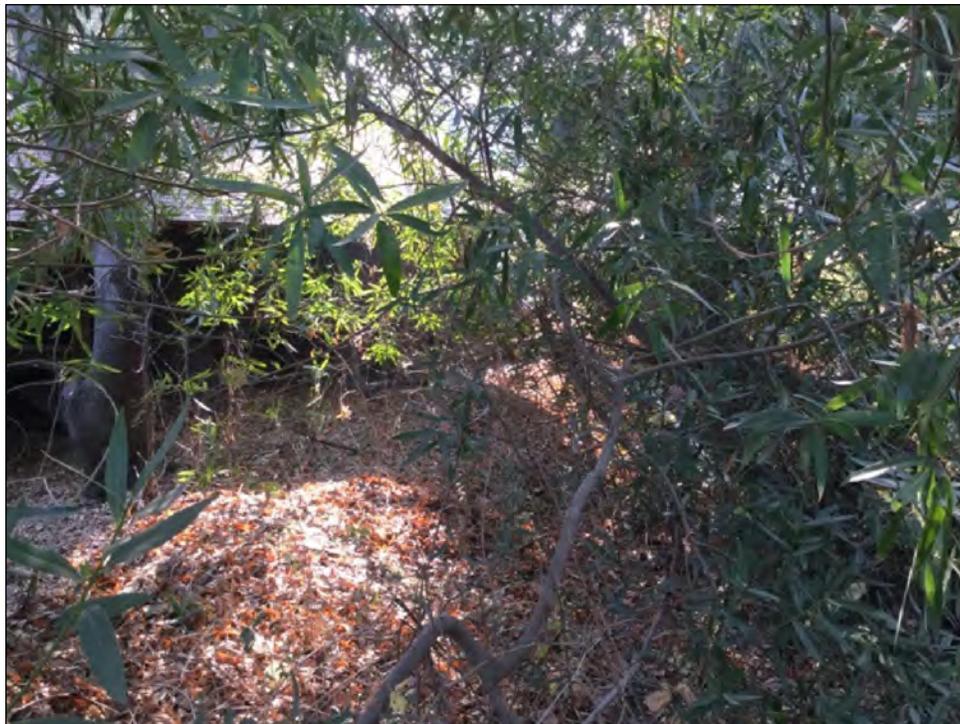
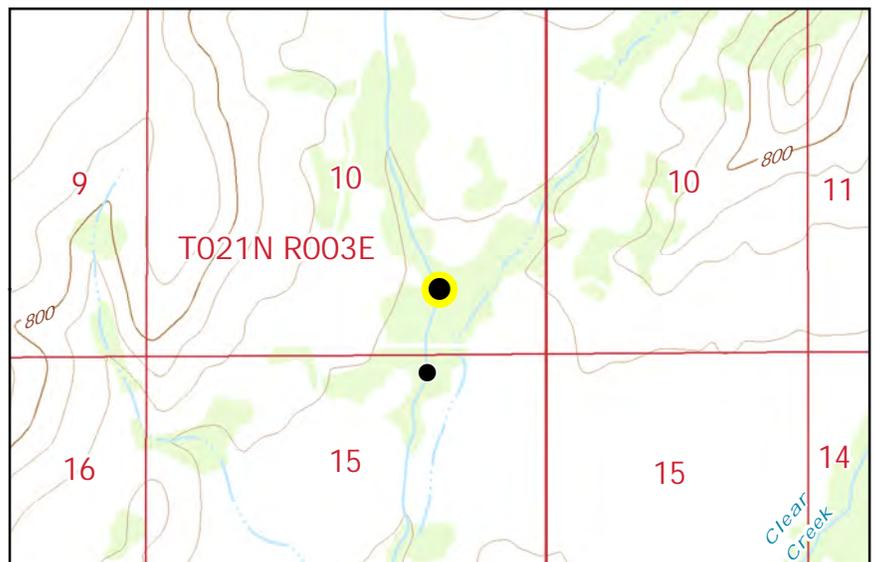
Community: Butte Valley
Site Number: 32
Feature: House
Feature Category: flood
Field Observation: Two garages located adjacent to channel. Structures could be at risk of flooding.

Potential Hazard to Life: low
Potential Hazard to Property: low
FEMA/DWR 100-yr Floodplain: no
Preliminary Emergency: Early warning system
Protective Measures

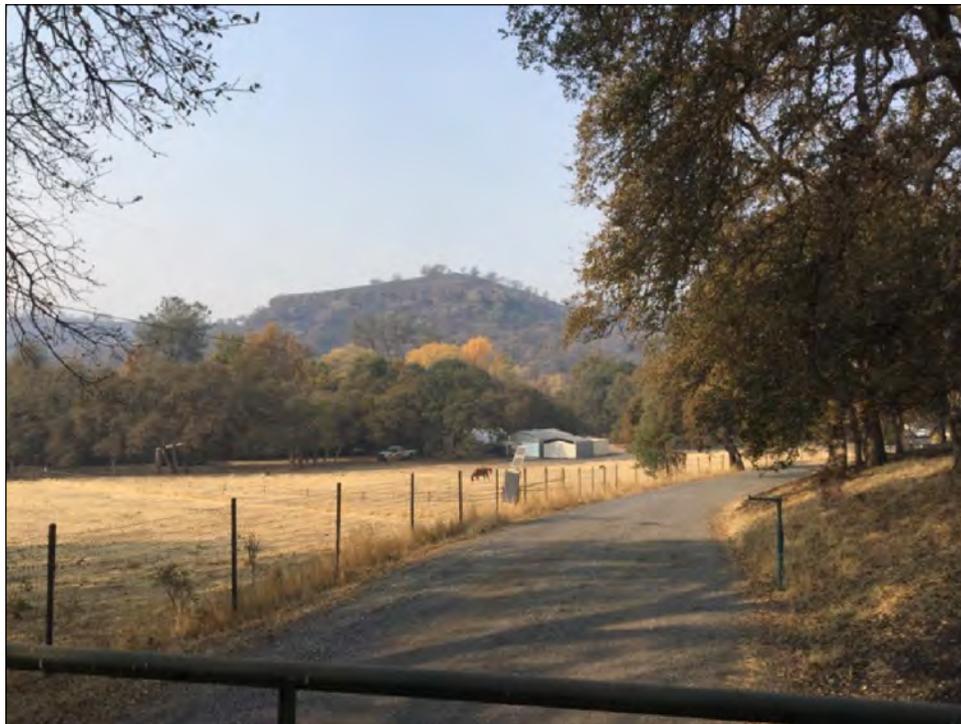
Community: **Butte Valley**
Site Number: 33
Feature: House
Feature Category: flood
Field Observation: House mapped within flood zone

Potential Hazard to Life: low
Potential Hazard to Property: low
FEMA/DWR 100-yr Floodplain: yes
Preliminary Emergency: Early warning system
Protective Measures

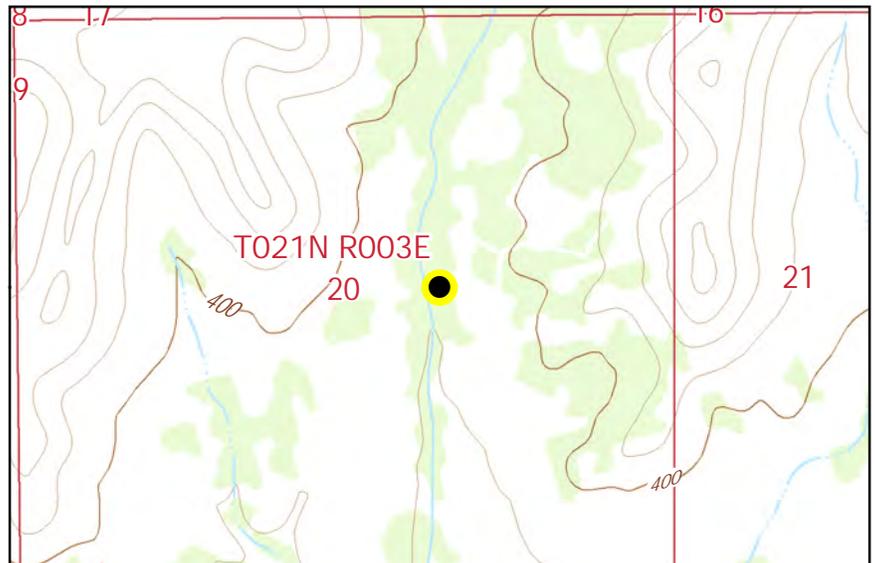
Community: Butte Valley
Site Number: 34
Feature: West Clear Creek Bridge
Feature Category: debris flow / flood
Field Observation: Sediment and debris could back up against bridge supports. Gas line observed across upslope side of bridge.

Potential Hazard to Life: low
Potential Hazard to Property: low
FEMA/DWR 100-yr Floodplain: no
Preliminary Emergency: Storm patrol
Protective Measures

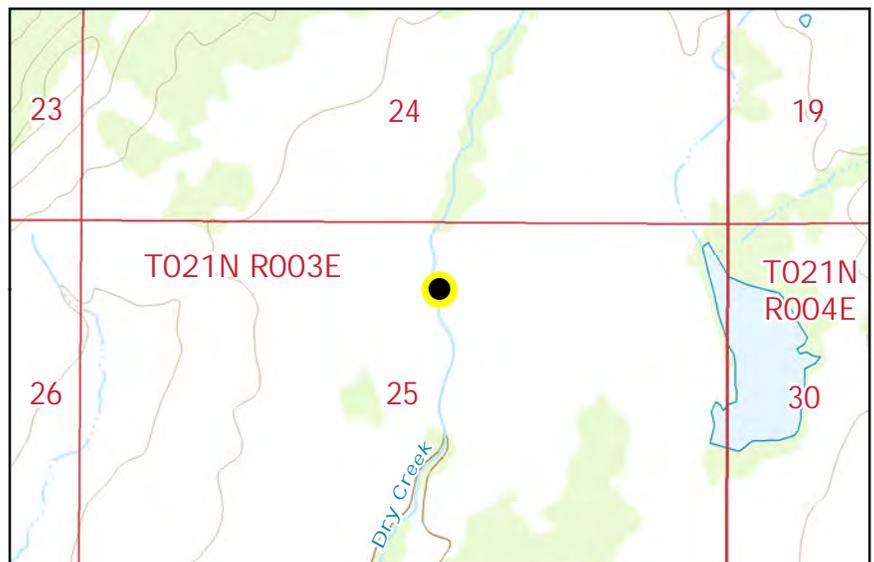
Community: **Butte Valley**
Site Number: 36
Feature: House foundation
Feature Category: flood
Field Observation: Burned houses located within flood zone, including burned bridge crossing

Potential Hazard to Life: low
Potential Hazard to Property: low
FEMA/DWR 100-yr Floodplain: no
Preliminary Emergency: Early warning system
Protective Measures

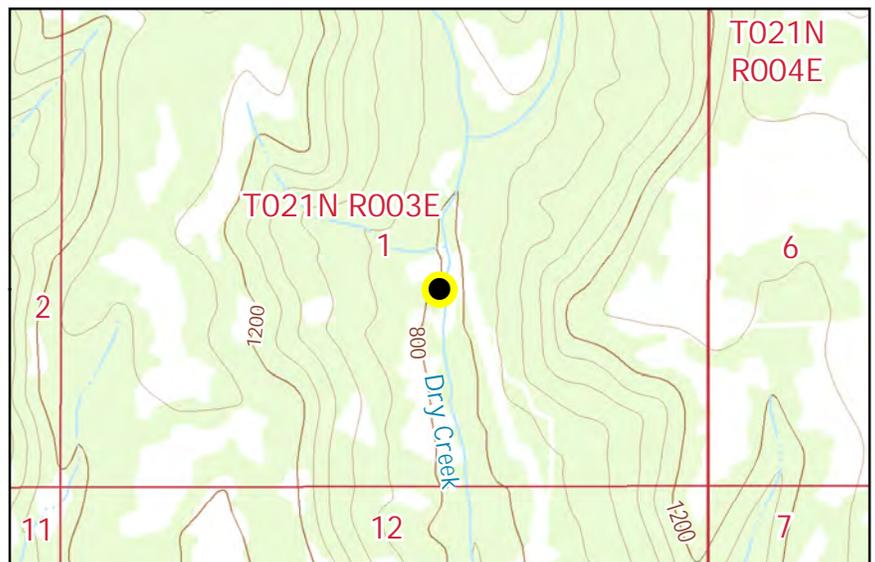
Community: Butte Valley
Site Number: 38
Feature: House
Feature Category: debris flow
Field Observation: House located on steep concave slopes and atop dormant landslide.

Potential Hazard to Life: low
Potential Hazard to Property: low
FEMA/DWR 100-yr Floodplain: no
Preliminary Emergency: Early warning system
Protective Measures

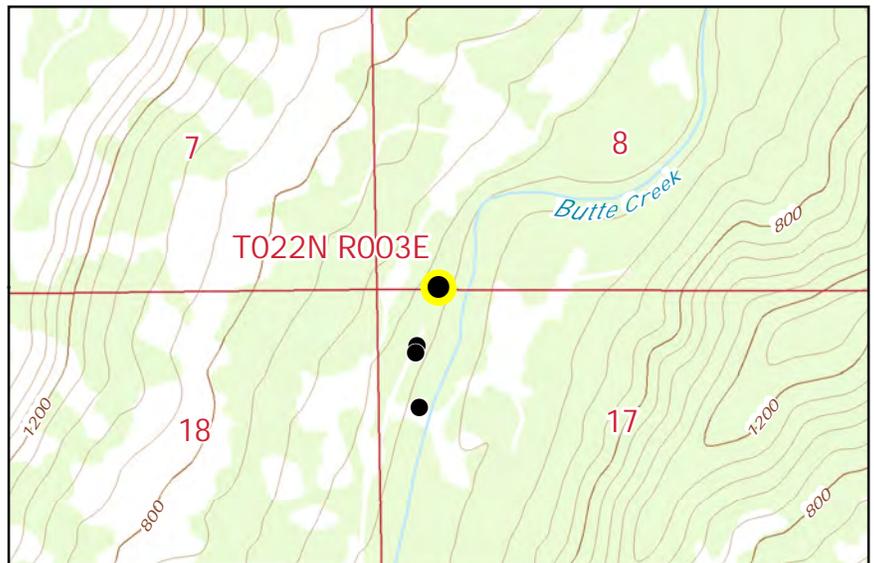
Community: Butte Canyon
Site Number: 46
Feature: Residence
Feature Category: debris flow
Field Observation: Residence located at the bottom of steep slopes. Based on a review of topographic maps residence is located near the outlet of channel, possible debris flow deposits observed upslope of residence.

Potential Hazard to Life: low
Potential Hazard to Property: low
FEMA/DWR 100-yr Floodplain: no
Preliminary Emergency: Early warning system
Protective Measures

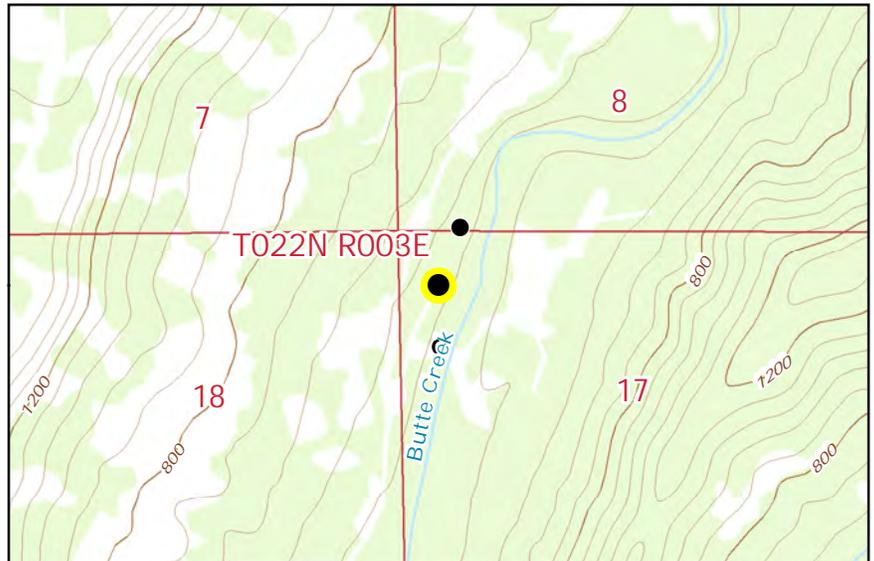
Community: **Butte Canyon**
Site Number: 47
Feature: Residence
Feature Category: debris flow
Field Observation: Residence located at the bottom of steep slopes. Possible debris flow deposits observed upslope of residence

Potential Hazard to Life: low
Potential Hazard to Property: low
FEMA/DWR 100-yr Floodplain: no
Preliminary Emergency: Early warning system
Protective Measures

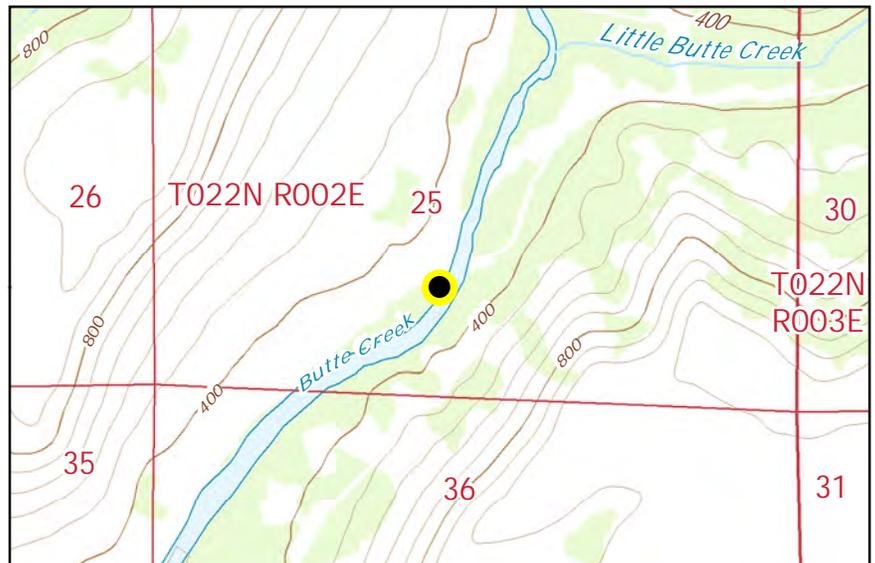
Community: **Butte Canyon**
Site Number: 50
Feature: Residence
Feature Category: debris flow
Field Observation: Debris flow plugging culvert and flowing toward downslope residence

Potential Hazard to Life: low
Potential Hazard to Property: low
FEMA/DWR 100-yr Floodplain: no
Preliminary Emergency: Early warning system
Protective Measures

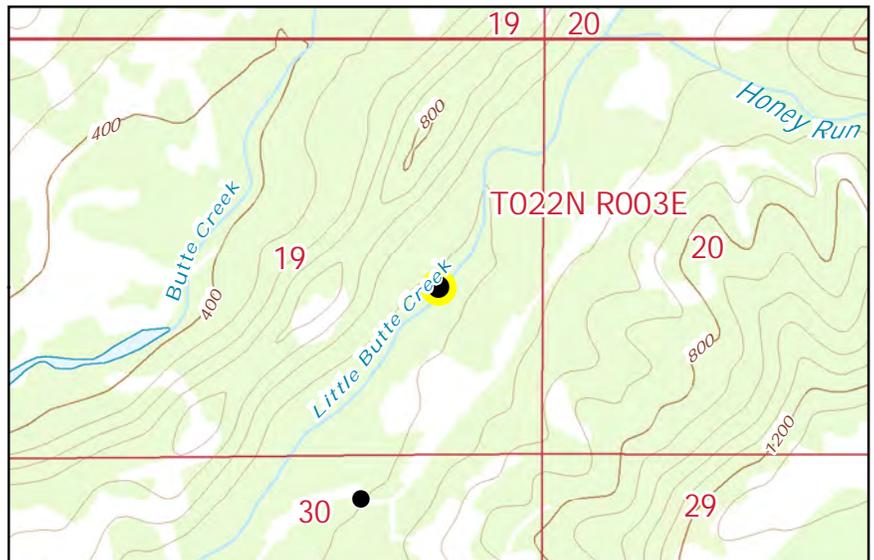
Community: **Butte Canyon**
Site Number: 53
Feature: Fish ladder and screen
Feature Category: flood
Field Observation: Flooding, debris racking, and sedimentation

Potential Hazard to Life: no
Potential Hazard to Property: low
FEMA/DWR 100-yr Floodplain: yes
Preliminary Emergency: Monitor
Protective Measures

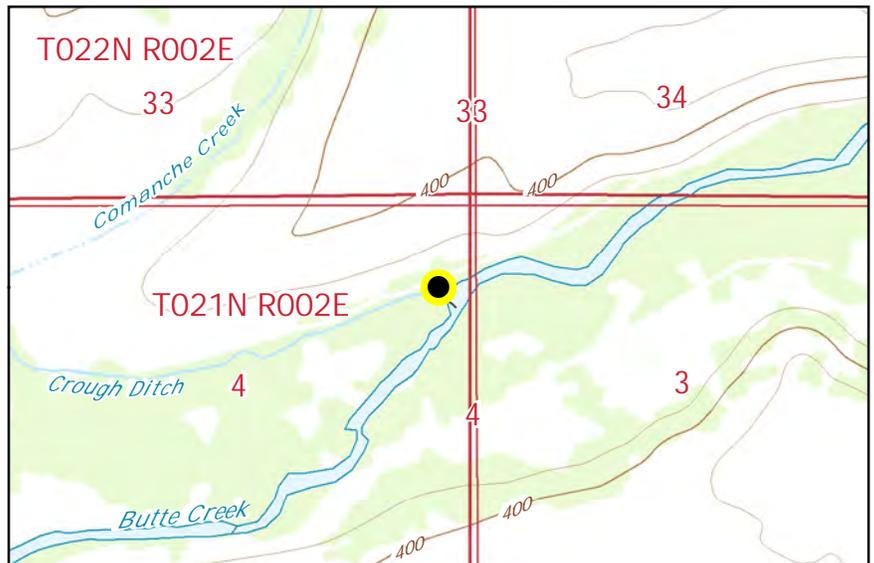
Photo ID:

Potential Hazard to Life: low
Potential Hazard to Property: moderate
FEMA/DWR 100-yr Floodplain: yes
Preliminary Emergency: Early warning system and storm patrol
Protective Measures

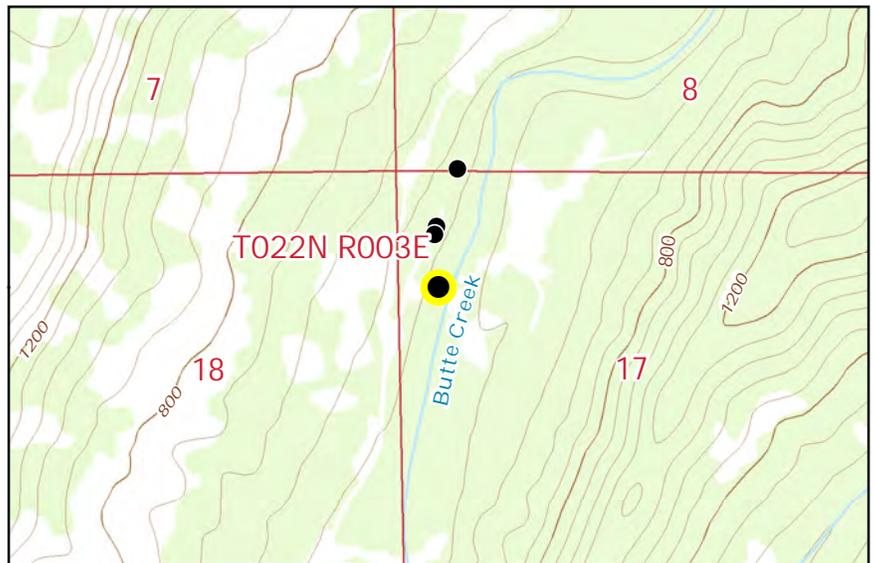
Photo ID:

Community: Paradise
Site Number: 056
Feature: Homesite
Feature Category: flood
Field Observation: Homesite in creek bottom/ flood risk. Evidence of erosion mitigations on lot adjacent to creek.

Potential Hazard to Life: low
Potential Hazard to Property: moderate
FEMA/DWR 100-yr Floodplain: no
Preliminary Emergency: Early warning
Protective Measures

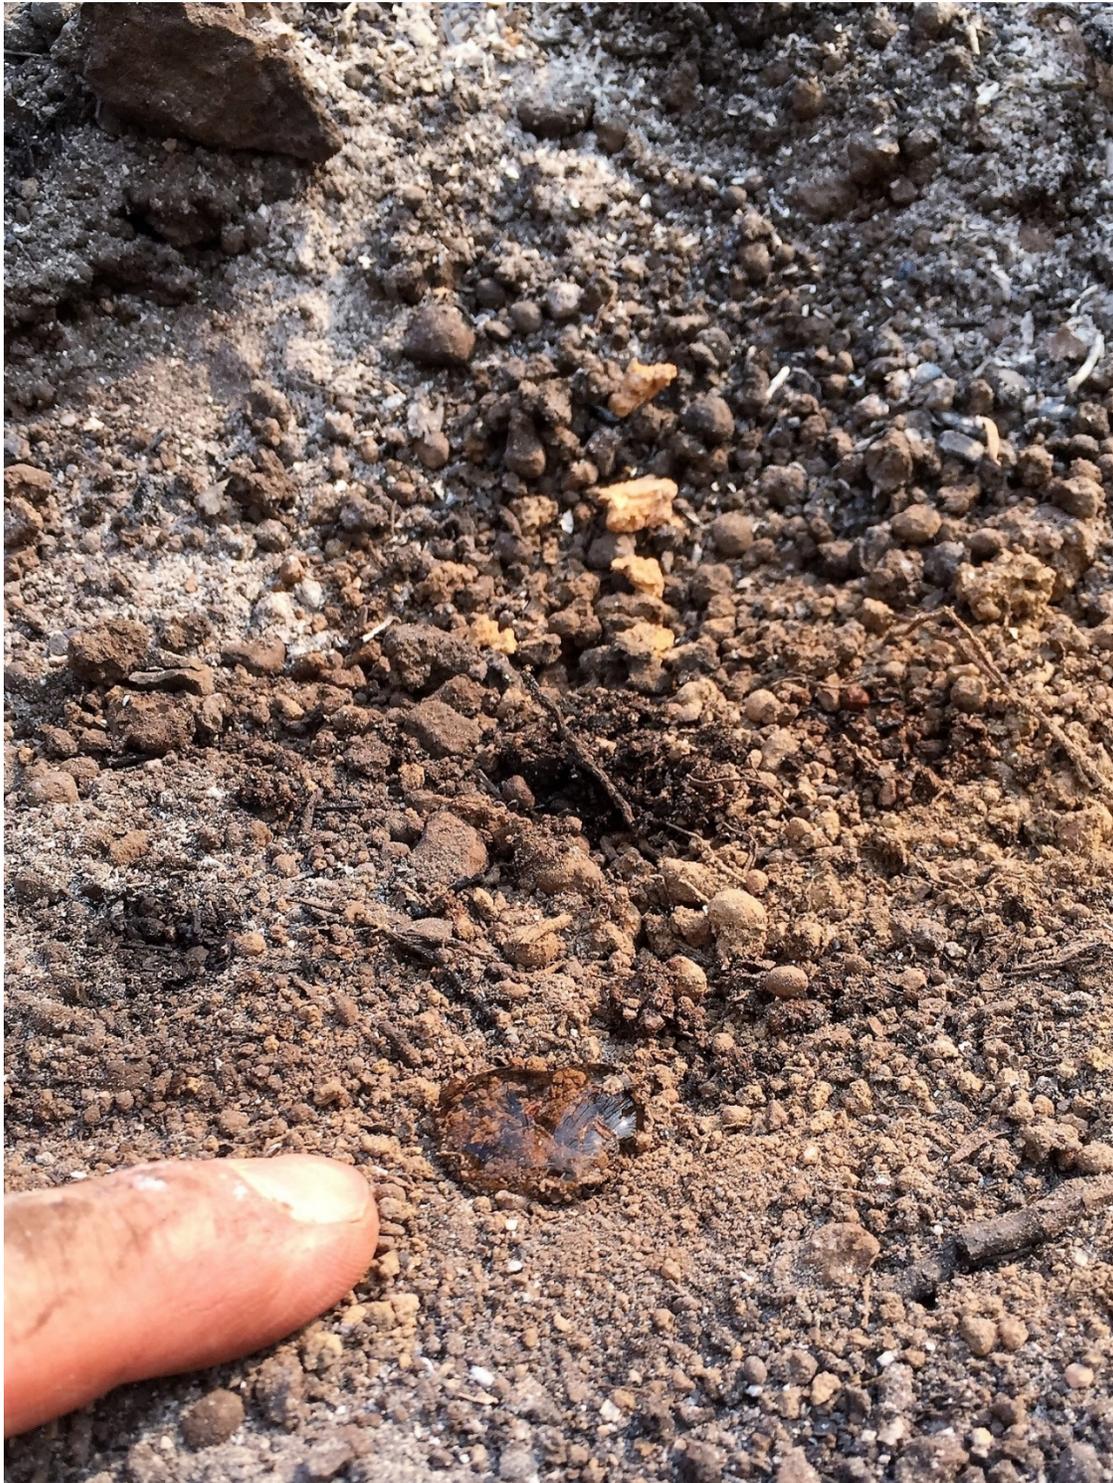
Figure 2. CAMP fire soil water repellency.

Soil burn severity observations were conducted at 50 sites. Soil water repellency testing took place on both the soil surface and at depth (see Figure 2 below). Surface water repellency testing was completed by scraping away the ash layer to expose bare mineral soil at the surface and then timing how long it took for a drop of water to infiltrate the soil.

Field testing revealed that soil water repellency was not a reliable indicator for determining soil burn severity, as water repellent conditions were highly variable and occurred naturally in unburned landscapes. Parsons et al. (2010) reported that the connection between soil burn severity and soil water repellency is neither universally consistent nor well defined (i.e., it does not necessarily correlate well with burn severity).

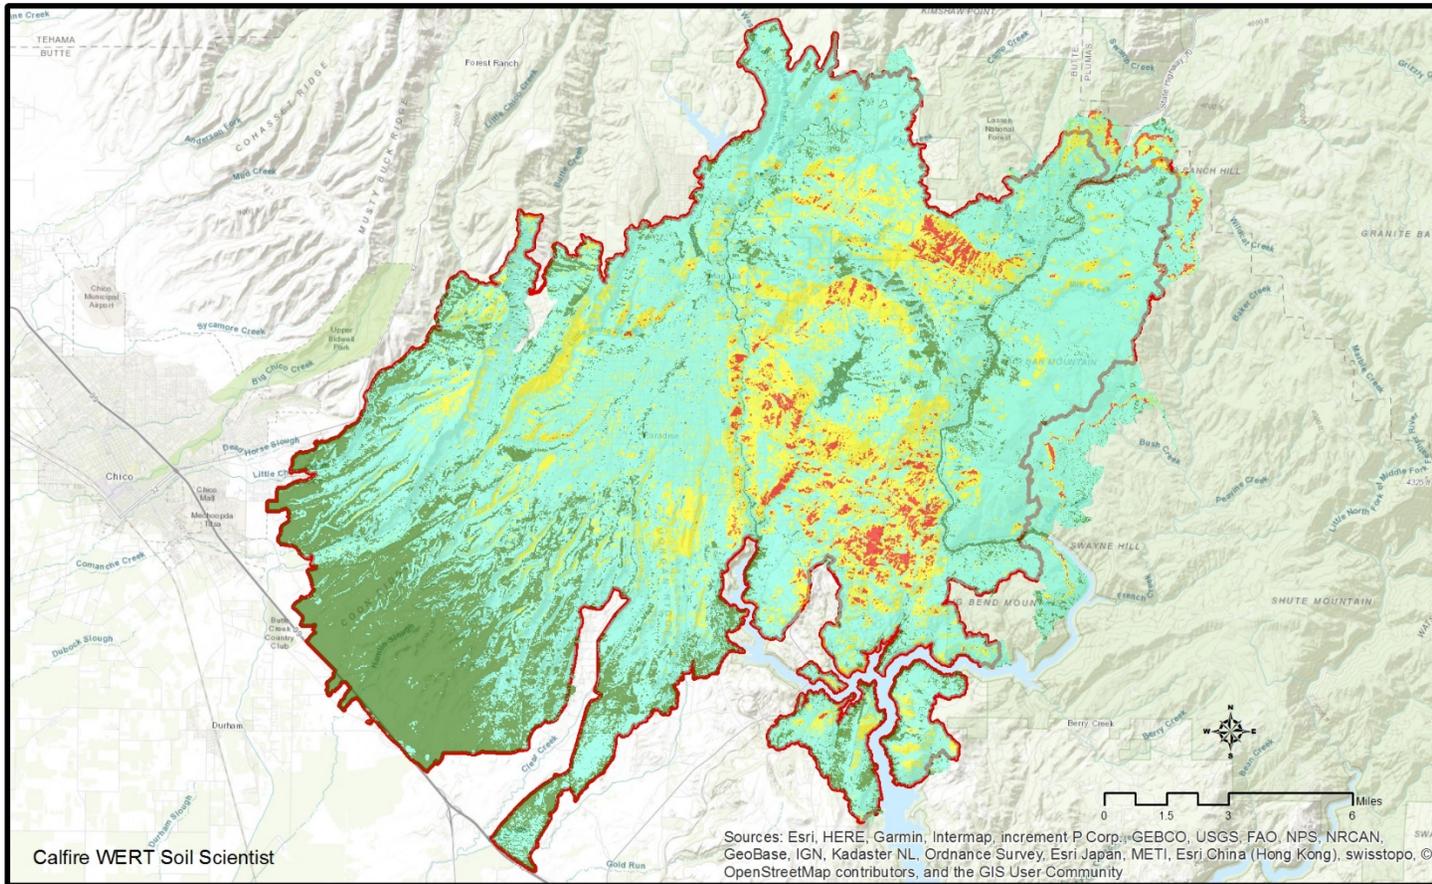
Figure 3. CAMP fire soil burn severity map.

As a result, the adjusted BARC map was denoted as the soil burn severity map (Figure 3). Typically the higher the soil burn severity, the more susceptible the area is to rapid runoff and erosion. The Camp Fire soil burn severity map was used by the WERT as a guide to help identify areas of likely erosion and debris flows that may occur during storm events that could threaten impacts to downslope values at risk (structures, roads, trails, water quality, etc.). There were approximately 28,438 acres (19%) of very low/unburned soil burn severity, 95,157 acres (63%) of low soil burn severity, 24,425 acres (16%) of moderate soil burn severity, and 3,389 acres (2%) of high soil burn severity.

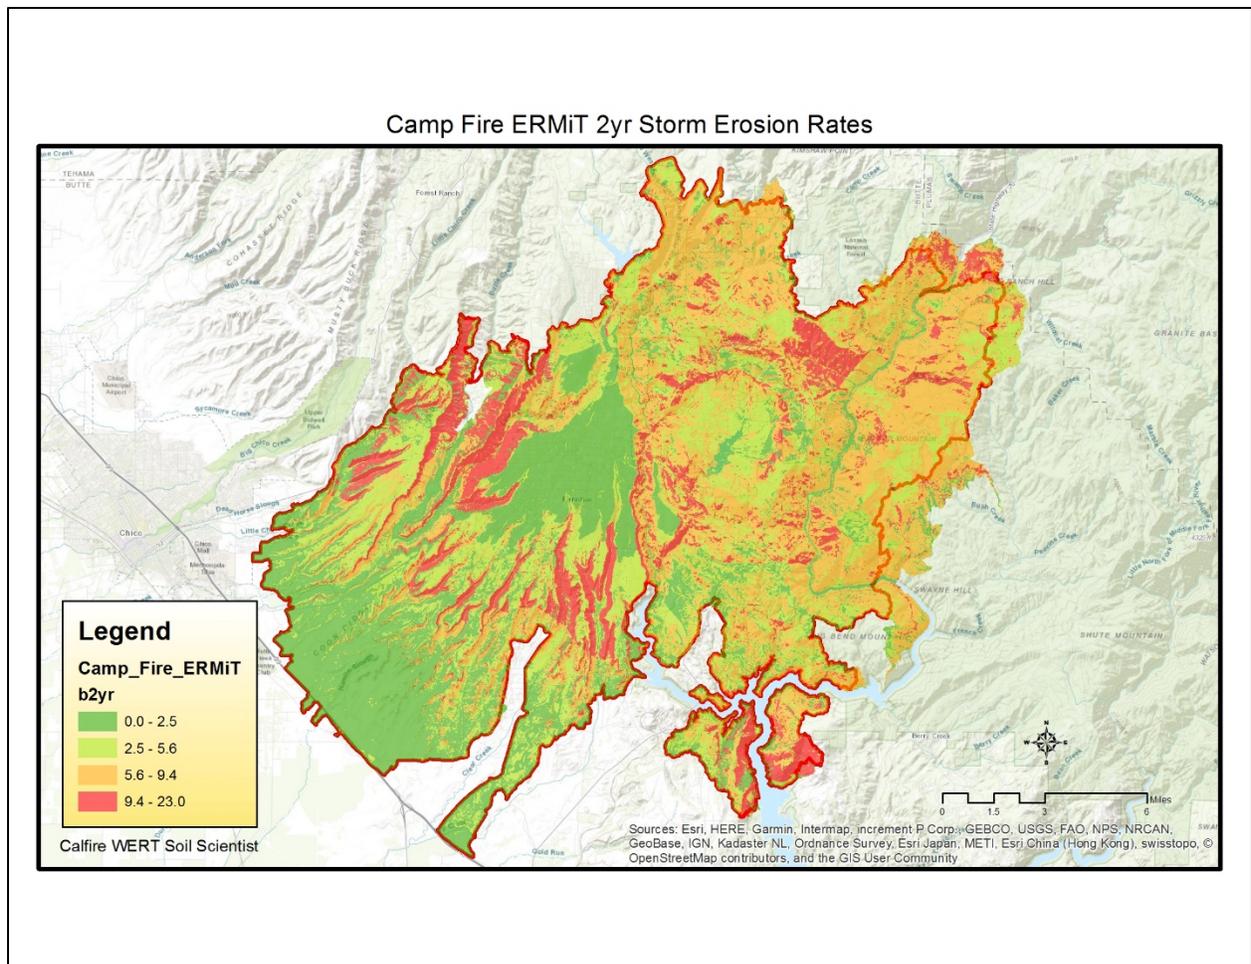
Figure 4. Batch ERMiT 2-year storm erosion rates for the Camp Fire.

Post-fire Batch ERMiT model predictions for the 2-year storm recurrence interval runoff event shows that surface erosion rates are estimated to range from 2 to 23 tons per acre depending on the area in the fire. These ranges take in the outliers (the very lowest to the very highest) inherent in all distribution models, but for the whole fire, it averages out to be 6 tons/acre (Figure 4). These rates have a 50 percent probability of exceedance. Hillslope erosion in these watersheds may affect downstream infrastructure, roads and drainage structures, fill stream channels with high levels of sediment, increase downstream turbidity, and bulk flood flows with higher than typical sediment loads. These areas would roughly be expected to have an 8-fold increase in sedimentation the first post-fire winter compared to pre-fire conditions.

The post-fire ERMiT model highlights areas of elevated erosion potential in the upper reaches of Butte Creek watershed (red areas in map below). This part of the fire differs from other regions of the burned area due to shallow very steep soils with hard volcanic rock below in chaparral-dominated vegetation making them more susceptible to erosion. Most of this area was in the moderate to high soil burn severity zone (see soil burn severity map above). This combination of factors makes this area stand out from the remainder of the burned area as a concern for increased sediment yield and possible debris flows.

The other area of potential concern is the metagranitic areas east of Concow Lake in the upper Concow and Flea Valley Creek watersheds. These areas shown up as red zones showing high susceptibility for erosion from an average 2-yr storm (see map below).
