CAMP FIRE

Watershed Emergency Response Team

Final Report

CA-BTU-016737

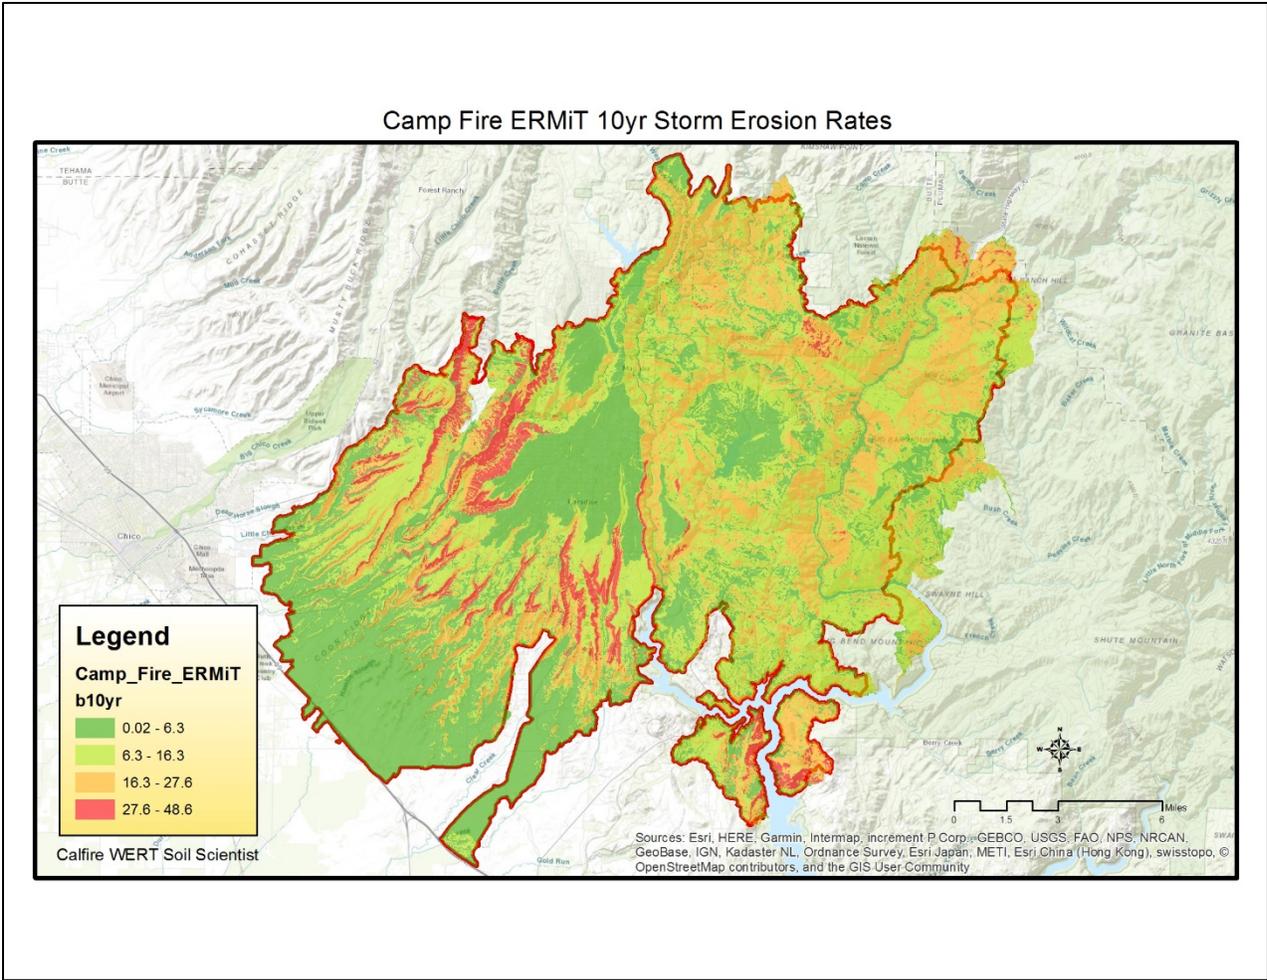
Figure 5. Batch ERMIT 10-year storm erosion rates for the Camp Fire area.

Based on a 10-year storm recurrence interval, the Batch ERMiT model prediction ranges from 3 to 48 tons per acre, with a whole fire average of 13 tons per acre (see Figure 5 below).

Using the 2-year storm erosion rates in comparison to the 10-year storm erosion rates, one can observe the areas that are very sensitive that even a normal storm will trigger accelerated erosion. These areas are the upper Butte Creek watershed and the Flea Valley Creek watershed draining into the Feather River at Pulga.
