Restoring Conservancy Lands Following the Angora Fire – a Preliminary Assessment

Daylin Wade, California Tahoe Conservancy
Susie Kocher, University of California Cooperative Extension

January 2012

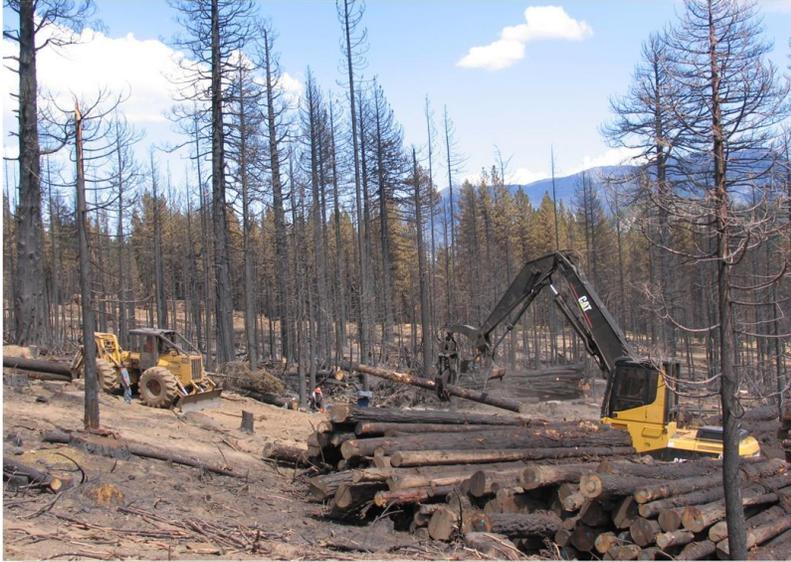
Figure 4. Fire-killed trees were skidded to a landing and taken to a lumber mill by Sierra Pacific Industries, September 2007.

Treatments were intended to establish a native conifer forest as quickly as possible, reduce hazards posed by dead trees falling, and reduce the risk of soil compaction, soil erosion, and sedimentation to Lake Tahoe. An emergency contract was put into place with Sierra Pacific Industries for salvage harvest operations on the Conservancy's two larger ownerships and designated urban lots within the burn area. Approximately 1.2 million board feet of timber was removed from the site and sent to Sierra Pacific Industries' mill in Camino (see Figure 4 and

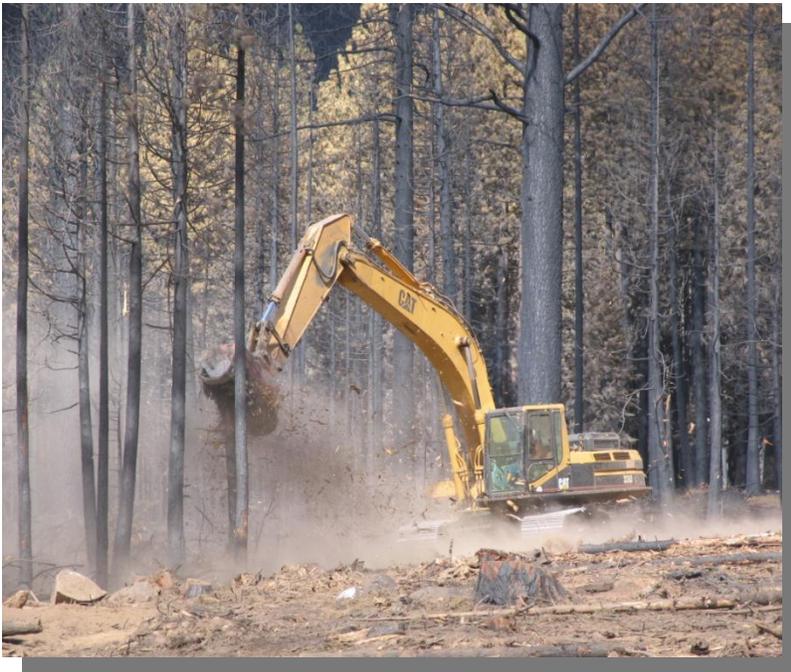
Figure 5. Limbs and small trees (10 inches in diameter and smaller) were masticated and left on site.

Figure 5). Un-merchantable material was masticated (see Figure 5) and left on site to provide cover of exposed soil to reduce erosion. Revenue generated from tree removal was used to offset the cost of mastication and erosion control treatments. Tree removal was completed by October 2007.

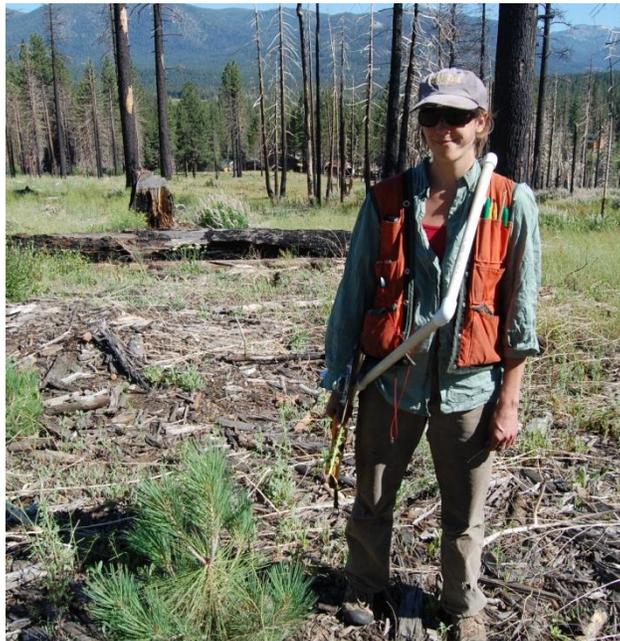
Figure 11. Jeffrey pine trees planted in Fall 2007 where almost three feet tall and vigorous, August 2010.

Yes, to date, post fire treatments have accelerated forest stand development on the Conservancy Mule Deer parcel. The healthiest planted trees are now two to three feet tall (Figure 11). Treatments have suppressed competition from shrub growth, which should allow for high survival and growth rates among the planted seedlings. On the untreated control plots, vigorous shrub re-growth in addition to distance from seed sources appears to be preventing re-establishment of a new forest. Forest recovery, however, is a long-term process. Final conclusions concerning how treatments have accelerated development cannot be made at this time. Continued monitoring of forest development would provide more solid conclusions regarding treatment effectiveness.

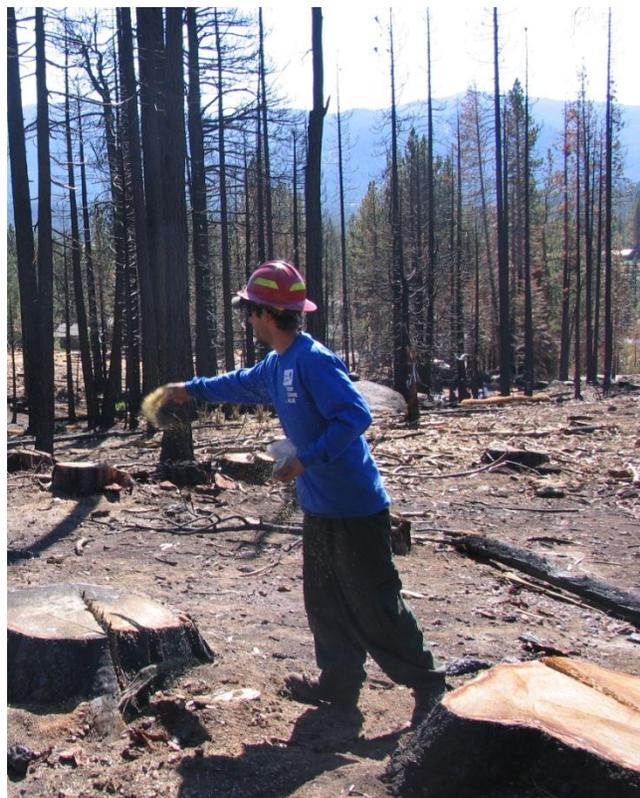
Figure 18. Scattering native seed mix on severely-burned Conservancy land.

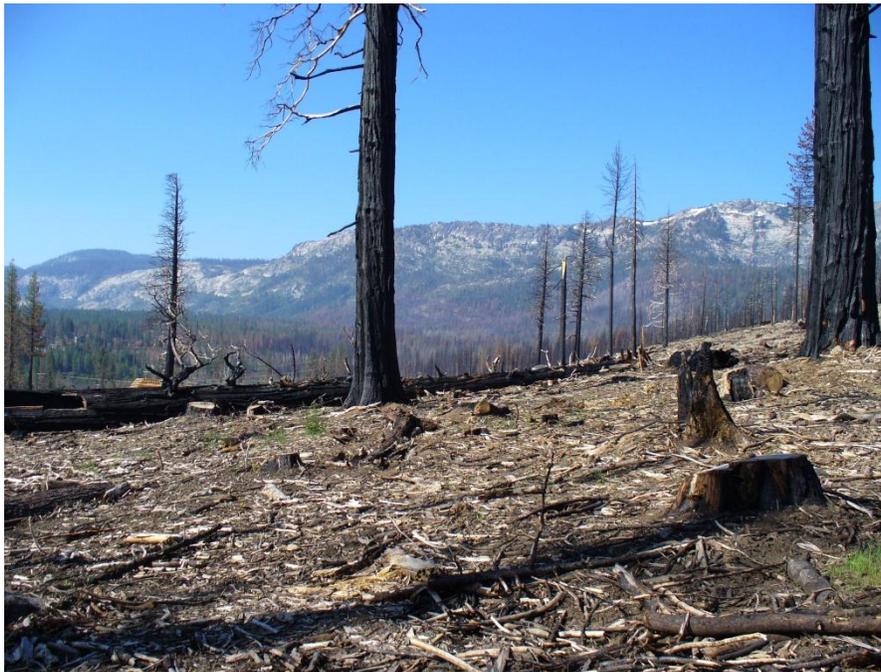
Figure 23. Typical condition of ground fuels following tree removal and mastication on Conservancy lots, 2008.

Treatment and Background: Very different ground fuels conditions were created by treatments on Conservancy and Forest Service lands. The entire Conservancy Mule Deer parcel experienced complete tree mortality and the stems of trees with diameters larger than 10 inches were removed, while the limbs and small trees were masticated and left on site (see Figure 23). Much of the Forest Service site experienced complete mortality, with a smaller portion being lightly or moderately burned. No trees were removed from the Forest Service plots, so no fuels were added to the site as a result of treatment¹. In severely burned areas, a layer of aerially deposited hydro-mulch was deposited for erosion control for the first winter season, but decomposed within the first year (see Figure 24). Moderately burned areas typically had a layer of wood straw applied to reduce erosion.

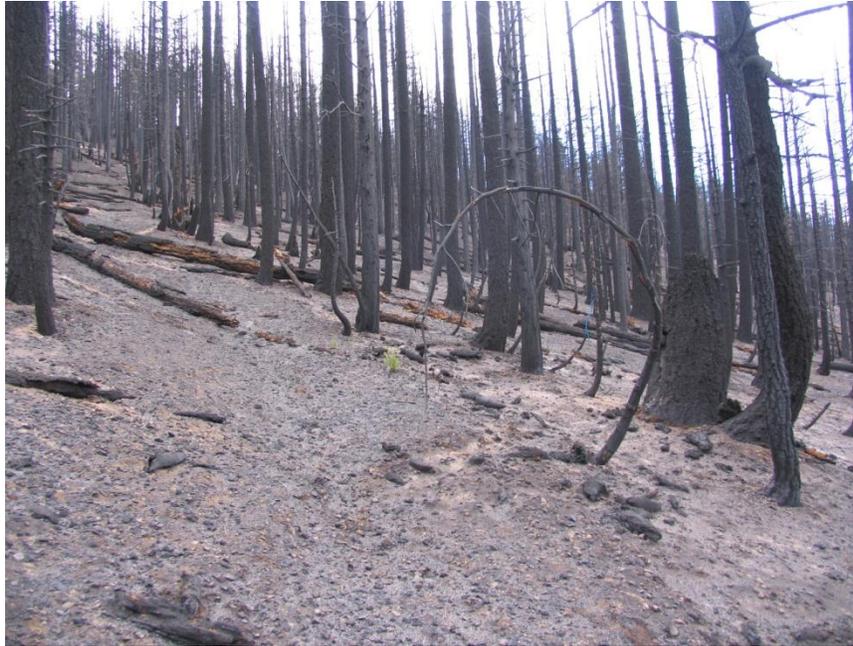
Figure 24. Typical slope on the Forest Service untreated site, covered with an aerielly-applied layer of hydro-mulch.

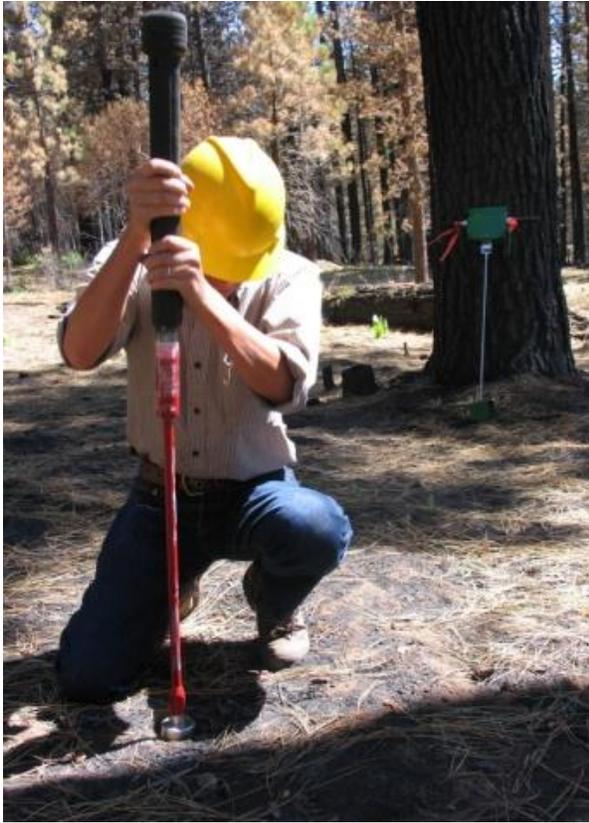
Figure 29. Using a slide hammer to obtain a soil sample.

Monitoring Methods: Soil strength was measured in order to evaluate any impacts from heavy equipment. Soil strength is a measurement of resistance to penetration and mimics the experience of plant roots pushing through soil. Pre-treatment soil strength was measured using a Rimik CP20 Recording Soil Penetrometer, and post-treatment soil strength was measured using a Rimik CP40II Recording Soil Penetrometer (Figure 30). Fifteen insertions were made within each forest inventory plot. Soil strength increases when soil has low moisture content, so care was taken to record strength measurements during similar moisture conditions so that results from different visits would be comparable. A soil sample was taken on each plot to measure the soil moisture at each visit (Figure 29). Soil samples were weighed immediately after collection, then dried and weighed again to determine the percent moisture content of the original sample.

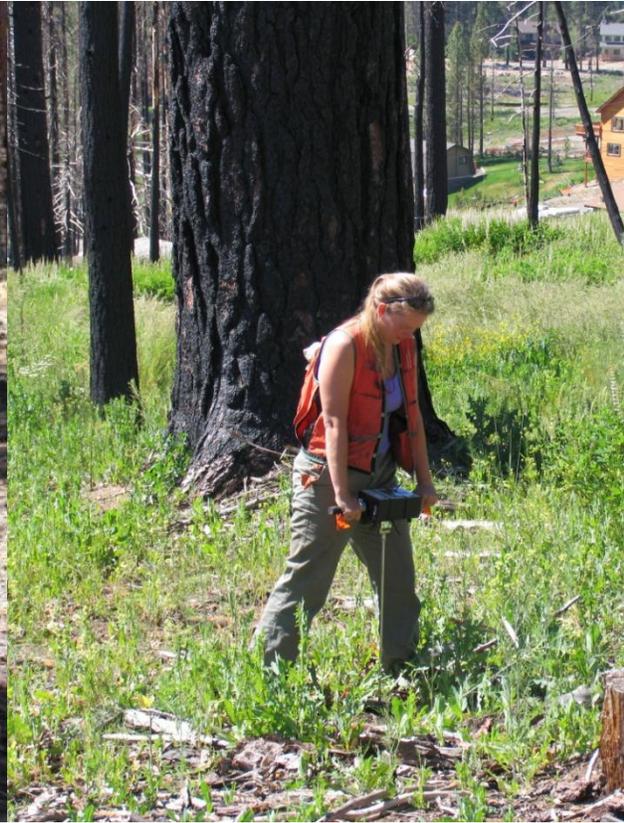
Figure 30. Measuring soil strength with a recording soil penetrometer.

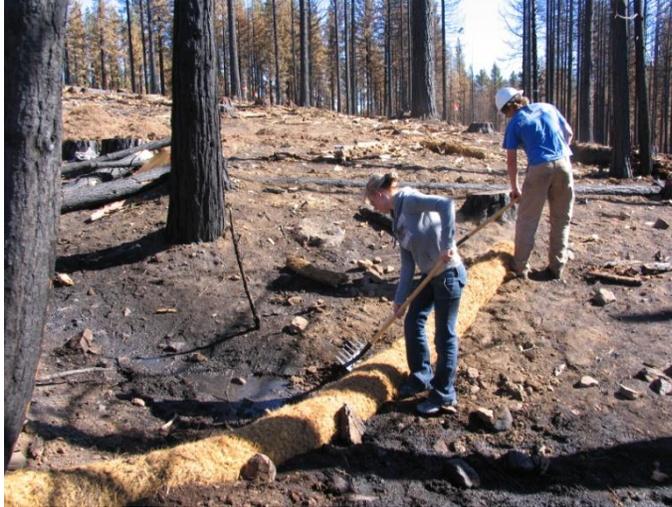
Figure 33. Placing a coir log in stream channel on the Mule Deer parcel, 2007.

catch sediment that would otherwise be delivered from the channel (Figure 33). Following the period of Spring 2008 runoff, sediment began to build up behind the coir logs and contour logs within the larger SEZ. This sediment was dug out, and the coir logs were armored with large rocks and logs to increase their sediment capture potential and avoid sediment overtopping these features. Also, additional pine needles were spread within the SEZ in order to further decrease the proportion of bare ground.

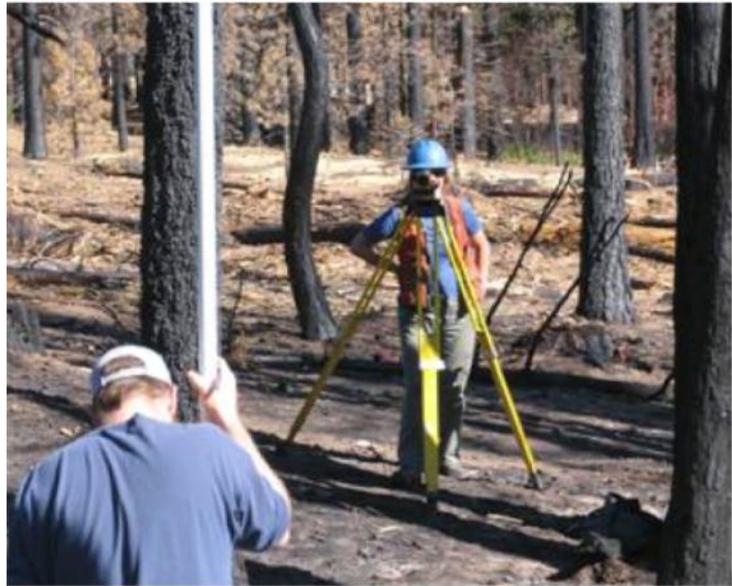
Figure 34. Conducting the stream longitudinal profile survey. Fall 2007.

Longitudinal profile survey data from 2007 and 2008 were compared to determine the degree of scour and fill, and the net change in elevation along the stream profile. Elevation data were entered into a simple model that calculates net change.

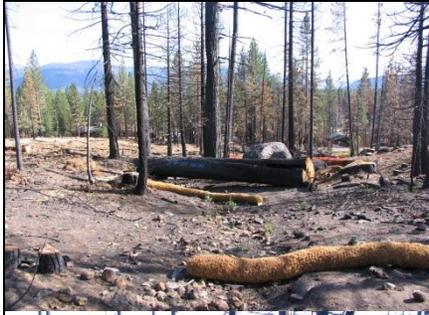
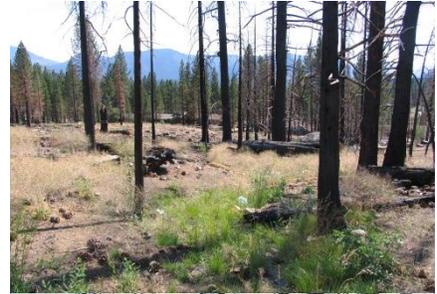
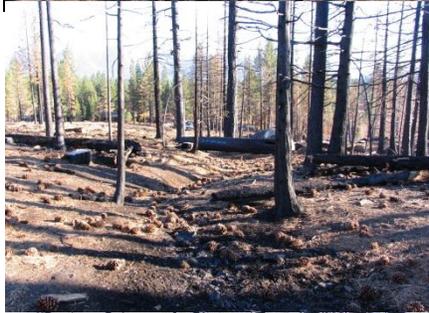
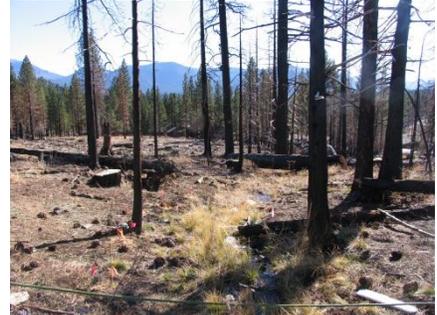
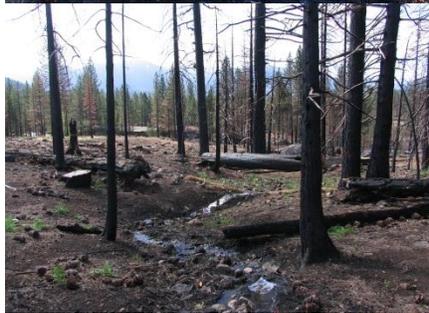
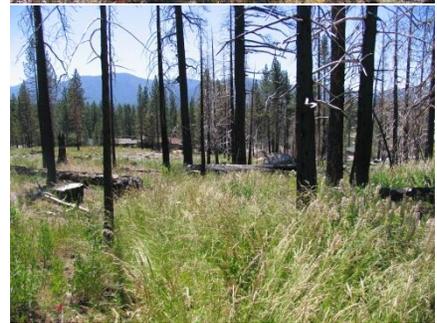
SEZ at Mule Deer

Figure 36. Photo series of one channel photo point at six different visits, September 2007 to July 2009.

Vegetative growth in the relatively wet stream area has been vigorous (See Figure 36) contributing to channel stability. The channel continues to appear stable as of January 2012, with very few rills on the side slopes entering the channel.

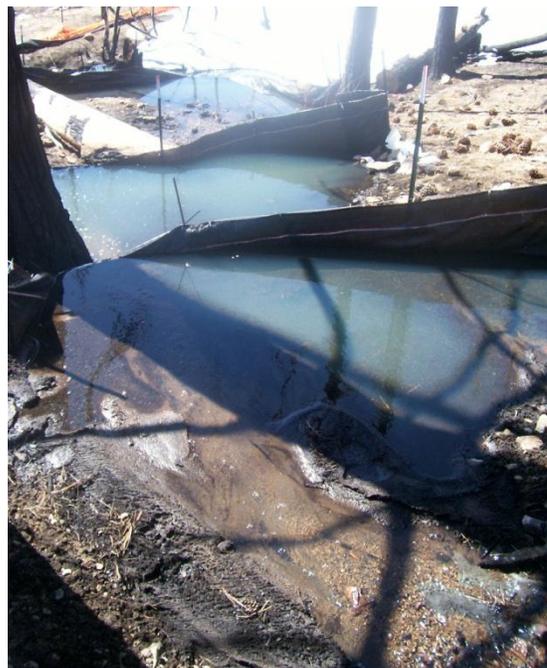
Figure 38. Monitoring silt fences holding sediment and water, late Winter 2008.

Sediment was removed from the silt fences each year in the spring or summer once the water had drained (Figure 38). Removal of sediment following each significant runoff event was not feasible due to retention of water following these events. Sediment was excavated using shovels and hand trowels, deposited in buckets, and weighed. Soil from each fence was mixed well and a sample was taken and weighed, then dried and weighed again to yield a ratio of dry to wet weight. This was used to calculate the dry weight of sediment captured by each fence.
