Visual Assessment of Riparian Health

Publication 8089

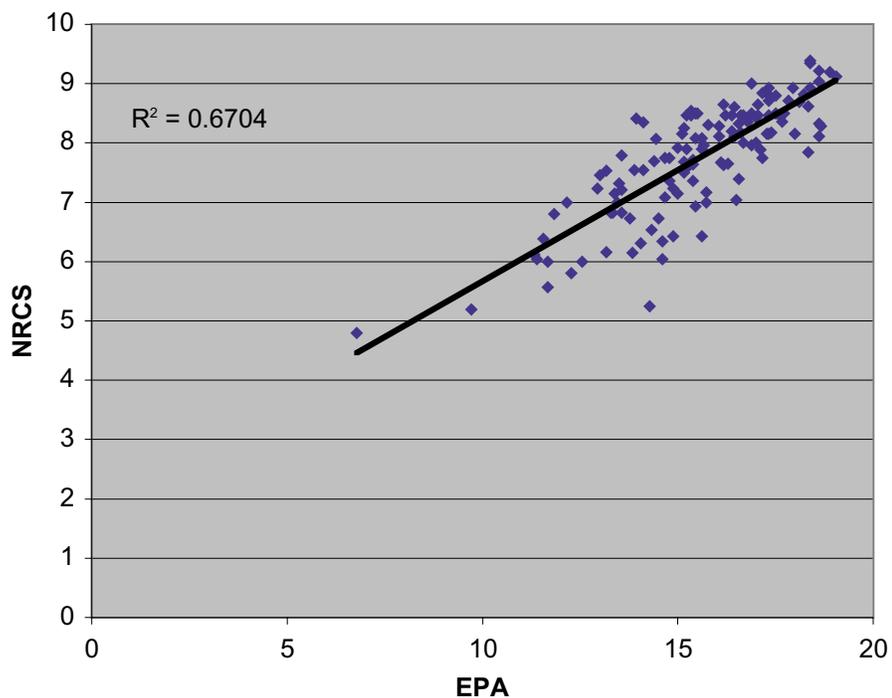
Figure 1. Fish and macroinvertebrate habitat. There is a linear relationship between EPA and NRCS outcome scores for habitat.

Strong relationships were found between the habitat assessments ($R^2=67\%$) (fig. 1), and between high habitat scores and Proper Functioning Condition (PFC) ($p<0.01$). This provides the manager with the best of the four assessments in one easy-to-use riparian health assessment method for rangelands.

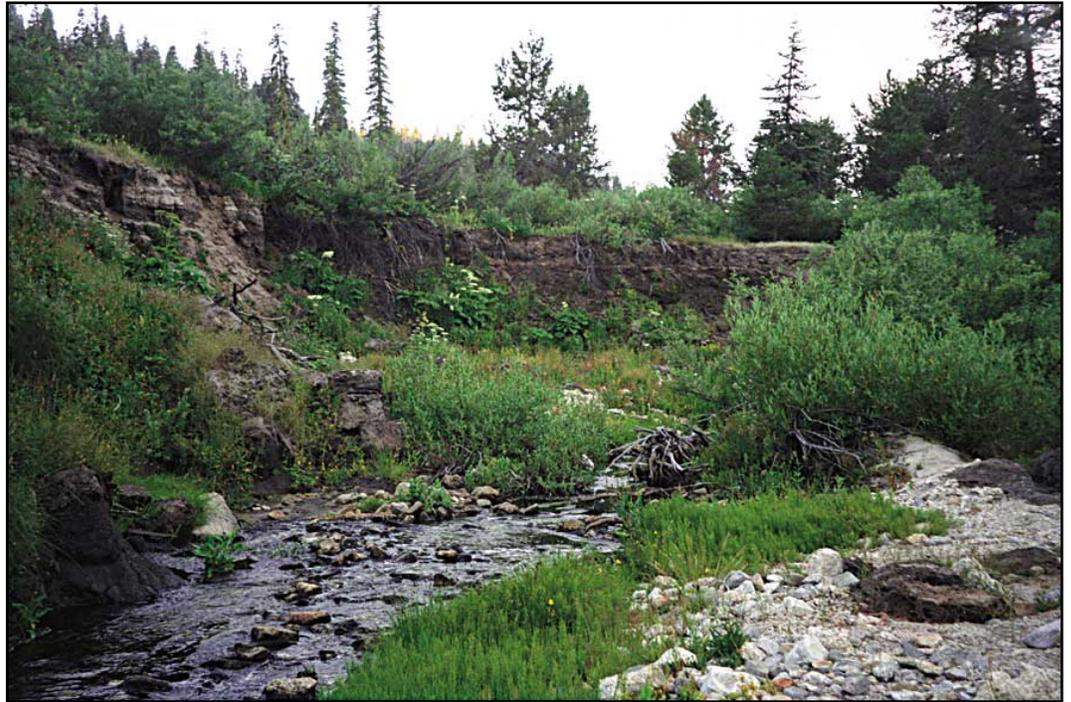
Figure 2. Channel condition. This creek scores a 3 since it no longer has access to the floodplain. See figures 3, 15, and 16 for more examples of scoring for channel condition.

This question determines whether a creek has experienced downcutting in the past, restricting full utilization of the floodplain. The score is lower if downcutting is currently active. A channel condition question was present on all assessments. It was found to be significant (NRCS: $p=0.001$; EPA: $p<0.001$; PFC: $p<0.001$) at predicting final habitat scores (NRCS: $R^2=0.998$; EPA: $R^2=0.997$; PFC: $R^2=0.757$).

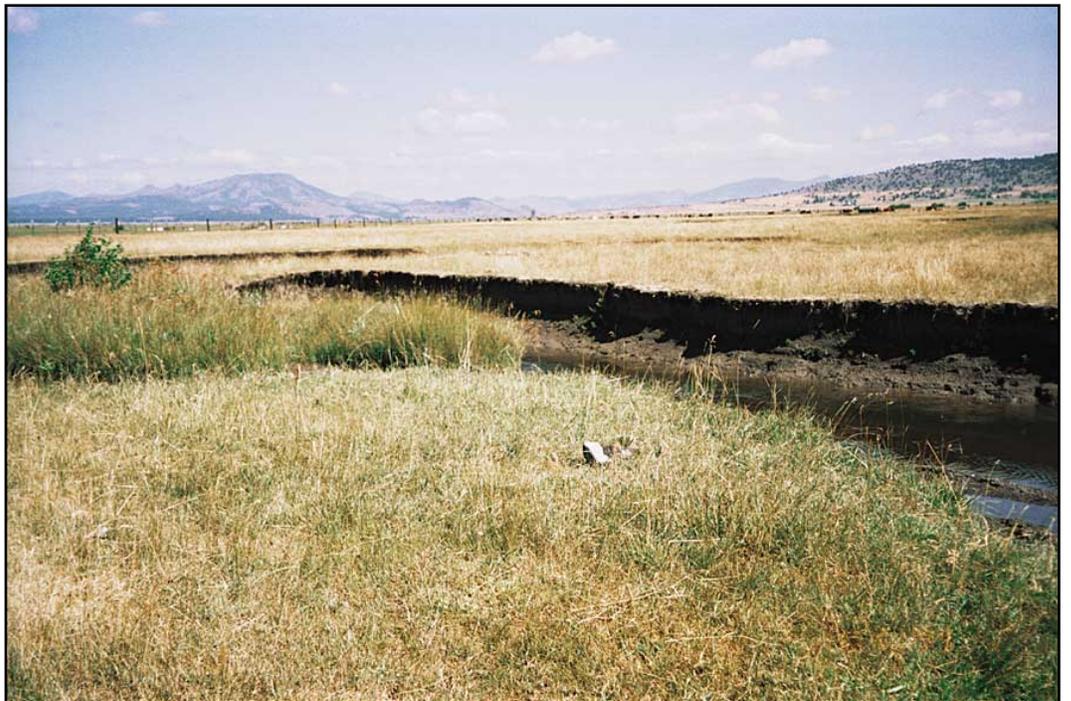
Figure 3. Channel condition. Evidence of past downcutting is one of the factors indicating a score of 8. See figures 2, 15, and 16 for more examples of scoring channel condition.

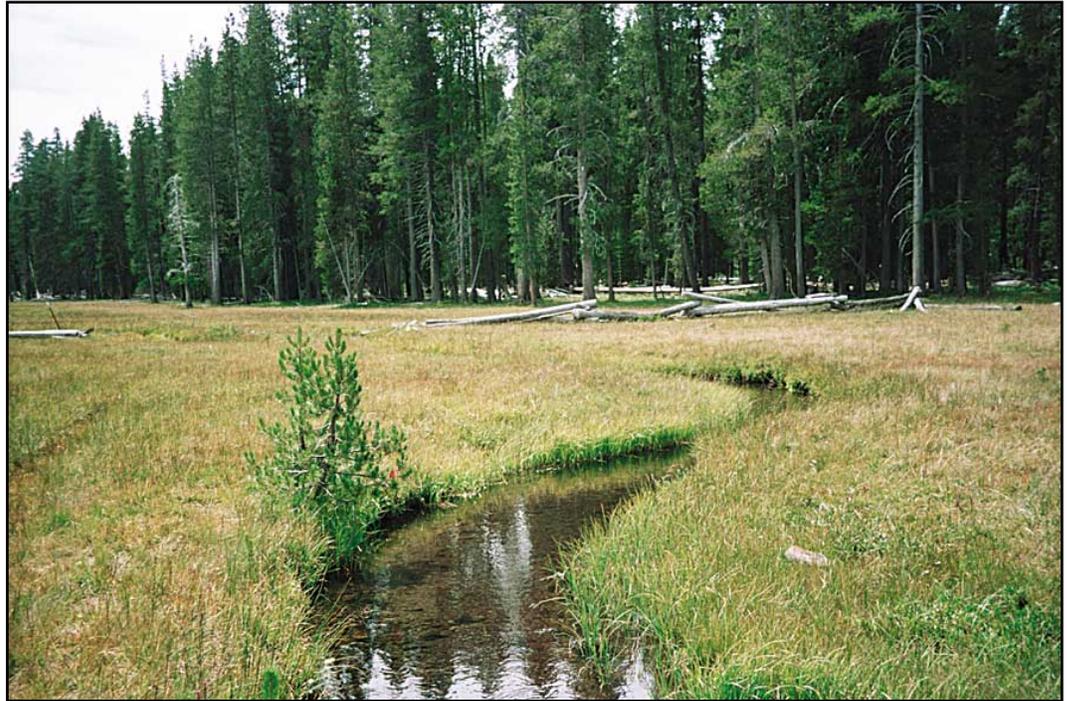
Figure 4. Access to floodplain. This site scores a perfect 12. See figures 5, 17, and 18 for more examples of scoring access to floodplain.

This question determines how often a creek exceeds bankfull. A creek should exceed bankfull every 1½ to 2 years, even if only briefly. This can be linked to Question 1. If a channel has been downcut, it will not have access to its normal floodplain (NRCS: $p=0.005$, $R^2=0.998$).

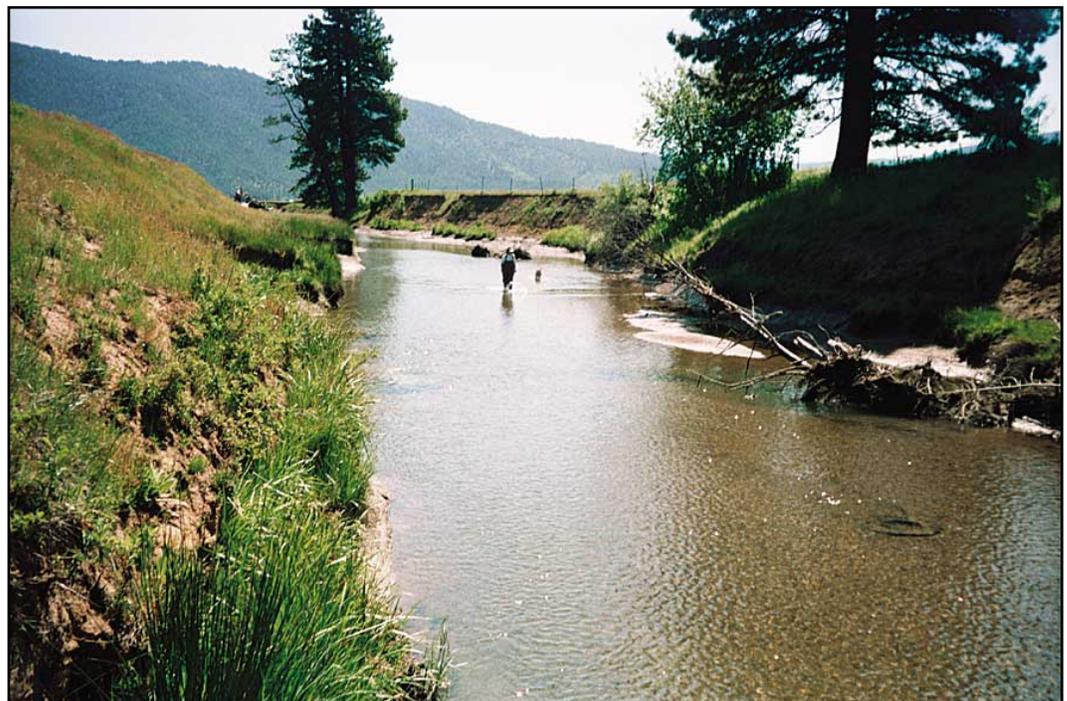
Figure 5. Access to floodplain. This creek receives a score of 1 because it is deeply incised and does not flood. See figures 4, 17, and 18 for more examples of scoring access to floodplain.

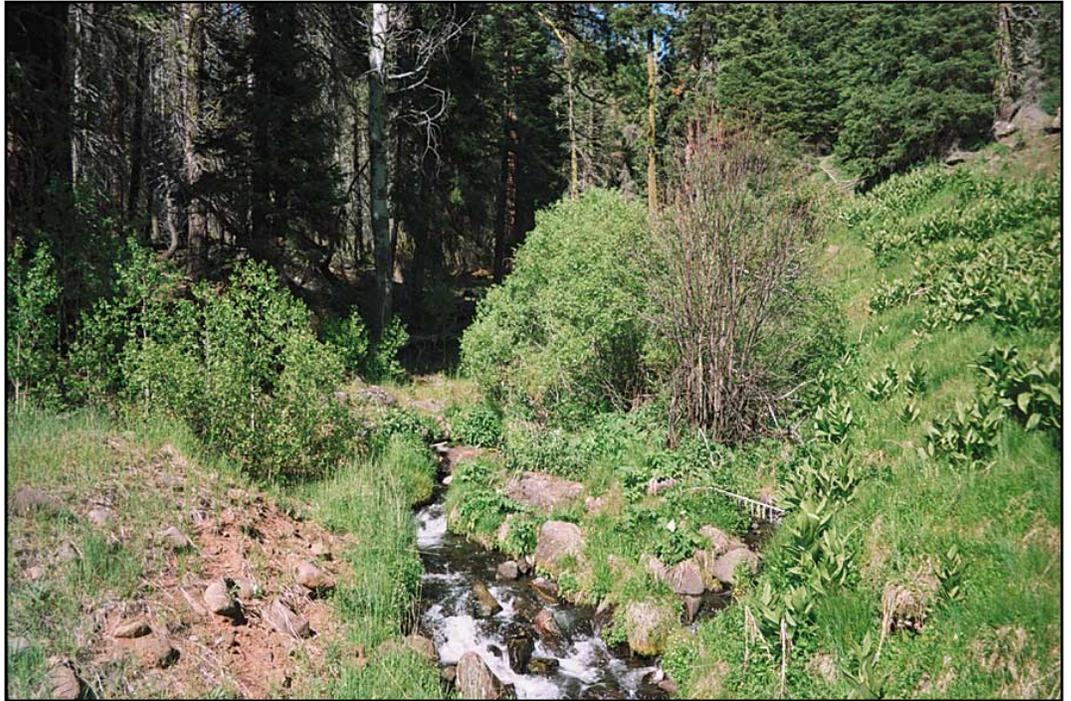
Figure 6. Bank stability. This site scores a 12 (6 for each bank). See figures 7, 19, and 20 for more examples of scoring bank stability.

This question was present in some form on all four existing assessments. Bank stability is important for healthy, functioning creeks (NRCS: $p < 0.001$, $R^2 = 0.998$; EPA: $p = 0.001$, $R^2 = 0.997$). Scoring banks separately allows for documentation of the condition of each one. For instance, if the right bank is actively eroding while the left bank is stable, assigning one score for the two together does not indicate an accurate assessment, while scoring each bank independently does. This also allows for improvements made on one bank to be more apparent in the future.

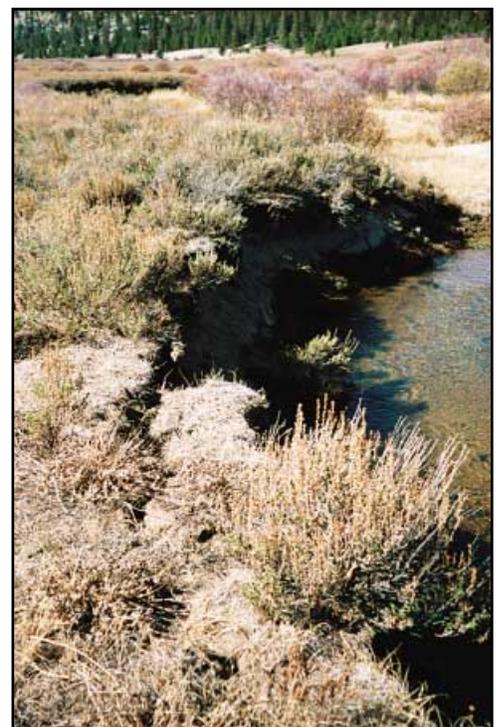
Figure 7. Bank stability. Active bank sloughing indicates a score of 2. See figures 6, 19, and 20 for more examples of scoring bank stability.

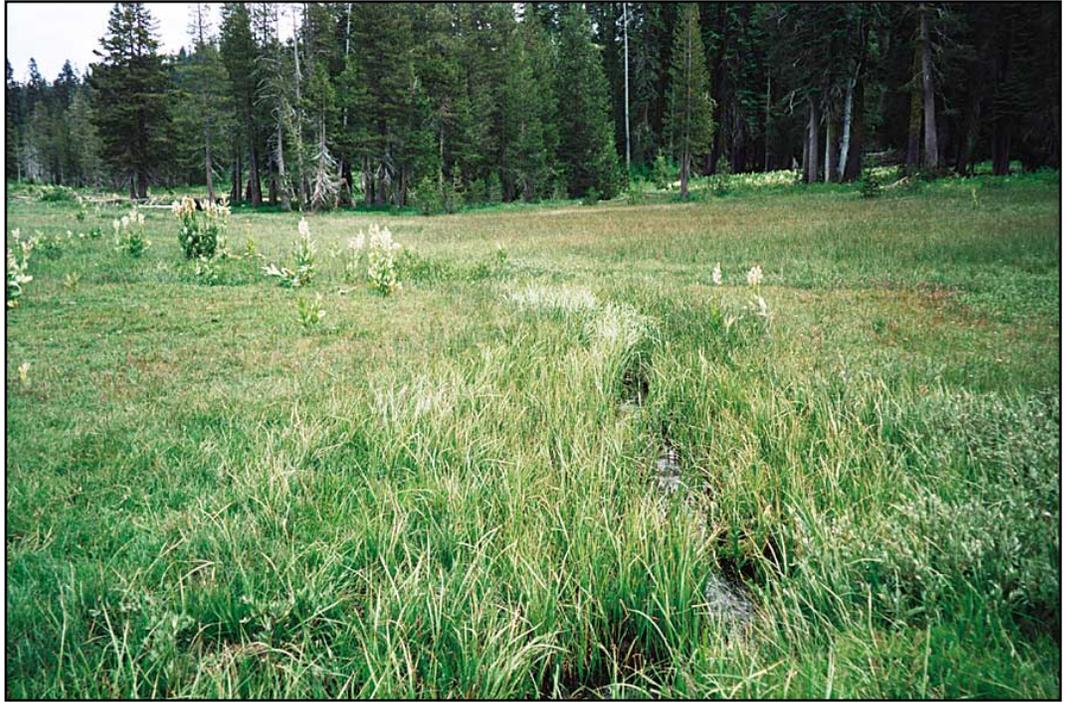
Figure 8. Riparian zone—perennial creek. This site scores a perfect 12. See figure 9 for another example of scoring the riparian zone of a perennial creek. See figures 21 and 22 for examples of scoring the riparian zone of annual systems.

Divided into perennial and intermittent creeks, riparian vegetation plays an important part in the health of a creek, providing root mats that can withstand high streamflow events (PFC: $p=0.007$, $R^2=0.757$), protect banks, and dissipate energy (PFC: $p<0.001$, $R^2=0.757$), as well as filter overland runoff of sediment and nutrients. As with bank stability, each bank is scored separately.

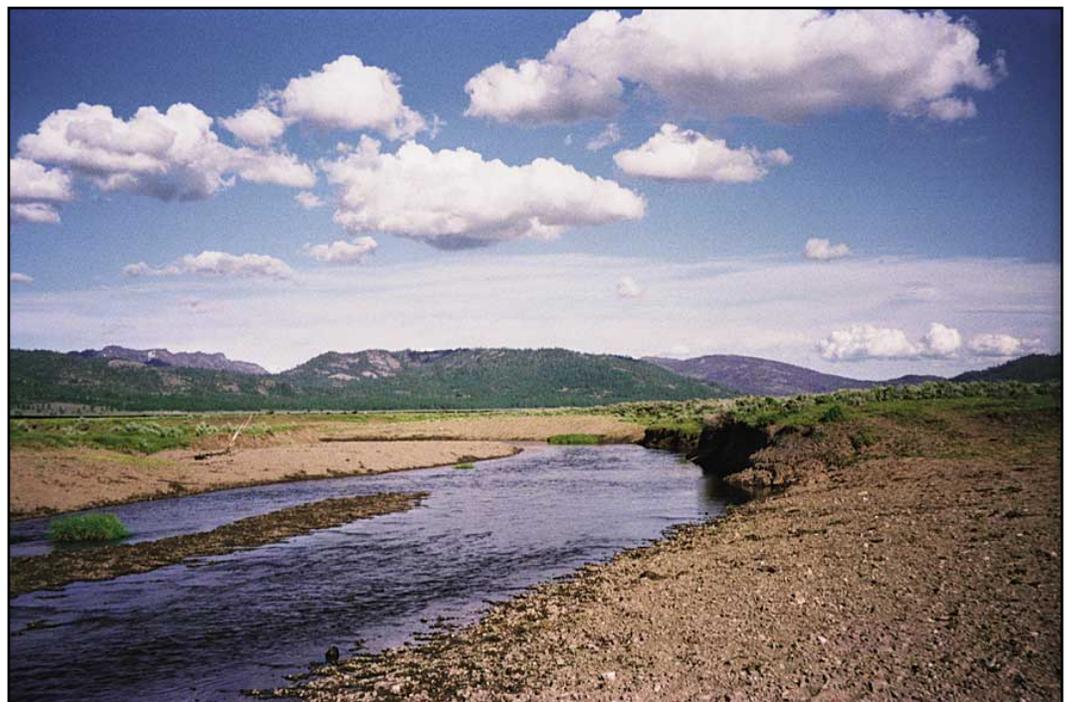
Figure 9. Riparian zone—perennial creek. Due to lack of vegetation, this creek scores a 1. See figure 8 for another example of scoring the riparian zone of a perennial creek. See figures 21 and 22 for annual systems.

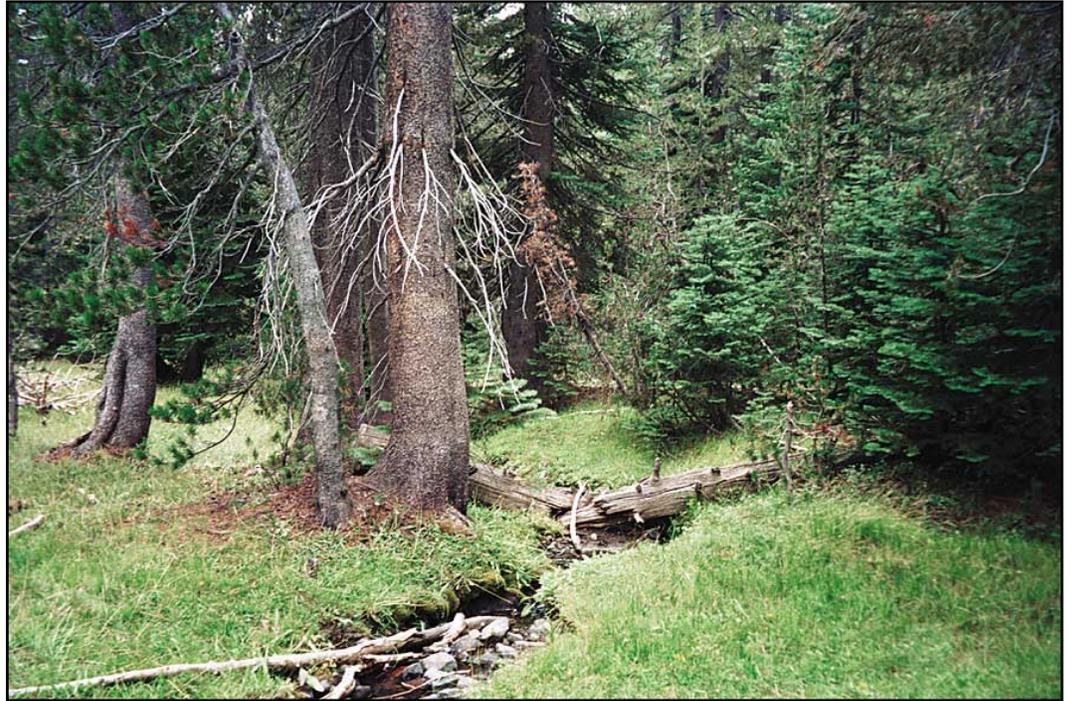
Figure 10.

Macroinvertebrate habitat. This site contains four habitat types: large woody debris, fine woody debris, cobbles, and undercut banks.

All creeks contain some macroinvertebrates. Therefore, it is important to examine the habitat available to them (EPA: $p < 0.001$, $R^2 = 0.997$). Possible habitats include cobbles, boulders, coarse gravel, and aquatic vegetation. To score this question, the types of habitats present are counted and categorized.

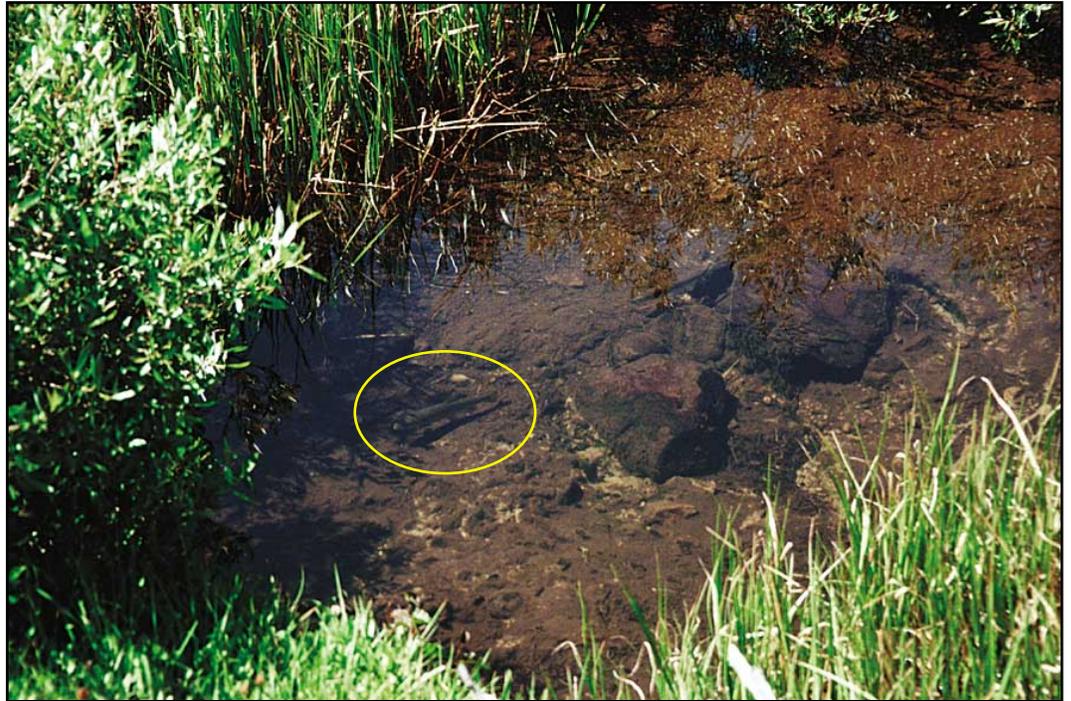
Figure 11. Fish habitat. This creek has a deep pool habitat with fish in it. See figures 12, 23, and 24 for more examples of fish habitat.

Not all of California's creeks and streams have the potential to support a fishery due to inadequate year-round flow, natural downstream obstructions such as waterfalls, and other natural factors. This question should be answered if it is reasonable to expect a fishery for the creek in question. Fish habitat is an important factor to consider (EPA: $p < 0.001$, $R^2 = 0.997$) and is scored similarly to macroinvertebrate habitat (Question 5), with possible habitat types including large woody debris, cobbles, boulders, aquatic vegetation, riffles, and so on.

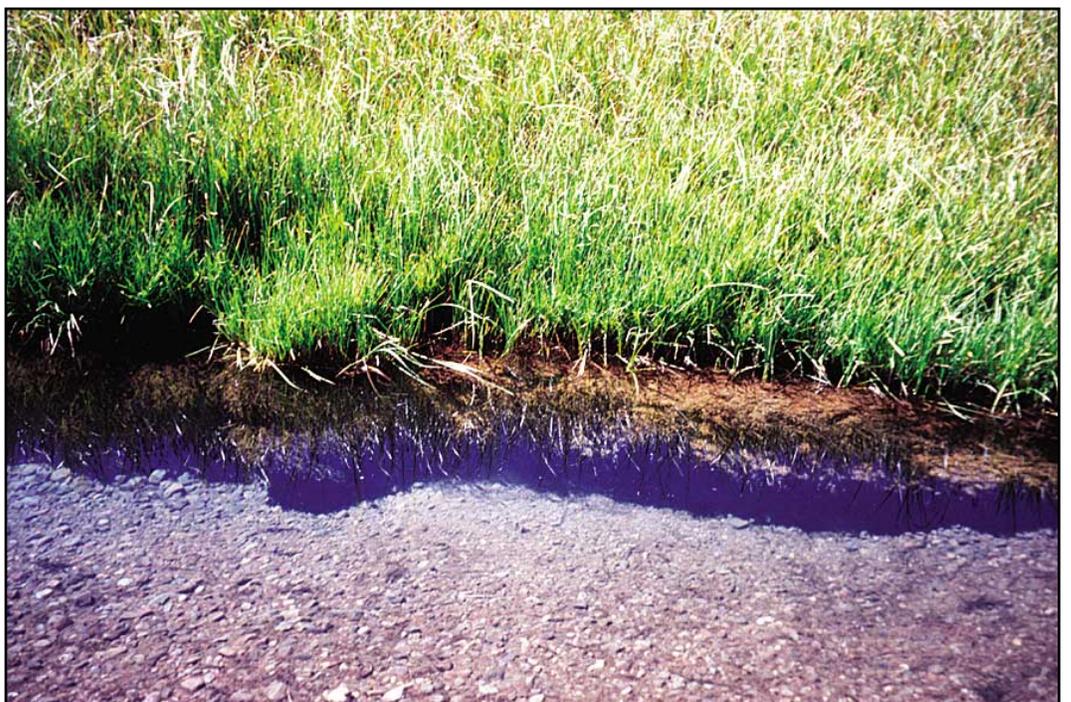
Figure 12. Fish habitat. This creek has a stable, undercut bank. See figures 11, 23, and 24 for more examples of fish habitat.

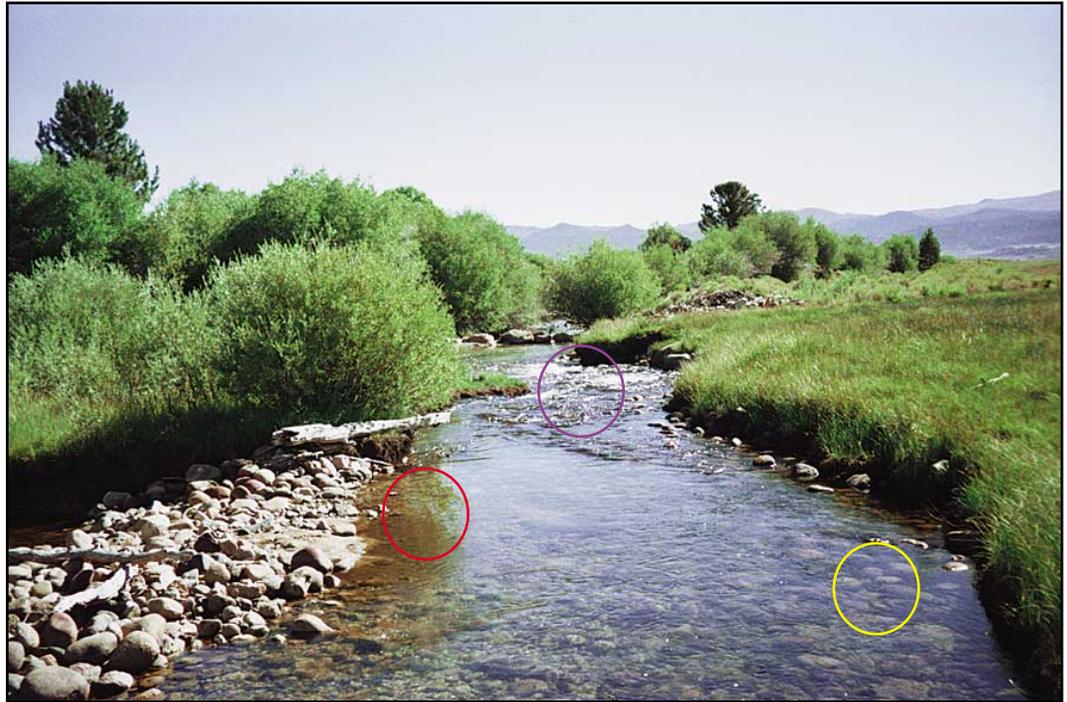
Figure 13. Velocity depth regime. A combination of fast-shallow (purple circle), fast-deep (yellow circle), and slow-shallow (red circle) regimes are present at this site.

High gradient creeks should have a variety of velocity depth regimes present, providing different habitat niches for various aquatic life. Fast-shallow sections add dissolved oxygen into the creek, and slow-deep sections allow fish cover out of the current. This question was again found to be a significant factor in stream health (EPA: $p < 0.001$, $R^2 = 0.997$).

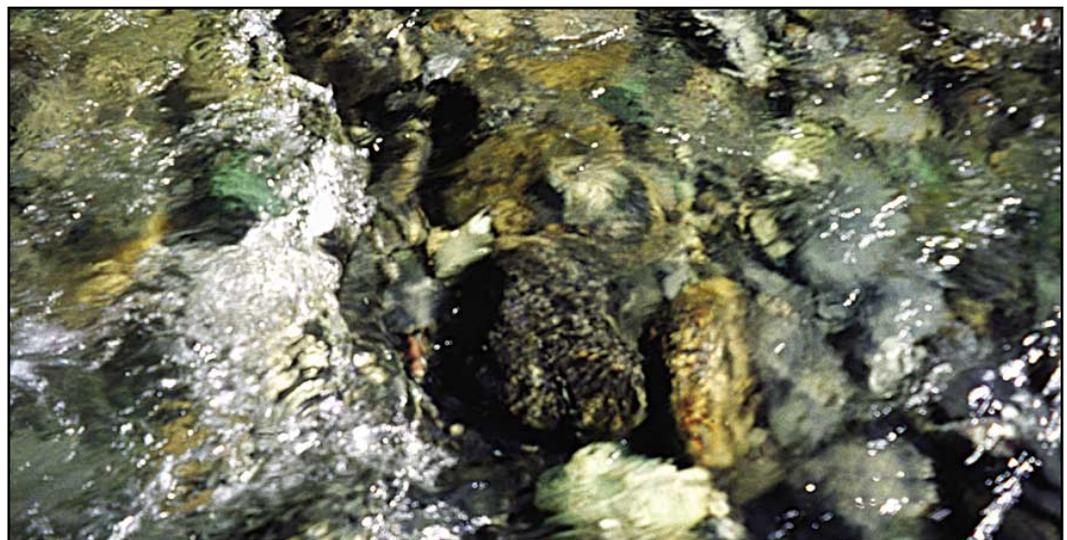
Figure 14. Riffle embeddedness. This creek shows a good example of a clean riffle.

High gradient creeks are dominated by riffles, important features in both dissipating velocity and providing habitat. To function properly, riffles should be free of sediment and the cobble and gravel substrate should not be embedded in the silts and clays. This question was evaluated by the percent of fines accumulating in the riffle (EPA: $p = 0.027$, $R^2 = 0.997$).

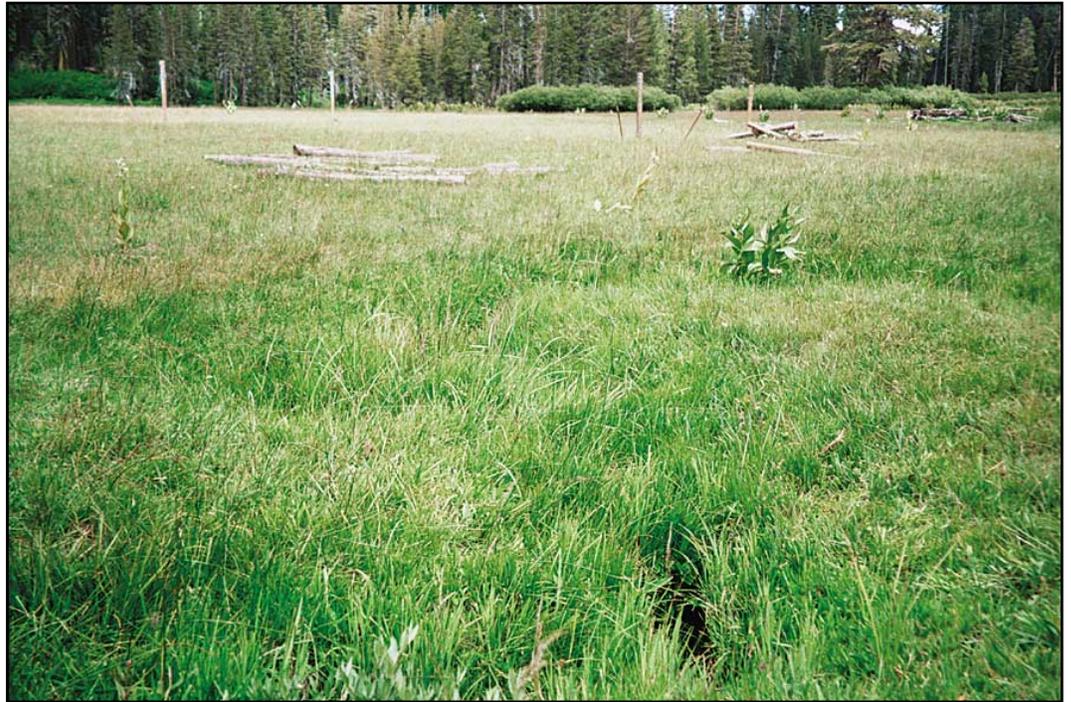
Figure 15. Channel condition. This site scores a 12 because this is the natural channel and there is no evidence of downcutting. See figures 2, 3, and 16 for more examples of scoring channel condition.

This question determines whether a creek has experienced downcutting in the past, restricting full utilization of the floodplain. The score is lower if there is active downcutting. A channel condition question was present on all assessments in some form. It was found to be significant (NRCS: $p=0.002$; EPA: $p<0.001$; PFC: $p<0.001$) at predicting habitat scores (NRCS: $R^2=0.996$; EPA: $R^2=0.996$; PFC: $R^2=0.774$).

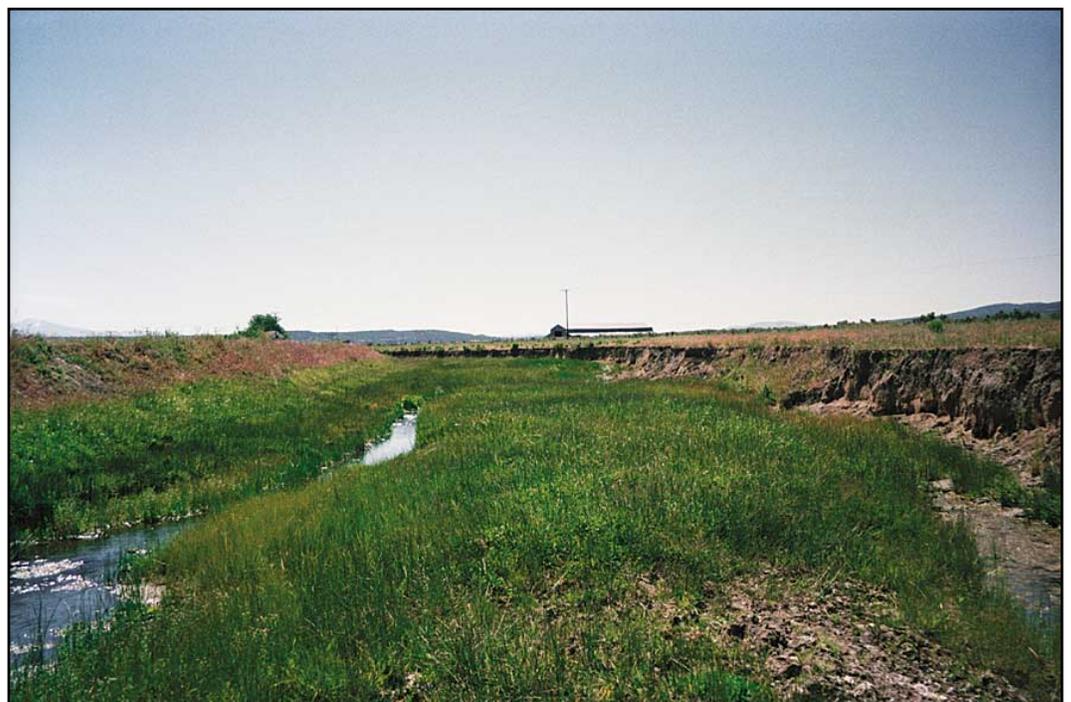
Figure 16. Channel condition. A score of 4 goes to this creek because the floodplain is restricted and downcutting has been extensive throughout the reach. See figures 2, 3, and 15 for more examples of scoring channel condition.

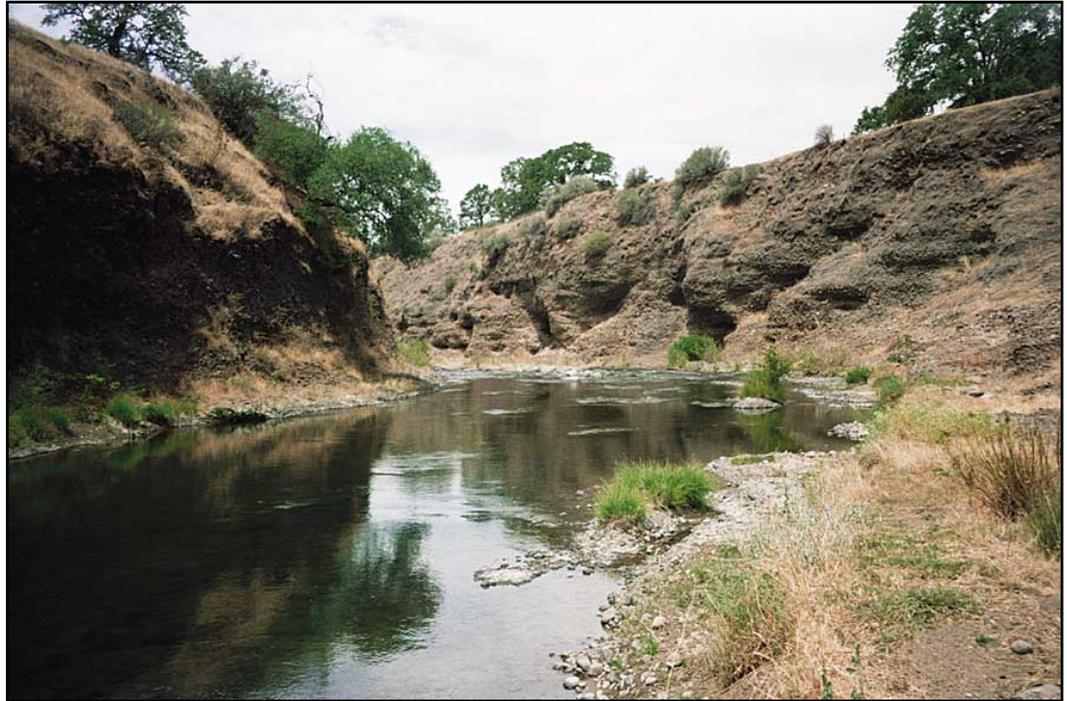
Figure 17. Access to floodplain. This creek scores a 7 due to limited flooding. Flooding only takes place with large storm systems that occur approximately every 10 to 15 years. See figures 4, 5, and 18 for more examples of scoring access to floodplain.

This question determines how often a creek exceeds bankfull. A creek should exceed bankfull every 1½ to 2 years, even if only briefly. This can be linked to Question 1. If a channel has been downcut, it will not have access to its normal floodplain. (PFC: $p < 0.001$, $R^2 = 0.774$)

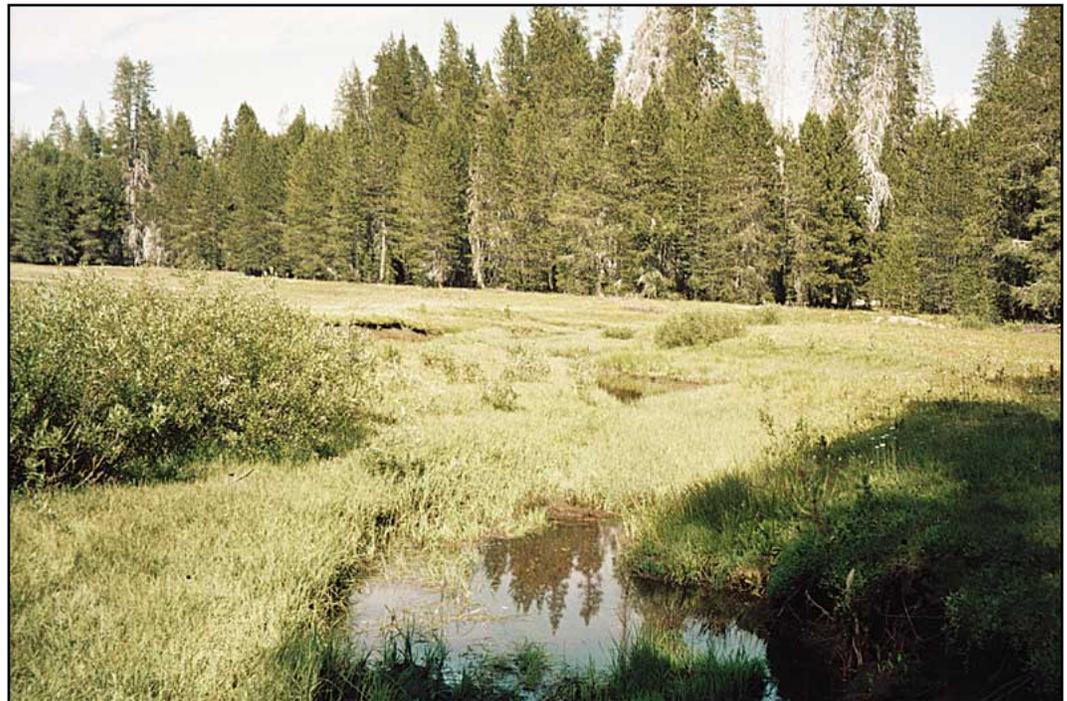
Figure 18. Access to floodplain. This site scores an 8 because there is a limited incision that reduces access to the floodplain to 3- to 5-year events. See figures 4, 5, and 17 for more examples of scoring access to floodplain.

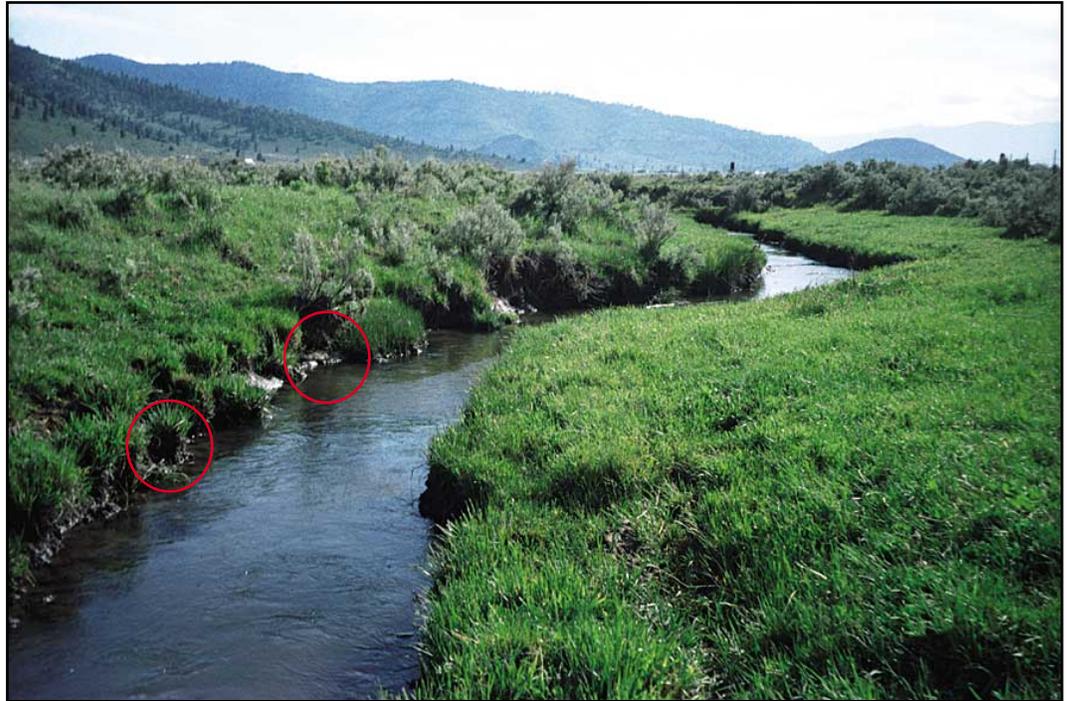
Figure 19. Bank stability. Because of the unstable areas circled in red, a score of 11 is given to this creek (6 for the right bank and 5 for the left bank). See figures 6, 7, and 20 for more examples of scoring bank stability.

This question was present in some form on all existing assessments. Bank stability is important for healthy, functioning creeks (NRCS: $p < 0.001$, $R^2 = 0.996$; EPA: $p < 0.001$, $R^2 = 0.996$). Scoring banks separately allows for documentation of the condition of each one. For instance, if the right bank is actively eroding while the left bank is stable, assigning one score for the two together does not indicate an accurate assessment while scoring each bank independently does. This also allows for improvements made on one bank to be more apparent in the future.

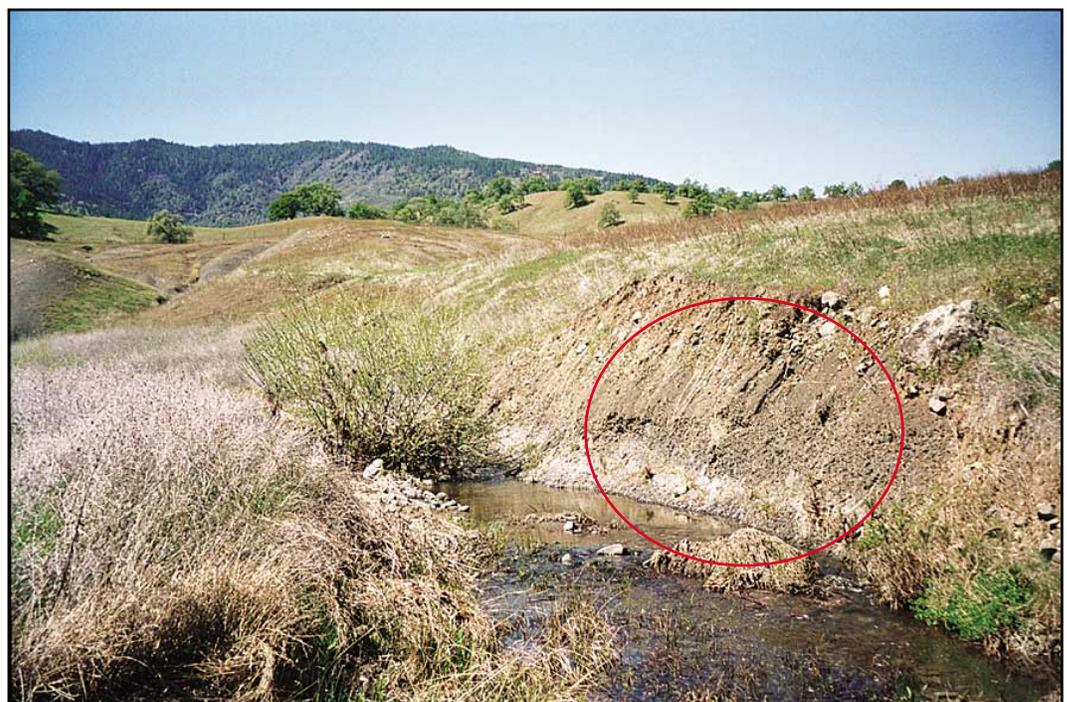
Figure 20. Bank stability. Because of the unstable area circled in red, this site scores 8.5 (3 for the eroding left bank and 5.5 for the stable right bank). See figures 6, 7, and 19 for more examples of scoring bank stability.

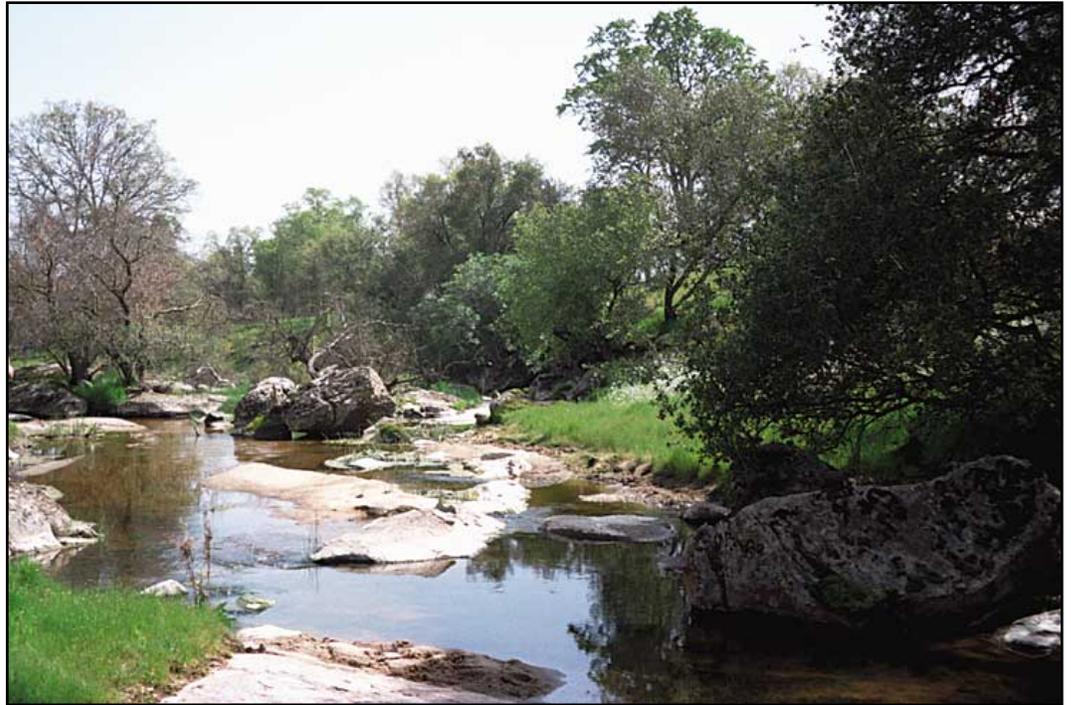
Figure 21. Riparian zone—intermittent creek. This creek scores an 11 (left bank: 5; right bank: 6), noting the bare sand bars. See figure 22 for more on scoring the riparian zone of an intermittent creek, and figures 8 and 9 for perennial systems.

Divided into perennial and intermittent creeks, riparian vegetation plays an important part in the health of a creek, protecting banks and dissipating energy (NCRS: $p=0.001$, $R^2=0.996$; PFC: $p<0.001$, $R^2=0.774$), as well as filtering overland runoff of sediment and nutrients. It is also important that a diverse age class (PFC: $p=0.020$, $R^2=0.774$) and a diverse composition (PFC: $p=0.038$, $R^2=0.774$) be present. Revegetating point bars are also an upward sign of riparian health (PFC: $p<0.001$, $R^2=0.774$). As with bank stability, each bank is scored separately.

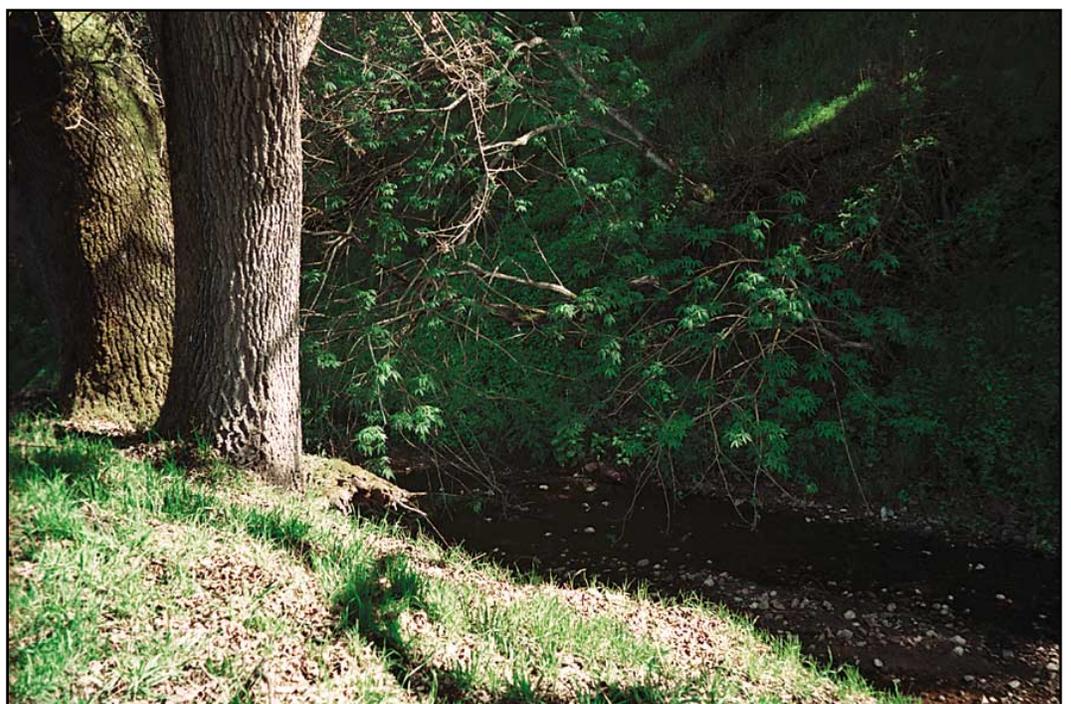
Figure 22. Riparian zone—intermittent creek. Due to the bare gravel bars, this creek scores a 10 (left bank: 4.5; right bank: 5.5). See figure 21 for more on scoring the riparian zone of an intermittent creek, and figures 8 and 9 for perennial systems.

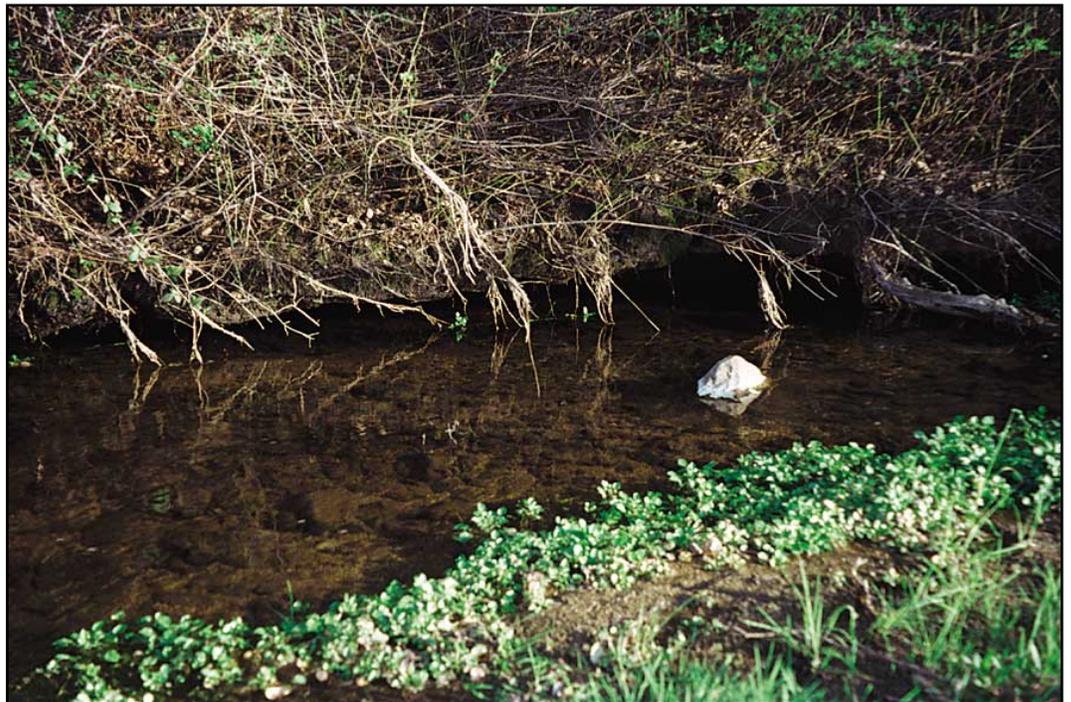
Figure 23. Fish habitat. A stable, undercut bank is a good fish habitat. See figures 11, 12, and 24 for more examples of fish habitat.

Not all of California's creeks and streams have the potential to support a fishery due to inadequate year-round flow, natural downstream obstructions such as waterfalls, and other natural factors. This question should be answered if it is reasonable to expect a fishery for the creek in question. Fish habitat is an important factor to consider (NRCS: $p < 0.001$, $R^2 = 0.996$; EPA: $p < 0.001$, $R^2 = 0.996$) and is scored similarly to macroinvertebrate habitat (Question 5), with possible habitat types including large woody debris, cobbles, boulders, aquatic vegetation, and riffles.

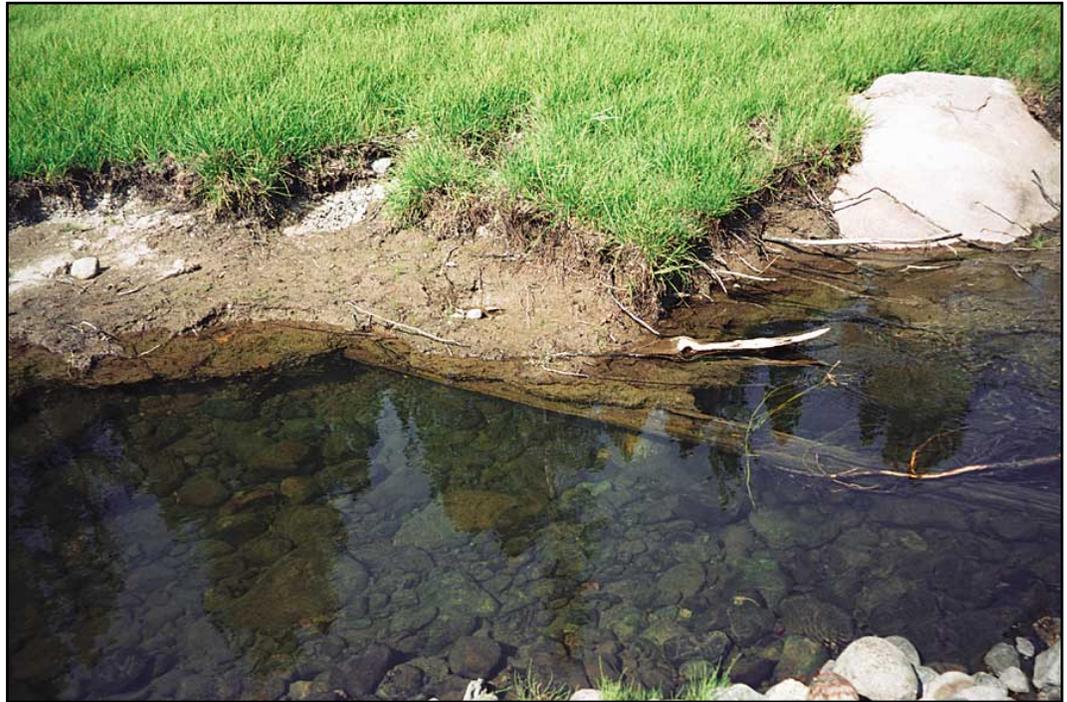
Figure 24. Fish habitat. A deep pool and large woody debris are good habitats for fish. See figures 11, 12, and 23 for more examples of fish habitat.

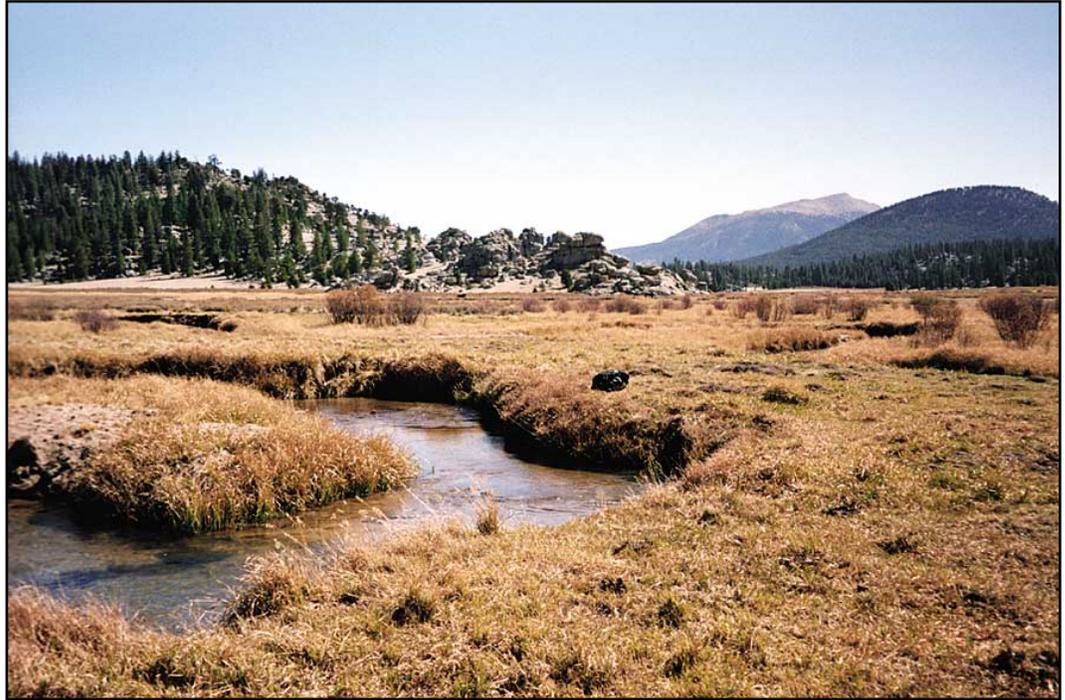
Figure 25. Channel flow. This site scores a 12 because of its full flow. See figure 26 for another example of scoring channel flow.

Even while considering that channel flow varies depending on the time of year, it is still an important factor to monitor (EPA: $p < 0.001$, $R^2 = 0.996$). When water does not fill the majority of the channel, substrate can be exposed, limiting both fish and macroinvertebrate habitat potential. For intermittent or ephemeral creeks, the assessment should be completed while there is still a flowing creek.

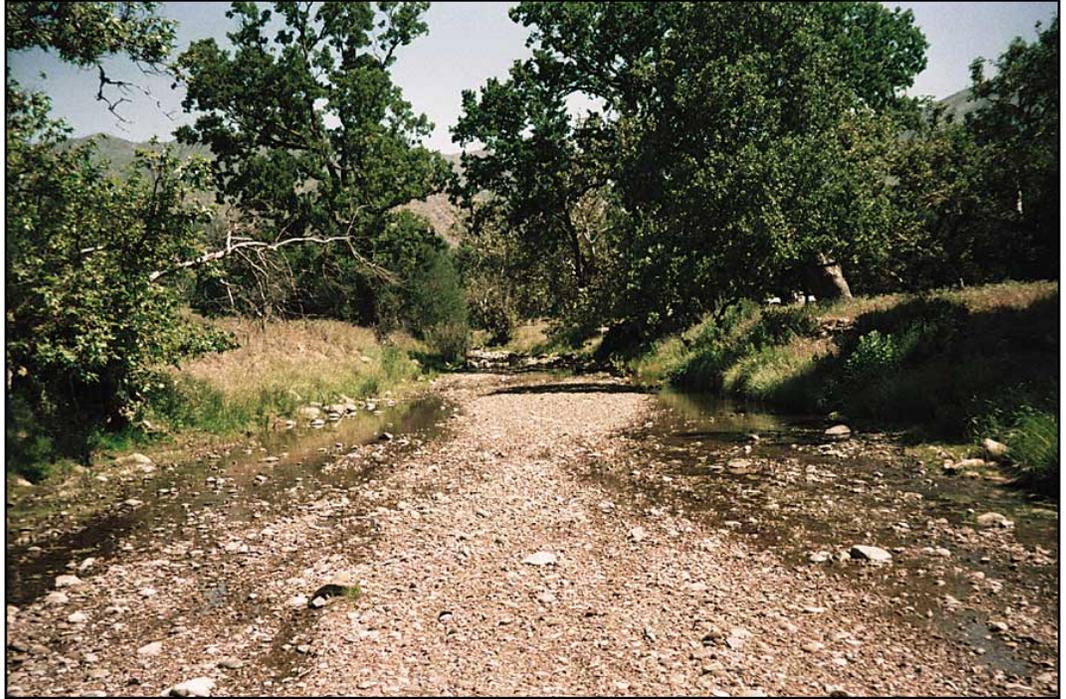
Figure 26. Channel flow. This creek has low channel flow. It scores a 3. See figure 25 for another example of scoring channel flow.
